# WIRE Case Study

## WIRE Failure Case Study

by James S. Barrowman

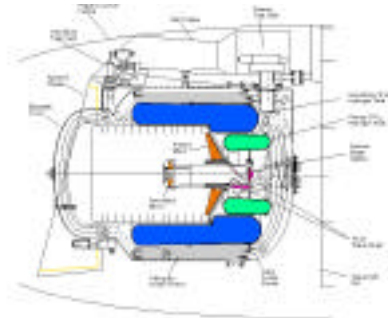
A cutaway of the WIRE Cryostat

A contributory design issue was the placement of the cryogenic vent. The vent itself followed good design practice and had a "T" fitting at the end to eliminate thrust from the venting of the cryogen. Because the thermal loads were much greater than expected, the vent rate was much higher and more forceful than anticipated. Unfortunately, the vent was close enough to another structure that the higher level of venting was deflected by that structure and induced a thrust and moment on the spacecraft that sent it tumbling.

The detailed vent design was never reviewed because it was not done until after the cryostat was built and delivered. The potential impingement problem was noticed by the project systems engineer when the instrument was delivered; but, based on low expected vent rates, the project office decided that it was not prudent to pursue a change four months before launch.
