6.0 RE-USABLE SOLID ROCKET MOTOR

7.0 SOLID ROCKET BOOSTER

8.0 SPACE SHUTTLE MAIN ENGINE

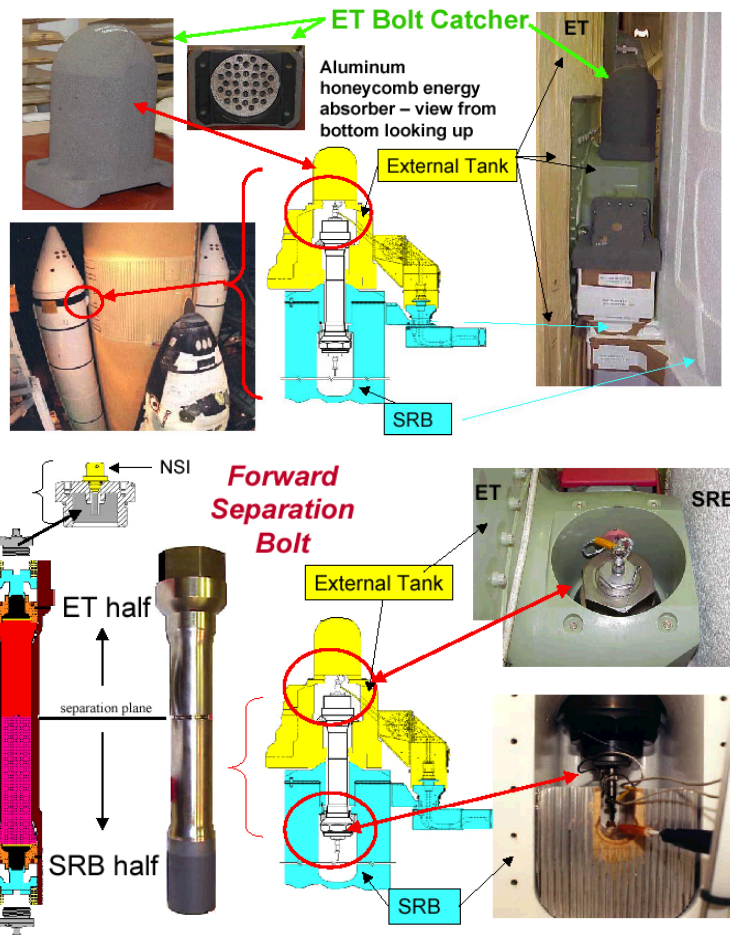
Four blocks on the STS-107 SRB fault tree remain open pending completion of forward bolt catcher testing. The bolt catcher, shown in Figure 7-1, was not qualified as an assembly, and structural qualification testing was not representative of the current flight configuration. The exact magnitude of loads transmitted to the bolt catcher housing cannot be determined based on available data. The SLA-561 thermal protection system (TPS) material on the bolt catcher was qualified by test and analysis for general ET application, but no pyrotechnic shock testing was performed. There is no test data available on the bolt catcher honeycomb dynamic crush strength versus separation bolt velocity, and random pressure loading from the NASA Standard Initiator (NSI) ejection was not included in the original qualification tests. Lastly, the running torque/break-away torque was not measured during STS-107 bolt catcher fastener and ET range safety system (RSS) fairing installation, which is used to verify the insert locking feature is in place. A review has determined that the bolt catchers and RSS fairings were installed and secured for flight with the correct bolts and final torque. Testing is in work to close the four remaining fault tree blocks, but initial static tests results show failure below the required safety factor of 1.4.

Figure 7-1. Details of SRB/ET forward separation bolt catcher assembly

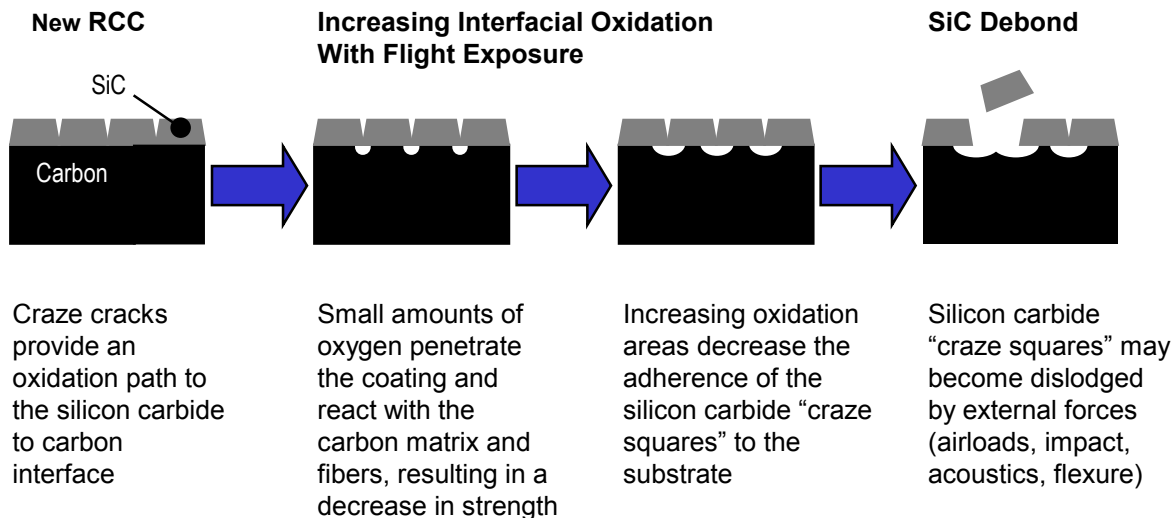
Subsurface oxidation has been discovered beneath the silicon carbide surface cracks in the sealant and coating which allow the oxidation process to thrive. This process is considered to be an impact to RCC mission design life, but is not generally considered to be a safety of flight issue. This oxidation process (Figure 10-7) starts with the breakdown of the coating due to entry heating. Surface craze cracks allow oxygen to migrate to the subsurface carbon fibers and react with them. This increase in oxidation develops into larger crazed areas, which eventually allow pieces to become dislodged due to vibration, aerodynamic, or thermal loads. Once the pieces dislodge, they leave a large path for the oxidation process to continue.

Figure 10-7. RCC corrosion process

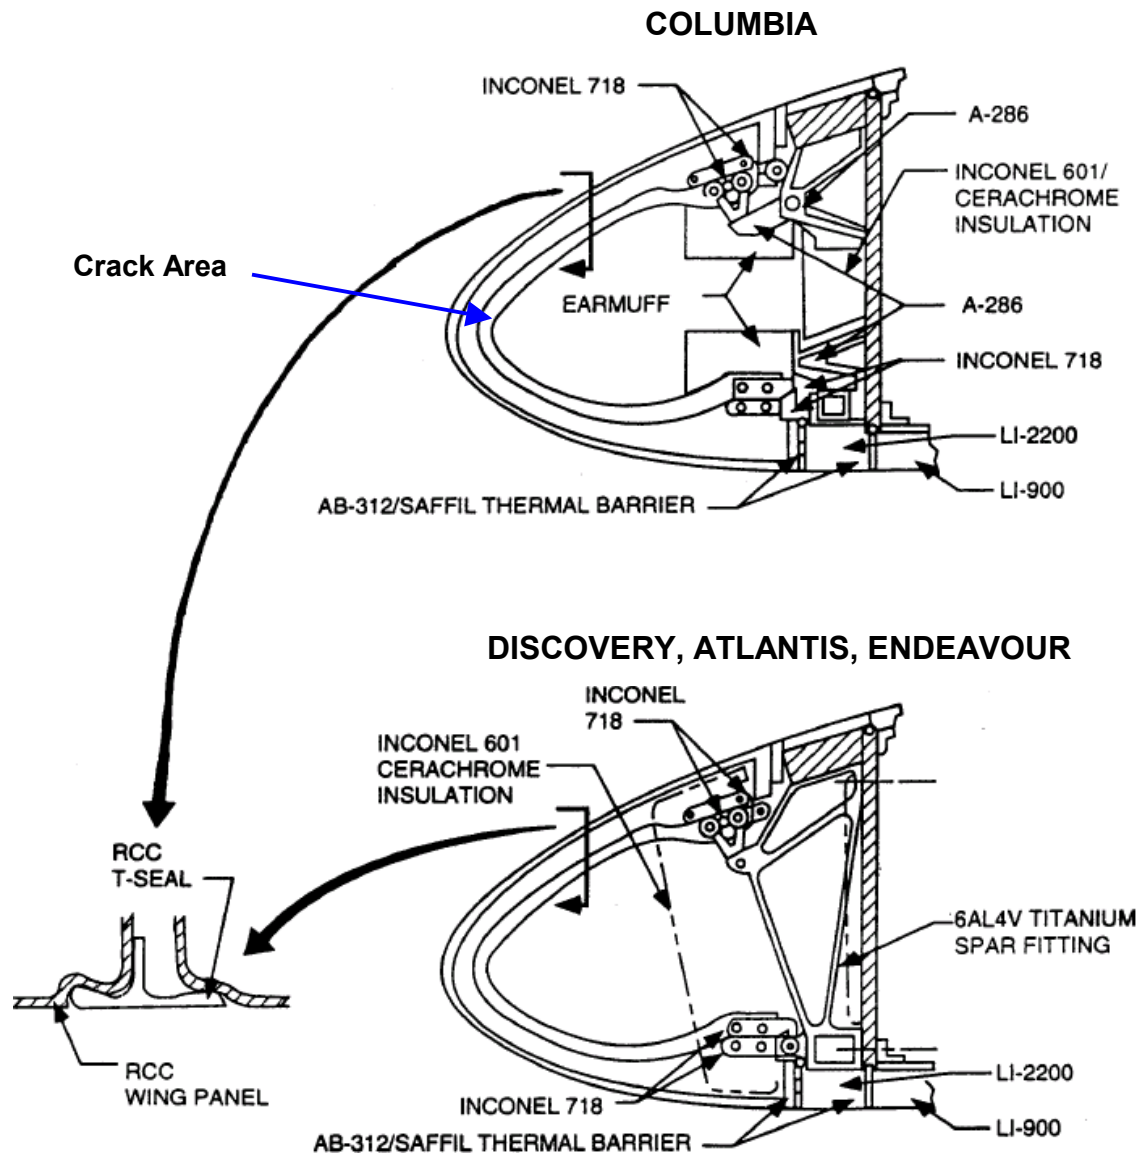
Each wing leading edge RCC panel shares a Tee seal that is used to close the gap between adjacent RCC panels. Following STS-43 (Atlantis) in August 1991, routine inspections identified cracks in the web of a Tee seal. The cracks were in the silicon carbide coating and occasionally in the substrate, and were due to normal shrinkage. They were typically less than 1/2 inch long, were not visible to the naked eye, and usually occurred in the web of the seal, on the backside of the seal (Figure 10-8) near the apex rather than on the leading edge. Further examination of the remainder of the shuttle fleet identified 20 (of 132) cracked Tee seals. Columbia had 11 Tee seals identified with possible cracks. Detailed inspections determined that all the cracks were typical of the surface craze cracks in the coating. The Tee seal cracks were determined to be caused by warping of the substrate fabric during lay-up during the original build. The Tee seal cracking (Figure 10-9) leads to a reduction in mission life and loss of oxidation protection. All the seals were refurbished with new coating and sealant and were reinstalled. Failure analysis showed that cracks would form after excessive wishbone loading (bending) caused the brittle coating to crack. Crack testing was performed in 1991 on Tee seal 10 (attached to RCC panel 9) from the left wing of Columbia to try to determine the crack mechanism. The Tee seal was cycled 400 times in bending up to 70% of its ultimate load and no discernable damage was noted. After an engineering evaluation was performed on the health and strength of the Tee seal, it was subsequently reinstalled on Columbia.

Figure 10-8. Tee seal crack location

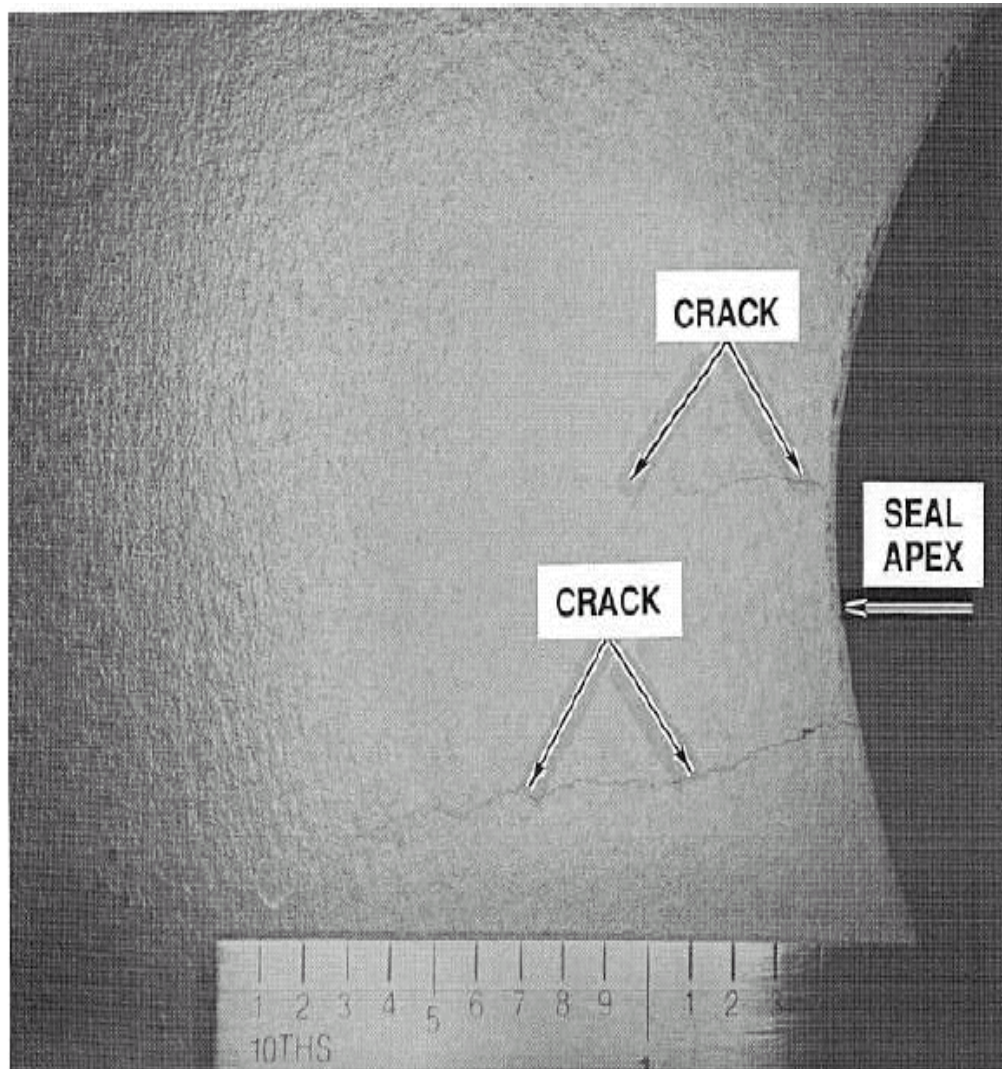
Figure 10-9. Tee seal cracking

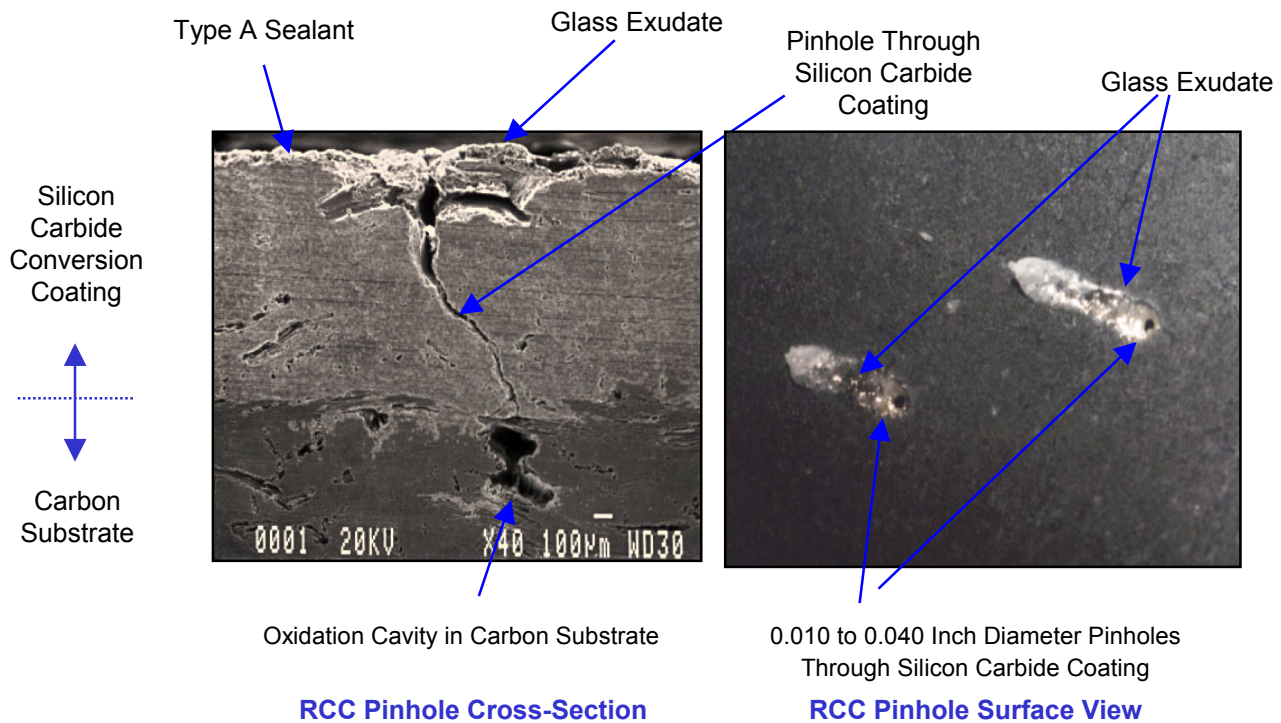
Another phenomenon, discovered first on Columbia after STS-50 landed, was the existence of pinholes (Figure 10-10) in the RCC panels. The pinholes were found primarily in the wing leading edge RCC and were subsequently identified on all orbiters. Testing has shown that the pinholes are most likely the result of the accelerated oxidation process involving zinc oxide and the silicon carbide coating. The reaction of the zinc oxide and the silicon carbide produces a silica (glass) exudate that flows out of the pinhole area. The presence of zinc oxide is theorized to originate from the paint primer used to recondition the launch pad after each mission and is considered an accelerator to the oxidation process. The zinc-based contamination accumulates on the wing leading edge RCC as rainwater drips off of the launch pad. This contamination rests on the RCC without reacting to the surface material while at ambient conditions at the pad. All of the damaging oxidation occurs once the RCC is exposed to the high temperatures, pressures, and excess oxygen of re-entry. Only a few pinholes have been observed on the nose cap RCC, most likely because the nose

cap remains under a protective cover while at the launch pad. It is also believed that sodium chloride contributes to the oxidation process, but to a much lesser extent than the zinc oxide.

Figure 10-10. RCC pinholes

In 1997, pinhole acceptance criteria were established. Pinholes with surface dimensions less than 0.040 inches discovered during routine processing flows are acceptable to fly as is for up to 16 missions unless the carbon substrate is exposed, in which case the panel must be repaired. Pinholes discovered at OMM greater than 0.040 inches are unacceptable. Although the pinholes themselves constitute only a small mass loss, they are not considered to be a safety-of-flight issue by themselves. Analysis has identified that the sustainable thru-hole size in-flight due to orbital debris is 0.25 inches in the lower surfaces of RCC panels 5-13. A hole under 1 inch in diameter anywhere else in the RCC is considered survivable for a single mission.

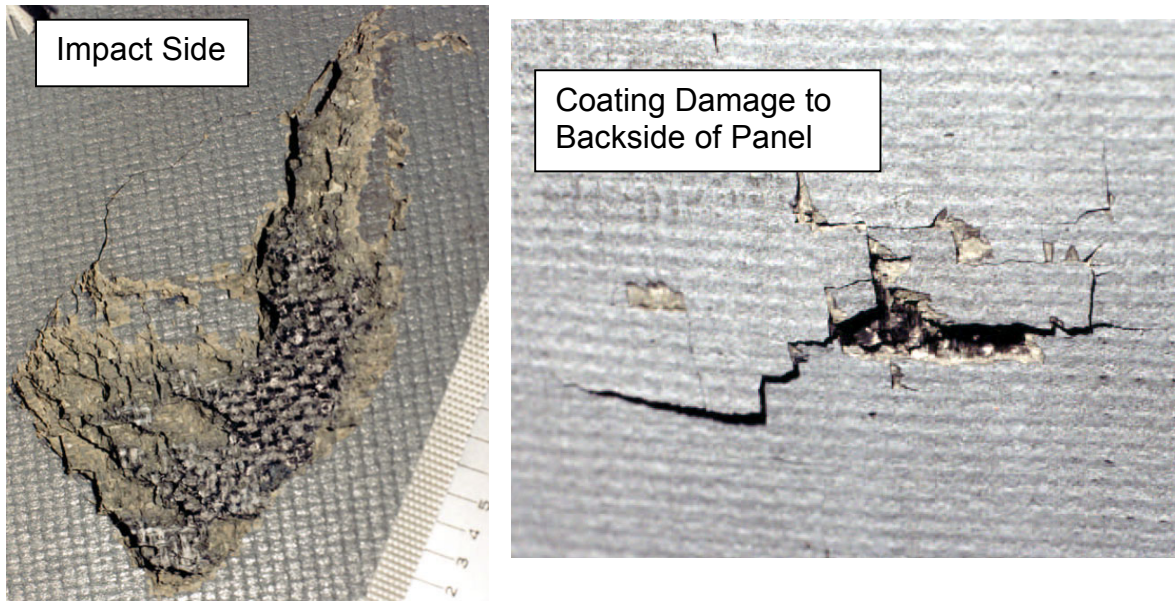
There have been damaged RCC panels that were discovered after the vehicle returned from space on various missions. Some of the impact damage was only to the surface, but some even caused damage to the coating on the backside of the panel. In 1992, after STS-45, significant impact damage (overall length of ~1.75 inches) was noted on RCC panel 10R on Atlantis. The damage (Figure 10-11) was theorized to come from Orbital debris or micrometeorite impacts during the mission. This type of RCC damage is of particular concern in that a significant impact could cause a hole in the RCC large enough to lead to wing spar burn through and subsequent loss of crew and vehicle. At that time, the maximum acceptable hole size (0.040”) criterion was established for

Figure 10-11. RCC impact damage

processing flows and advanced wing leading edge internal insulation was modified to reduce the risk should hot gas penetrate the RCC.

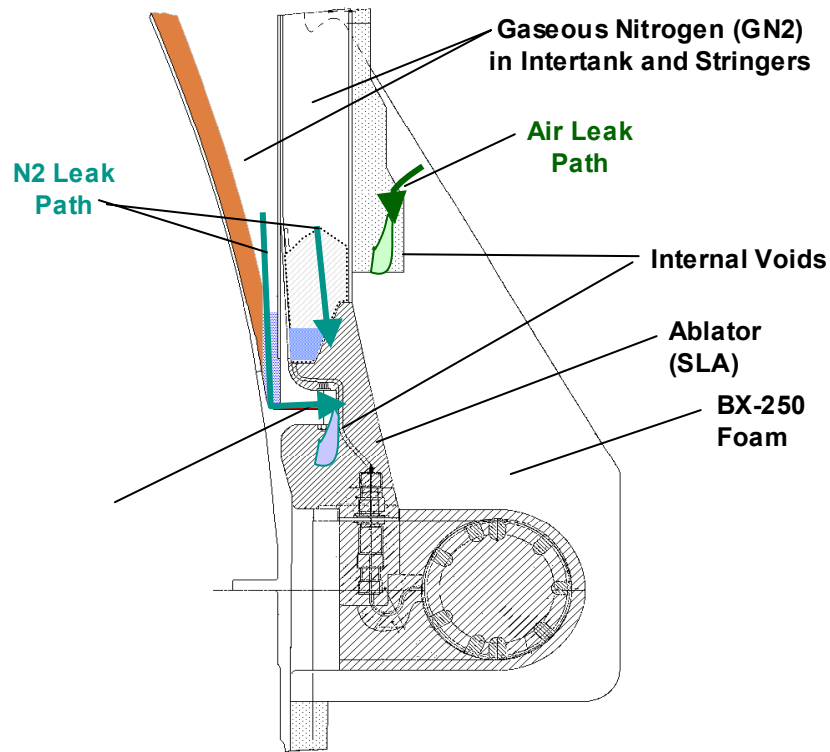
Cryopumping could contribute to bipod foam loss, shown schematically in Figure 11-8. The mechanism that drives cryopumping is the transformation of a gas to a liquid at cryogenic temperatures. Gases may condense within a void or porous material at low temperatures. Air in cavities or porous material liquefies when in contact with structure below -297°F for oxygen or -320°F for nitrogen. Pressure is reduced locally due to the condensation. If a leak path exists, more air will be “pumped,” providing more gas to condense. When the structure warms, the consequence of cryopumping is that the liquefied air returns to the gaseous state with a local pressure increase. If the leak path is large, gas escapes with no detrimental effect. However, if the leak path is small,

cracks may form in the TPS to relieve pressure, or a rapid increase in pressure may result in a divot. In order for this to occur, the inlet source must be blocked off to avoid venting out the inlet. It should be noted that testing has been unable to demonstrate cryopumping in this application.

Figure 11-8. Schematic of bipod ramp - potential cryopumping

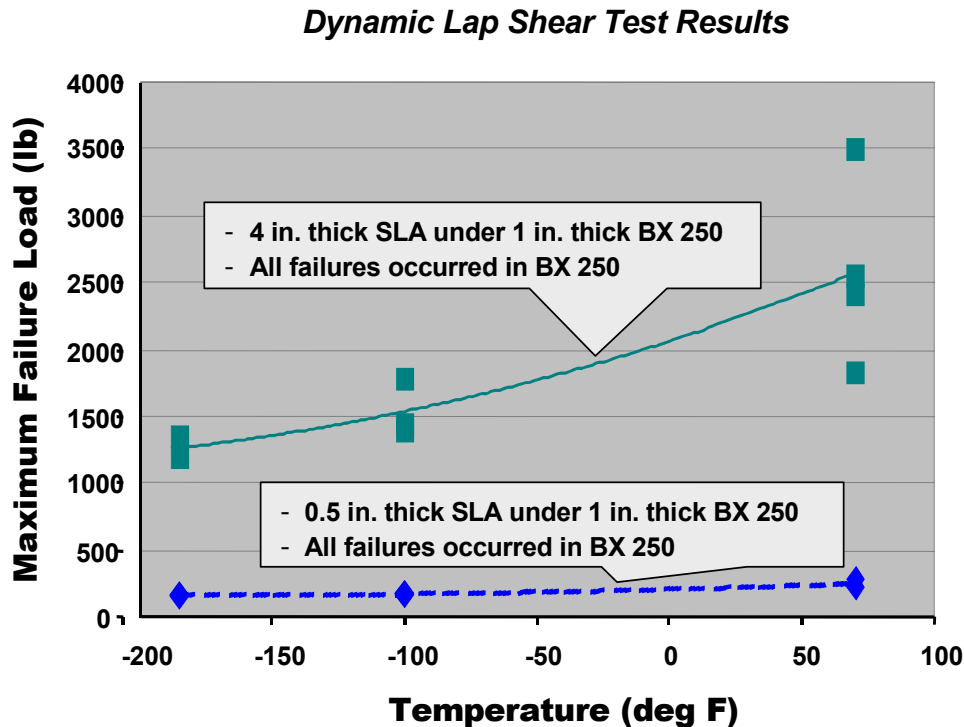
Testing shows that the potential loss of BX-250 does not liberate hand packed SLA due to impulse loading for cryogenic applications; the BX-250 fails before the SLA. For shear, testing shows BX-250 fails before SLA at all test temperatures. For tension, testing shows BX-250 fails before SLA when SLA temperatures are less than or equal to -100 °F (see Figure 11-9).

Figure 11-9. Critical test results in debris assessment

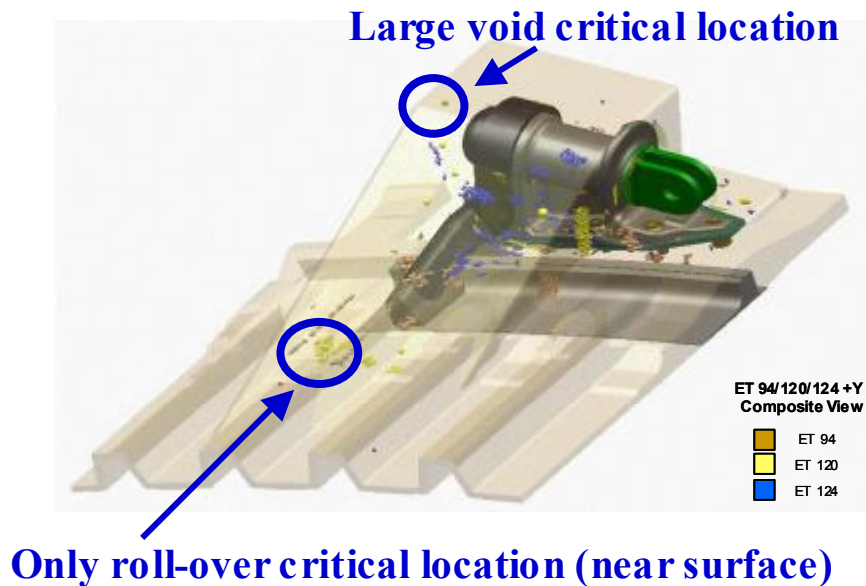
The dissection of six bipod ramps indicated similar patterns for geometry-induced defects in all ramps. Roll-overs were observed at complex substrate elements, and the majority of observations were associated with spraying over complex details at the substrate. Sporadic voids were also observed. One internal delamination and one weak plane at the knit line were observed. Critical locations, or areas at-risk for producing debris, were identified near the edge of the machined foam surface for both voids and roll-overs (see Figure 11-12). Vacuum pressure is the primary driver for divot formation; however, wind shear also contributes to flight loads. A combination of multiple large voids, geometry-induced defects, and critical locations is needed to produce significant foam loss. For example, a large interconnected void at close proximity to the surface plus a “weakened plane” (see Figure 11-13) may produce foam loss.

Figure 11-11. Defects found at critical locations

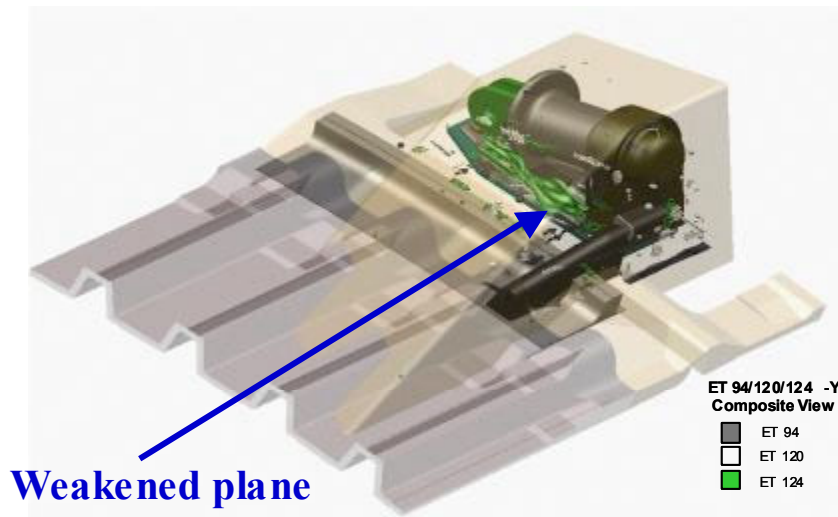
Figure 11-12. Weakened plane defect found

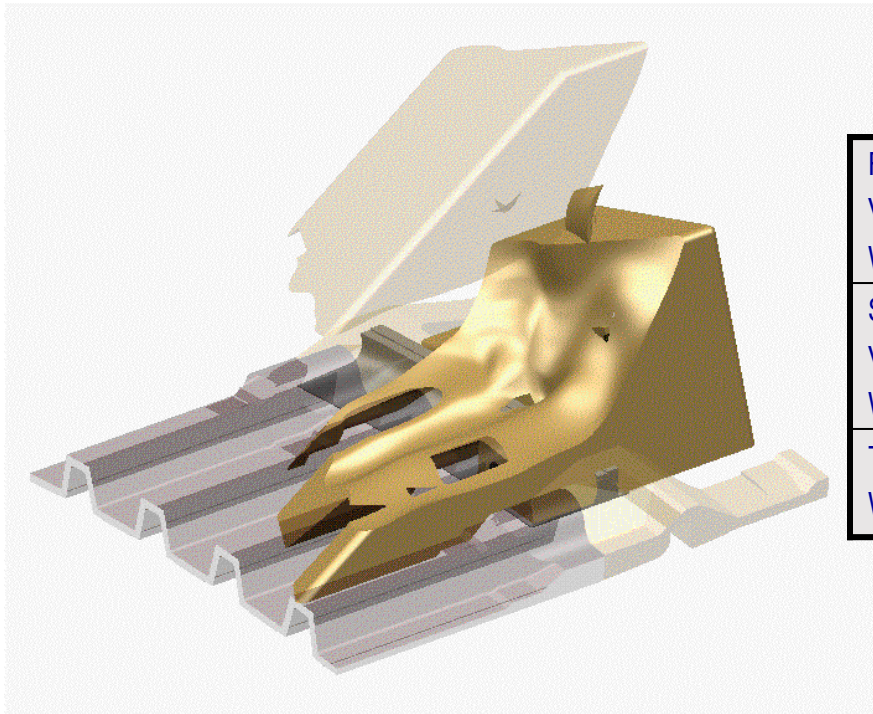
The determination of the STS-107/ET-93 bipod TPS debris is based on evaluation of fault tree findings, possible TPS failure modes and contributors, and results to date from TPS debris test programs including dissection, foam loss secondary effects assessment (SLA/BX-250), and bipod TPS debris size analysis. The TPS bipod debris size was determined by the ET Working Group to be approximately 870 cubic inches and 1.3 pounds.

Foam	
Vol.	~867.2 cu in
Weight	~1.23 lbs
SLA	
Vol.	~1.9 cu in
Weight	~0.02 lbs
TOT	
Weight	~1.3 lbs

Figure 11-13. Multi-failure mode bipod TPS debris estimated by the ET Working Group. Note that this size and weight were not used in the RCC impact testing as part of the STS-107 investigation.
