COLUMBIA

ACCIDENT INVESTIGATION BOARD

REPORT VOLUME II
OCTOBER 2003

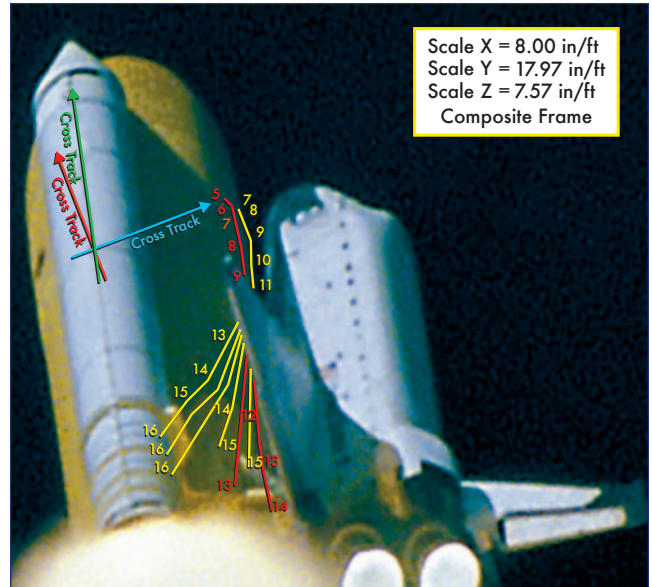
Figure 3-10. Video analysis shows impact is below wing leading edge stagnation line. Trajectories of particles are depicted after the impact.

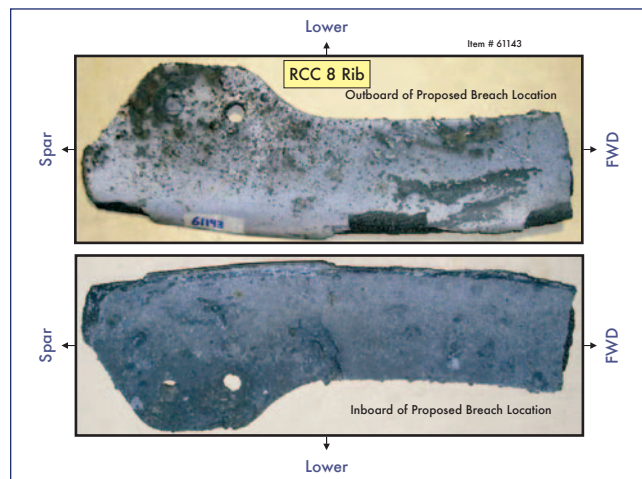
Figure 5-3. Samples of severe slag deposition on the panel 8 rib.

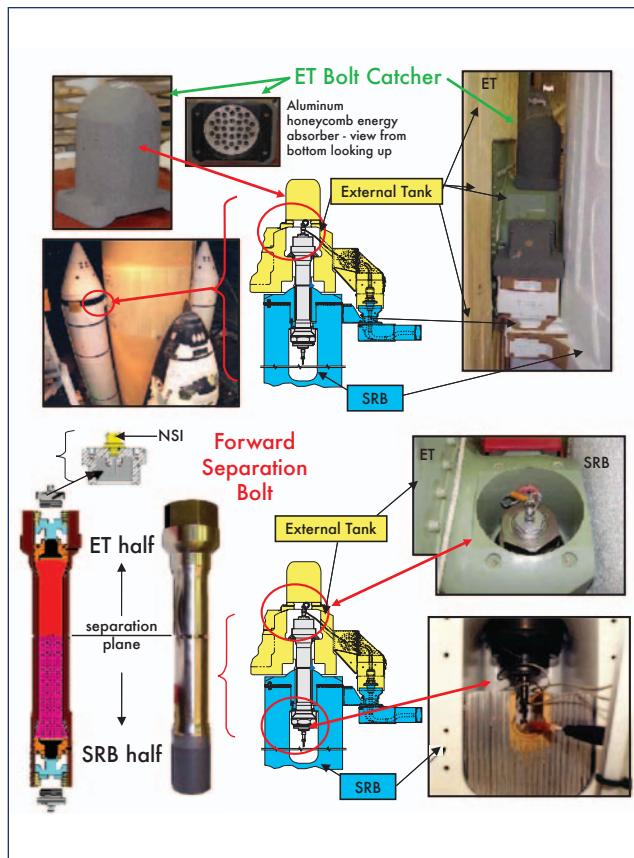
Four blocks on the STS-107 SRB fault tree remain open pending completion of forward bolt catcher testing. The bolt catcher, shown in Figure 7-1, was not qualified as an assembly, and structural qualification testing was not representative of the current flight configuration. The exact magnitude of loads transmitted to the bolt catcher housing cannot be determined based on available data. The SLA-561 thermal protection system (TPS) material on the bolt catcher was qualified by test and analysis for general ET application, but no pyrotechnic shock testing was performed. There is no test data available on the bolt catcher honeycomb dynamic crush strength versus separation bolt velocity, and random pressure loading from the NASA Standard Initiator (NSI) ejection was not included in the original qualification tests. Lastly, the running torque/break-away torque was not measured during STS-107 bolt catcher fastener and ET range safety system (RSS) fairing installation, which is used to verify the insert locking feature is in place. A review has determined that the bolt catchers and RSS fairings were installed and secured for flight with the correct bolts and final torque. Testing is in work to close the four remaining fault tree blocks, but initial static tests results show failure below the required safety factor of 1.4.

Figure 7-1. Details of SRB/ET forward separation bolt catcher assembly.

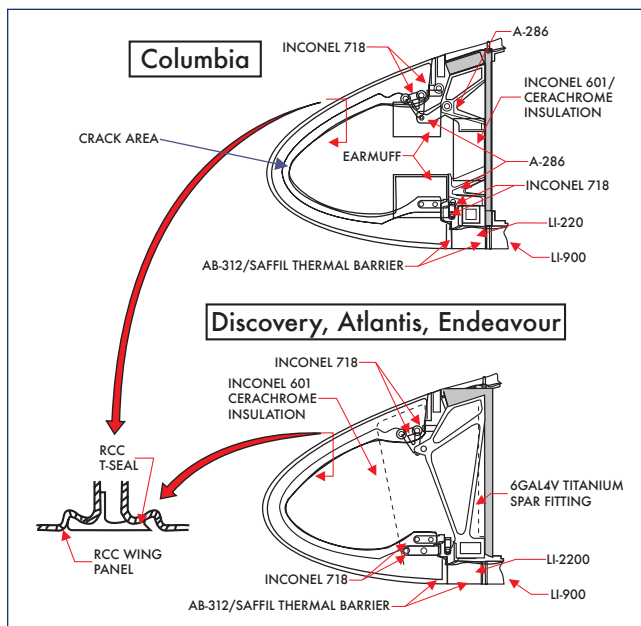
Figure 10-8. Tee seal crack location.

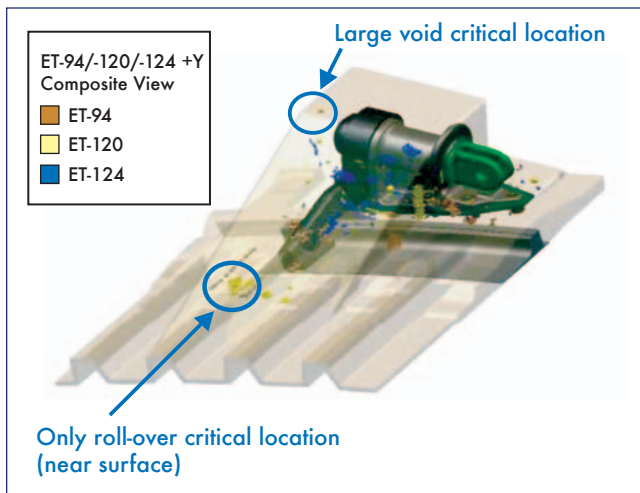
Figure 11-11. Defects found at critical locations.

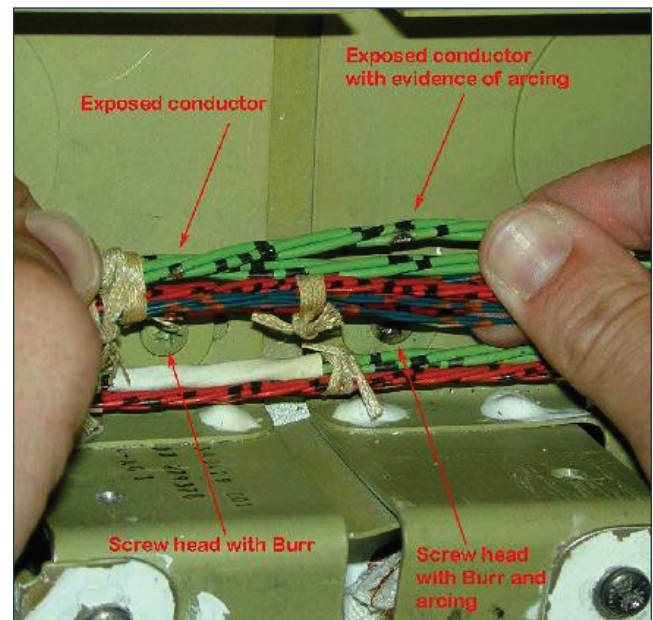
Figure 1.1.1. Picture of Kapton damage.

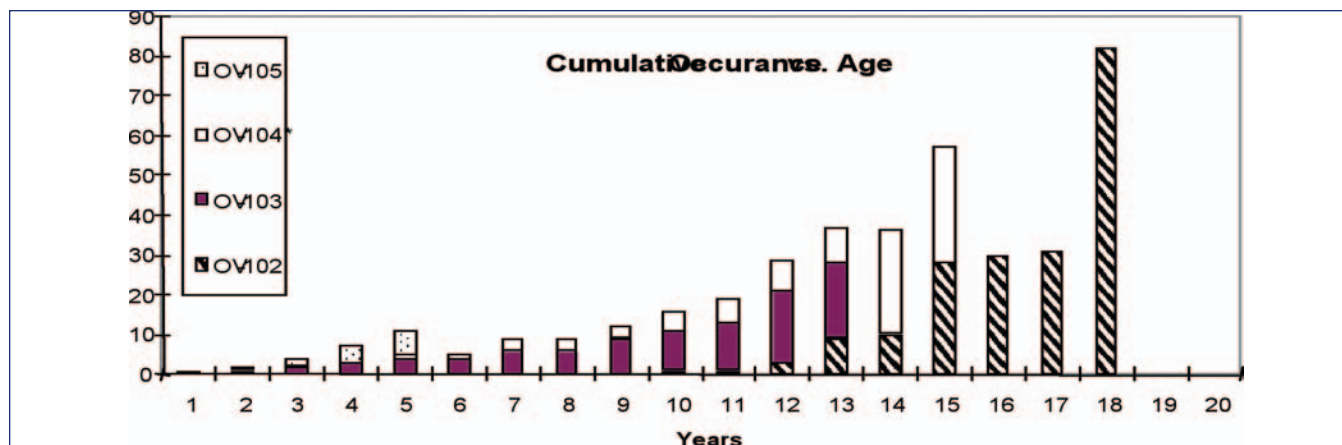
Figure 1.3.7. Fleet corrosion in body flap cove area.
