COLUMBIA ACCIDENT INVESTIGATION BOARD (CAIB)/
NATIONAL AERONAUTICS AND SPACE ADMINISTRATION (NASA)
ACCIDENT INVESTIGATION TEAM (NAIT)

WORKING SCENARIO

FINAL VERSION: JULY 8, 2003

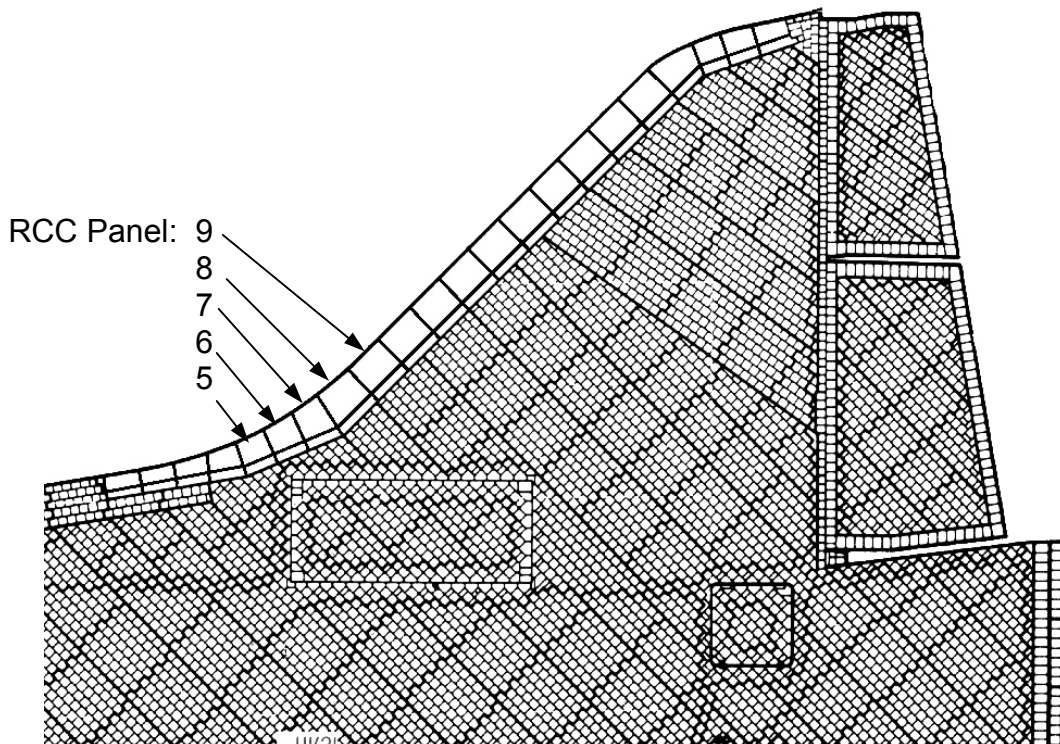
Figure 3-4. Area of most likely wing damage

Several approaches were taken to assess the area of left wing damage. The efforts included launch video and photograph analysis, review of launch MADS data, debris transport analysis, forensic analysis of debris found in Texas, wire bundle burn through analysis, and aero/thermal modeling of the entry. The data indicate that the area of the highest probability of damage to the left wing was between RCC panels 5 and 9, with the most likely damage occurring on the lower side of RCC panel 8 or an adjacent Tee seal. The damage was most likely equivalent in size to a 6 to 10 inch diameter hole or area broken from the RCC panel or an adjacent Tee seal. Figure 3-4 shows the area of highest probability of wing damage and Table 3-1 shows the methods used to determine the damage.

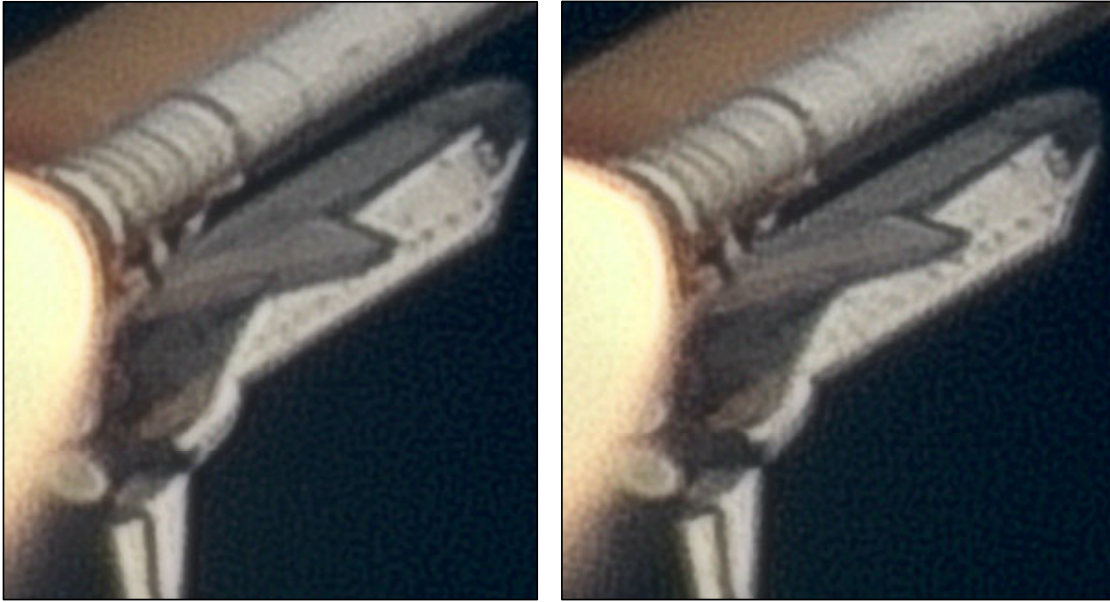
Figure 3-11. Pre-impact vs. post-impact shows no observable damage within the resolution limits

Enhancements of the ascent video indicated there was no discernable damage to the orbiter wing leading edge or lower tile surface. Figure 3-11 is a sample of these video enhancements. The figure compares 30 pre-impact integrated video fields with 21 post-impact integrated video fields. Based on these enhancements, photo experts have been unable to determine or quantify any damage to any portion of the orbiter vehicle as a result of the impact.

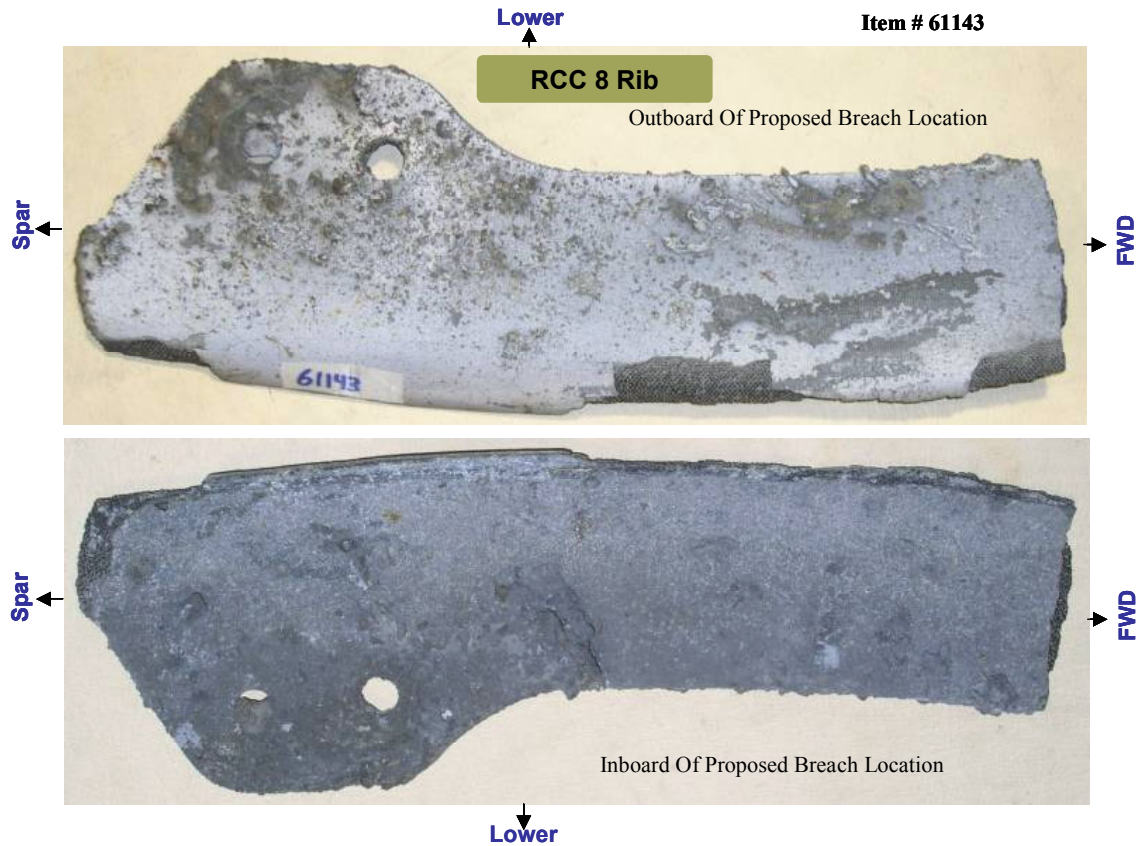
Figure 5-3. Samples of severe slag deposition on the panel 8 rib

these inner surfaces indicate flow from the panel 8 direction toward panel 9. This is also consistent with the knife-edge erosion shown in Figure 5-4 below. The proposed flow direction leading to the erosion and slag deposition on the lower carrier panel 9 tiles can be seen in this view as well. The detailed flow, erosion, and deposition are best viewed in Figure 5-5. The last significant feature in Figure 5-6 is the heavy slumping that is observed on the upper carrier panel 8 tile (50336T) in the upper right portion of the drawing.

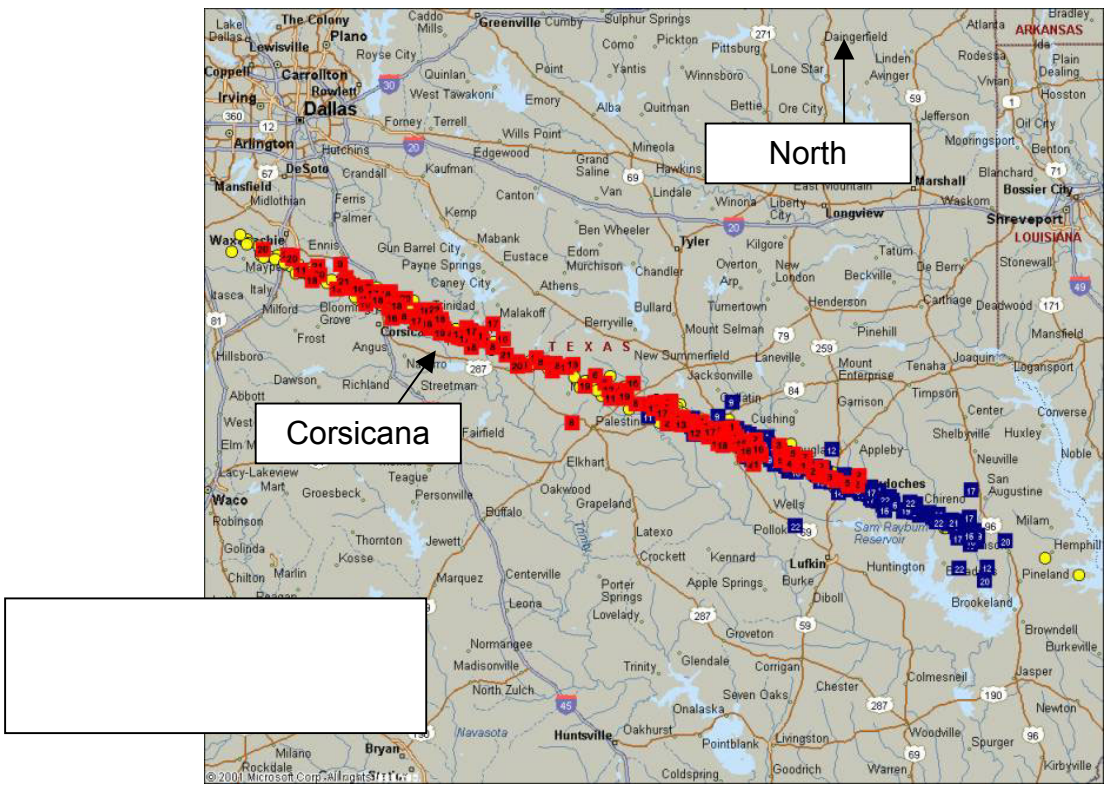
Figure 5-8. RCC panel debris location

In addition to the slag deposition and flow analysis, there are two other significant pieces of data that point to a breach in the RCC 8/9 area as the initial damage. The first item is the location of the leading edge RCC in the debris footprint. Figure 5-8 shows the recovered RCC for both the left and right wing and its location in the debris footprint. The eroded RCC pieces from panels 8 and 9 are found in the westernmost part of this debris footprint near Waxahachie, Texas, along with other pieces of RCC panel 8. Left wing RCC panel 9 and other aft panels appear to have been lost relatively early in the break-up sequence since their footprint spans the western to center part of the footprint. This is indicative of a left wing breach in the panel 8/9 area. The forward portion of the RCC panels on both the left and right wings (panels 1 through 7) are found from the center to eastern part of the debris footprint possibly indicating that these were lost in a secondary aerodynamic break-up.

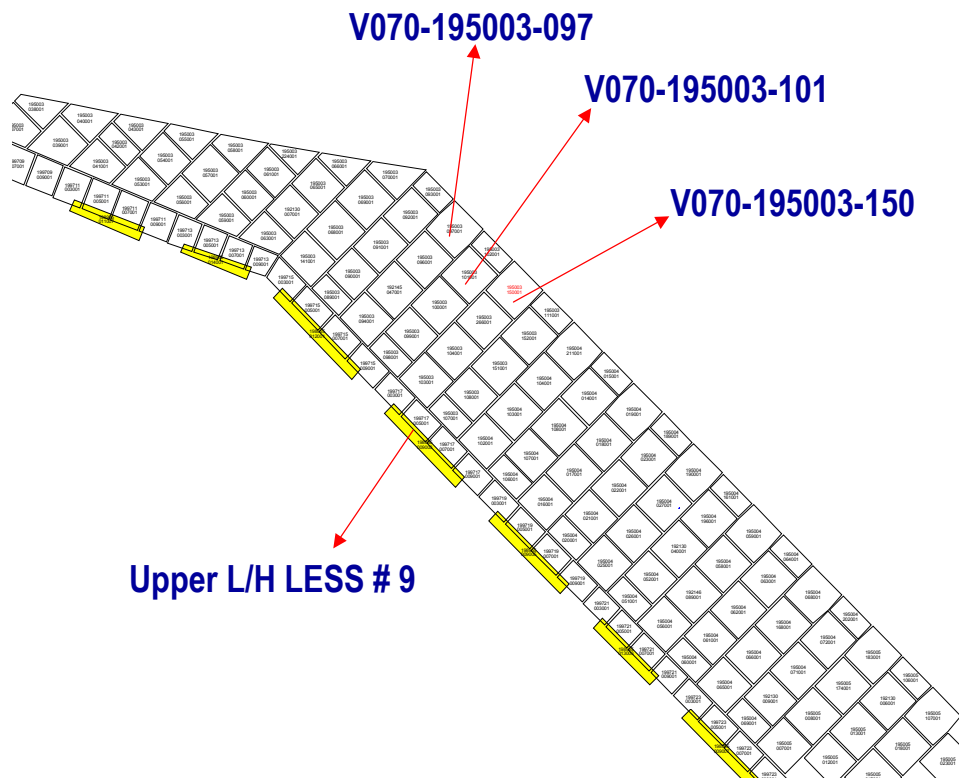
Figure 5-9. Three possible orbiter locations of the Littlefield tile on left wing

The tile departed the orbiter more than one minute prior to final break-up due to prolonged internal heating of the upper wing skin in the area shown in Figure 5-9. The tile shows indications of backside heating and an RTV debond. It was not a failure in the densification layer, which would have been caused by mechanical loading. This piece of recovered debris is not very significant on its own merit; however, it is consistent with the previously discussed forensics data (rib erosion, carrier panel 9 tile slumping, etc.) and other events that will be discussed later in Section 5.4.

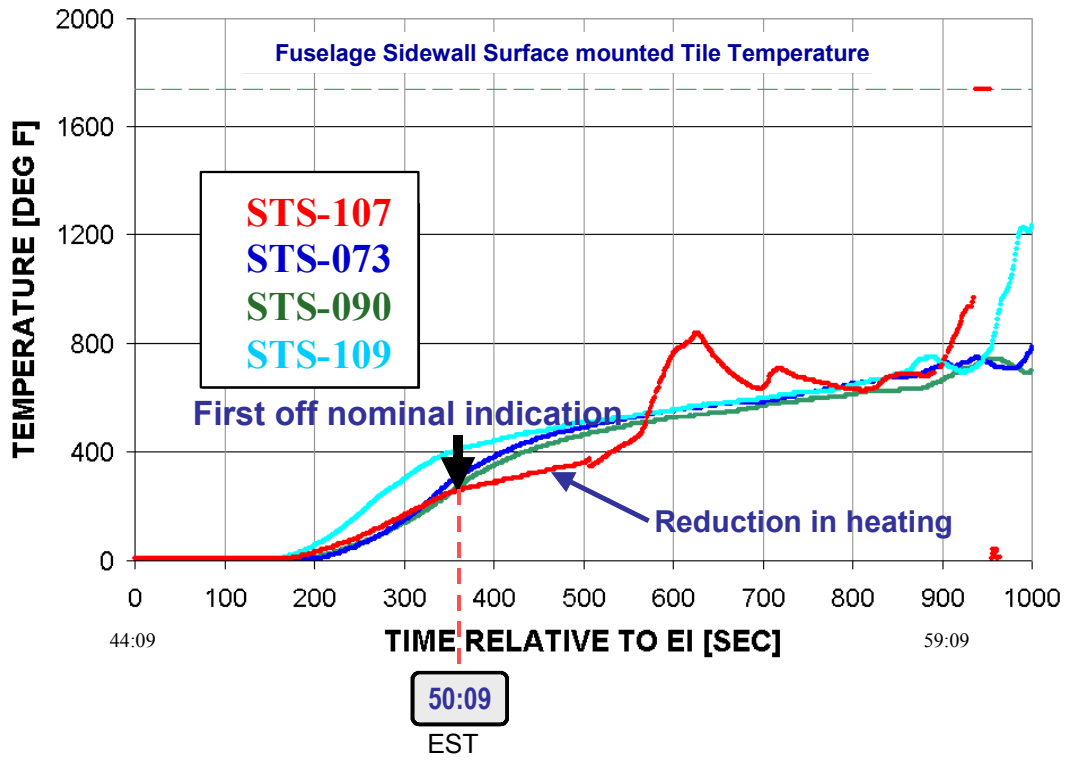
Figure 5-20. Off-nominal temperature indication on the left sidewall

In the same timeframe, at 8:50:09 EST (EI + 360 sec.), a left payload bay fuselage MADS surface temperature measurement (Figure 5-19) showed an off-nominal temperature trend. This trend is a reduced rise rate when compared to other previous Columbia missions, as shown in Figure 5-20. The previously discussed theory of venting and or disturbed flow due to panel 8 damage, causing a shift in the vortices on the upper surface of the wing, is also believed to be the cause of this off-nominal behavior. The flow field and venting on the upper surface rate are constantly increasing since the mass flow rate into the RCC breach is increasing as the orbiter descends lower into the atmosphere.

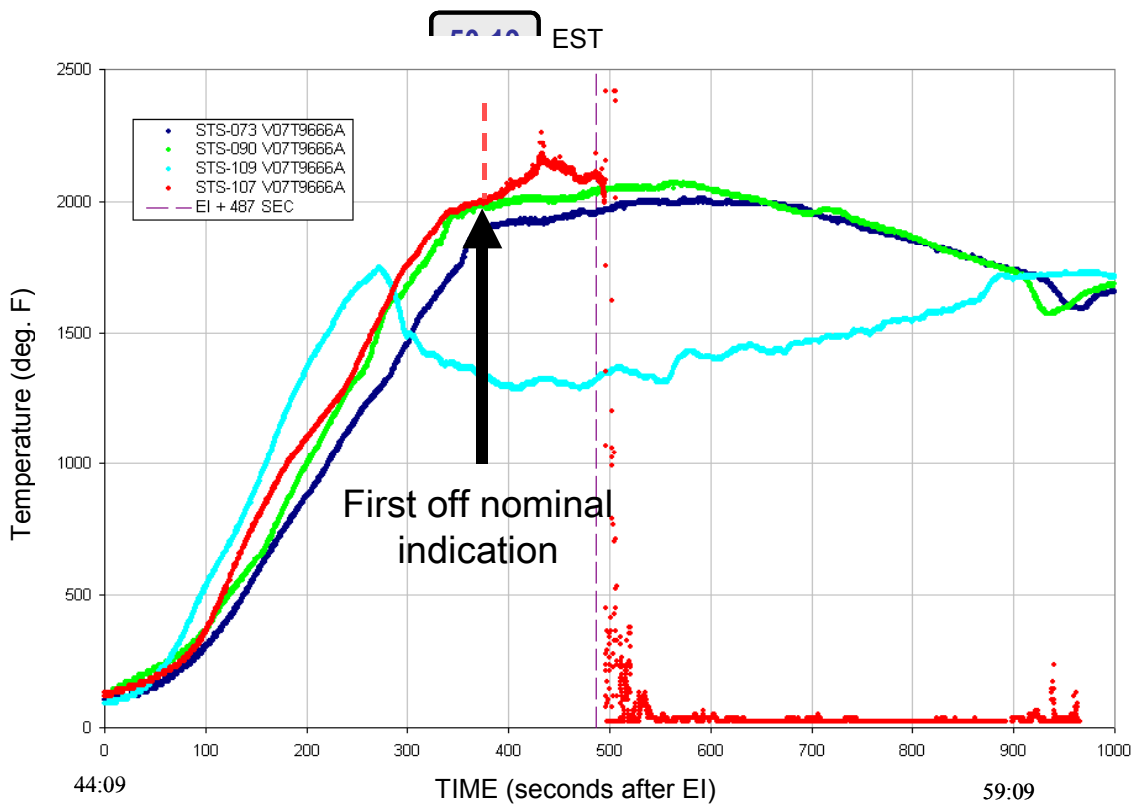
Figure 5-21. Temperature rise on tile surfaces aft of RCC panel 9

At 8:50:19 EST (EI + 370 sec.), a lower surface thermocouple showed signs of off nominal, increased heating. The best explanation for the increased heating in this area is severely disturbed, turbulent flow caused by the leading edge damage on the bottom of RCC panel 8 and flow from the lower corner of this panel as discussed in Section 5.3. Langley Research Center wind tunnel testing has confirmed that wing leading edge damage (notch or protuberance) near panel 8 will cause increased heating to the lower wing surface. As previously discussed, the eroded lower carrier panel tiles on panel 9 indicate this strong flow from panel 8. This is consistent with flow patterns observed on many recovered lower surface wing acreage tiles along the flow lines aft of the RCC panel 8 area. Figure 5-21 shows this temperature response as compared to other Columbia missions. The location of the sensor can be seen in Figure 5-22.

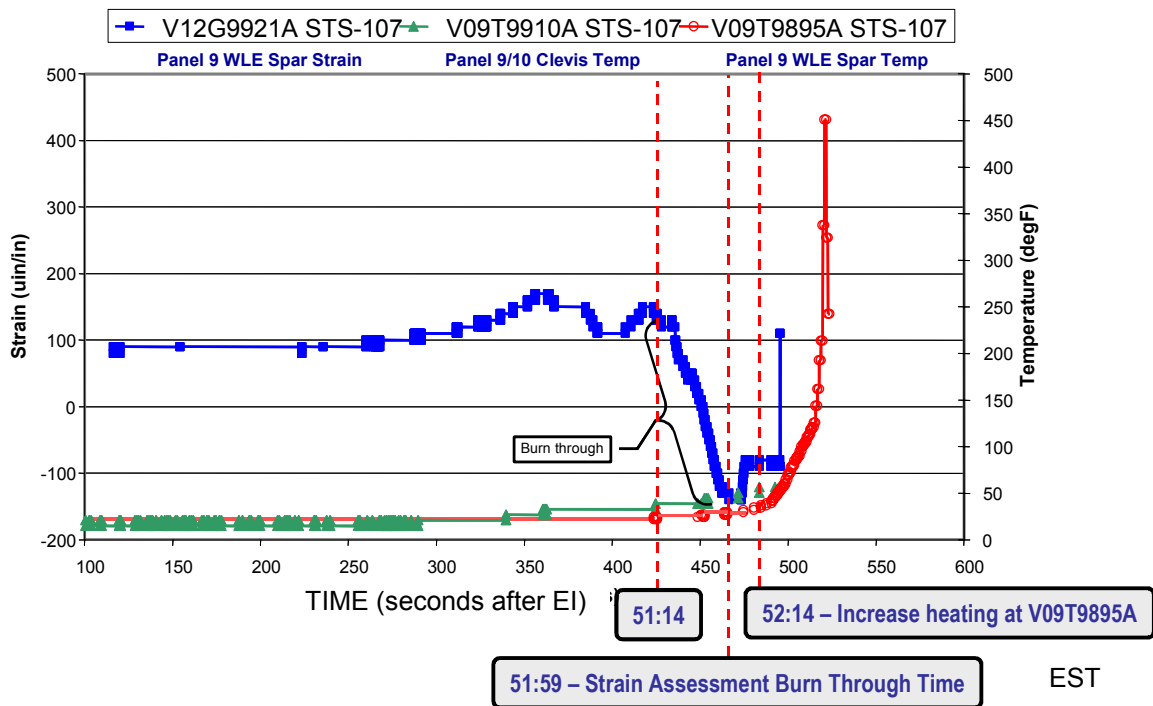
Figure 5-23. RCC panel 9 MADS strain and temperature measurements, STS-107

By 8:51:14 EST (EI + 425 sec.), the wing leading edge spar temperature began an early, off-nominal rise, shown in Figure 5-23. At the same time, the clevis temperature in the RCC panel 9/10 region continued to increase. The initial spar temperature rise was relatively slow and was caused by conduction since this measurement is on the backside of the spar in the wing cavity. Eventually, the rise rate increased dramatically as first the Inconel and Cerachrome insulation and later the aluminum honeycomb were destroyed. The exact time of the spar breach is unknown; however, it is estimated to have occurred between 8:51:14 to 8:51:59 EST (EI + 425 to 470 sec.) based on the observed wing leading edge linear decrease in strain during this timeframe. A more detailed discussion of the method used to bracket the time of the wing spar breach is contained in the following section.

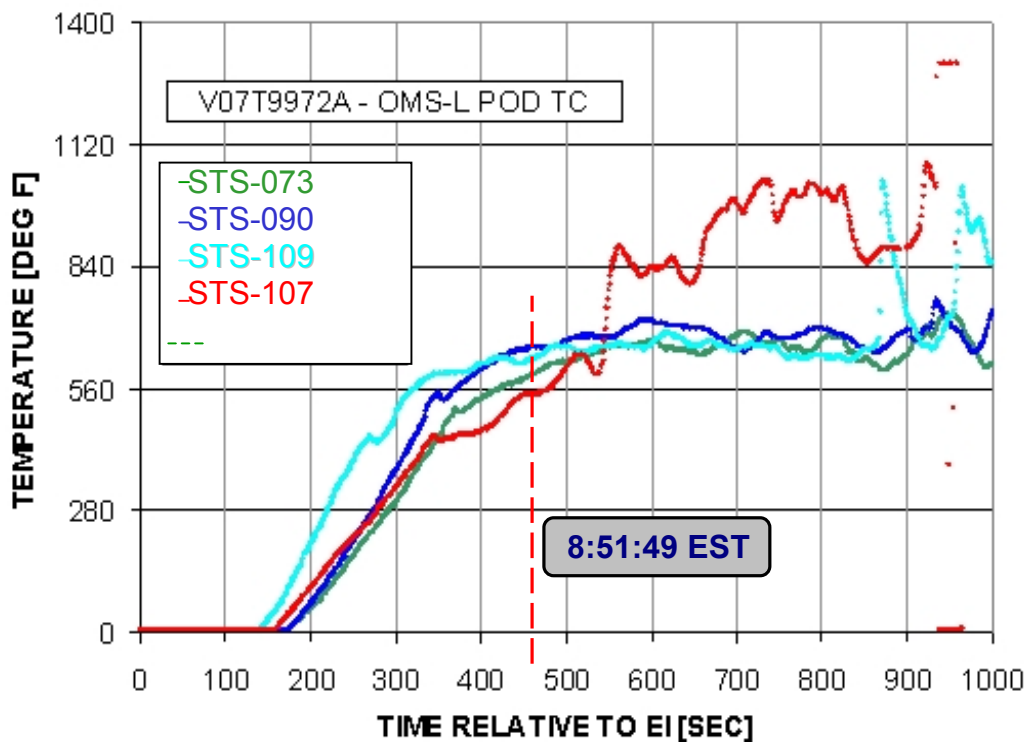
Figure 5-24. Off-nominal low OMS pod thermocouple (V07T9972A)

At 8:51:49 EST (EI + 460 sec.), one of the left OMS pod measurements (V07T9972A) began to show an increased temperature rise, indicating that the upper surface flow has changed again. This is shown in Figure 5-24 along with this measurement on other Columbia missions. It is evident that the measurement rises to a higher temperature and at a faster rate than has been observed on previous missions within the next few minutes. Figure 5-25 shows other left OMS pod and fuselage temperature measurements that exhibit an off-nominal rise later in time. The sensor locations on the left side of the orbiter are also shown in Figure 5-25.

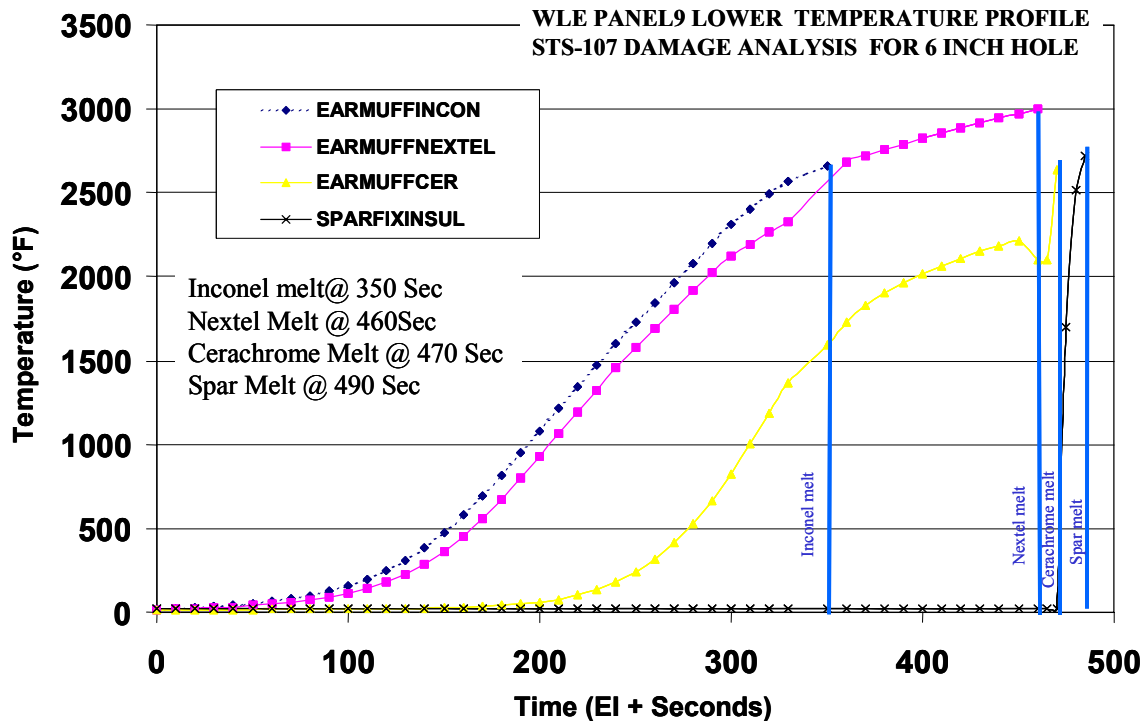
Figure 5-30. Thermal model prediction of wing spar burn through

The second technique used a detailed thermal model to determine the time required to burn through the various insulations immediately in front of the wing leading edge spar (Inconel, Nextel, Cerachrome) and then the honeycomb spar. This model assumed the equivalent heating of a six-inch diameter hole in the bottom of RCC panel 8. Using the expected aero heating rate and the various material properties, the spar burn through occurred at 8:52:19 EST (EI + 490 sec.). This time would be accelerated slightly for a larger diameter hole. The results of this thermal model are shown in Figure 5-30.

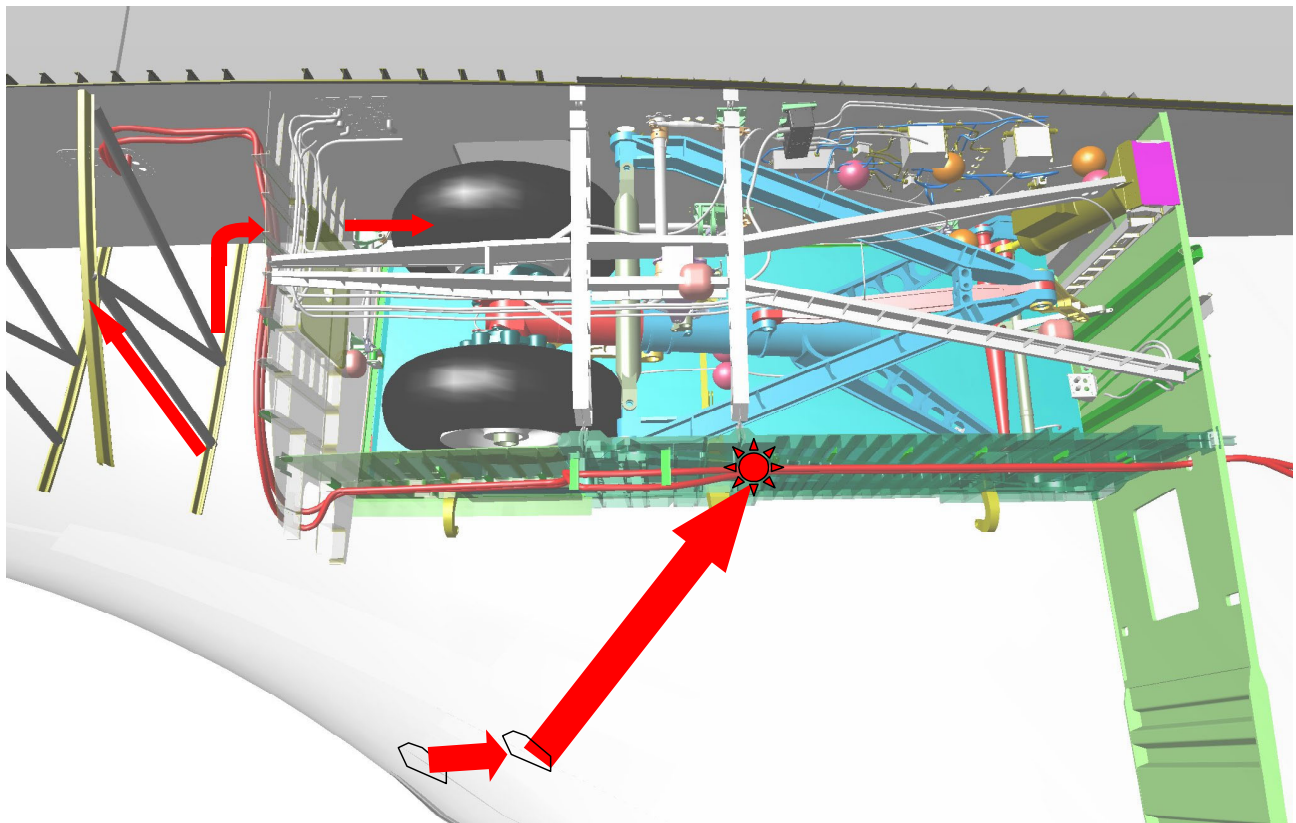
Figure 5-31. Hot gas begins to fill left wing

Immediately after the breach, hot gas inside the wing began to heat the remaining wire bundles that contained real-time telemetry and the recorded MADS measurements. Figure 5-29 shows an inside-the-wing view of the approximate breach location based on this wire failure analysis. The view on the left is of the panel 8/9 spar location. This area is not visible in the right photo, which contains the transition spar and a view of the three wire bundles along the outside of the wheel well wall. Figure 5-31 shows the overall spar breach location with respect to the rest of the wheel well. The distance from the spar to the wheel well wall in this area is approximately 56 inches, as shown in Figure 5-32. Figure 5-33 shows a sketch of the venting of the left wing into the payload bay, driving the direction of the internal flow depicted in Figure 5-31. Note the 142 square inch vent into the midbody fuselage located forward of the wheel well.

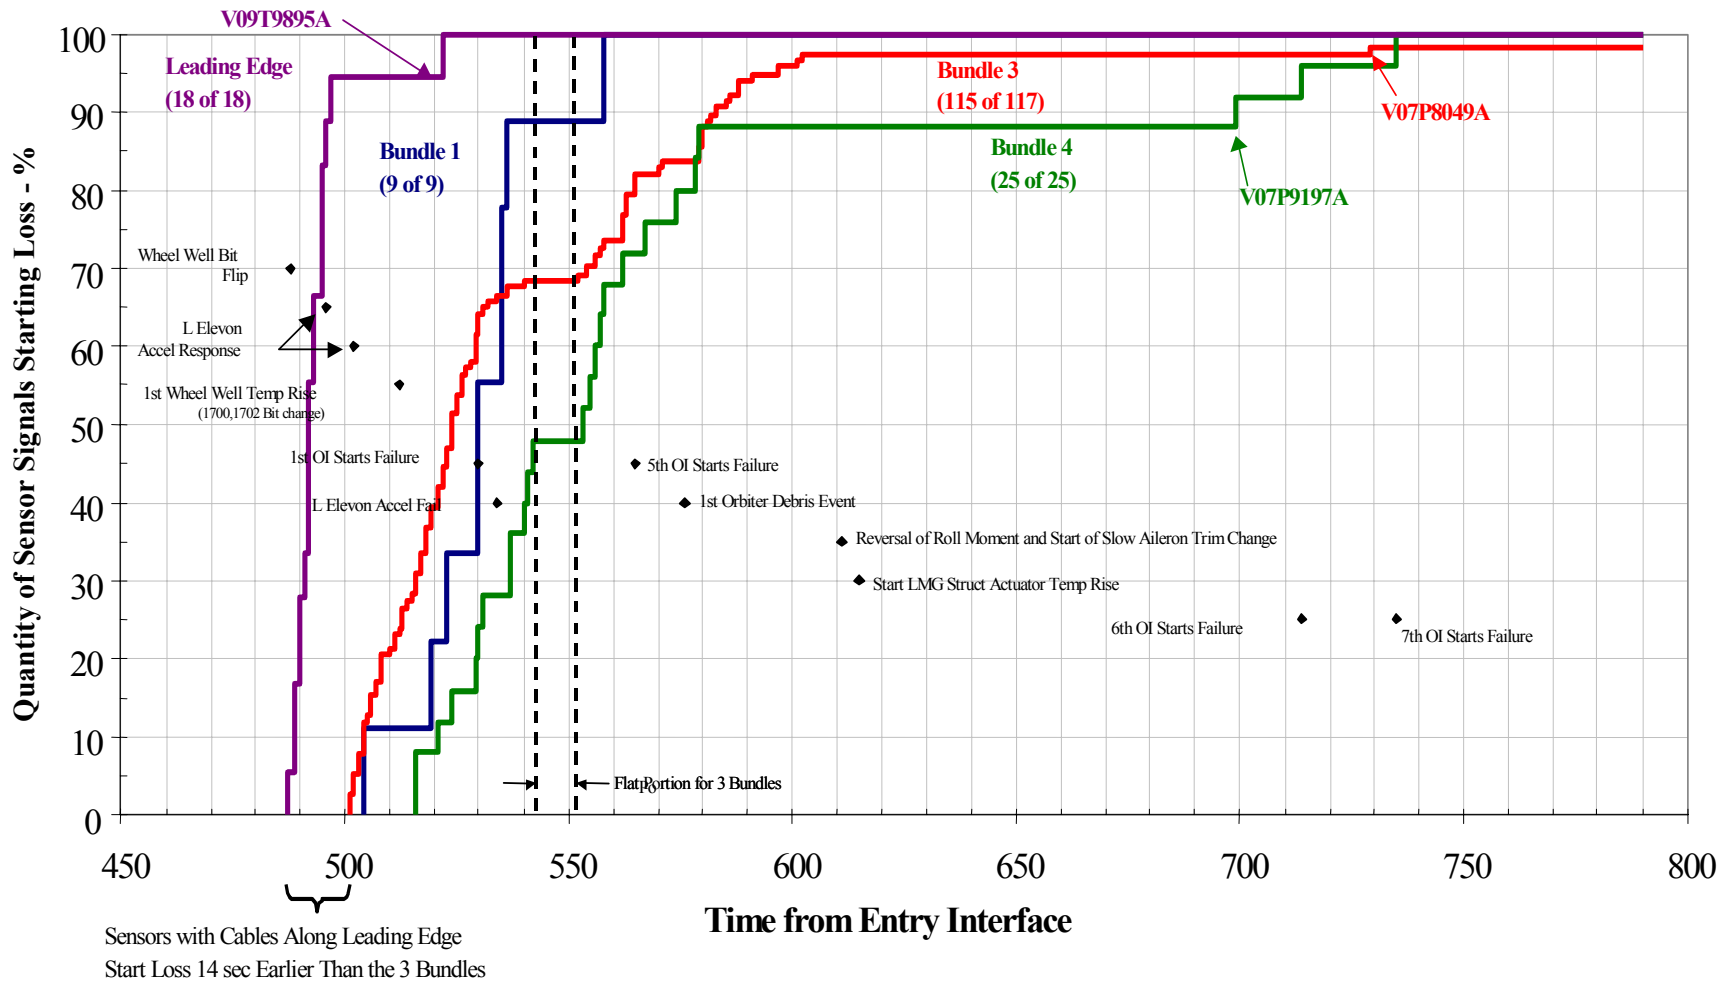
Figure 5-34. MADS data failure due to wire burning

Arc-jet testing was performed in a facility at JSC to demonstrate how quickly a hole in a 0.1 inch thick aluminum plate would grow in an attempt to determine the feasibility of a rapid spar burn through followed by rapid wire measurement failures. The test configuration had an initial 1-inch diameter hole, and a stagnation heat rate of 12.13 BTU per square foot per second (equivalent to the flight environment at about 8:50 EST, EI ~ 351 sec). During the test, the aluminum plate hole grew from 1 inch in diameter to 5 inches in diameter in approximately 13 seconds. This was consistent with thermal math models developed to analytically predict hole growth. A wire bundle placed 15 inches from the heat source showed very rapid erosion after the hole grew to 5 inches in diameter. The measurement losses in this bundle were very consistent with those observed for wire bundle number 3 (see Figure 5-34). The hole would have grown to a larger diameter; however, the test set-up provided a heat sink that eliminated further hole growth. Overall, the test indicated that a hole in the aluminum honeycomb would grow rapidly, allowing a substantial plume to destroy the wire bundles on the wheel well wall.
