# BIM-FM integrated solution resourcing to digital techniques

Facility Management, BIM, Maintenance Management, Photogrammetry, BIM-FM.

VIPERC2022, 1st International Virtual Conference on Visual Pattern Extraction and Recognition for Cultural Heritage Understanding, 12 September 2022

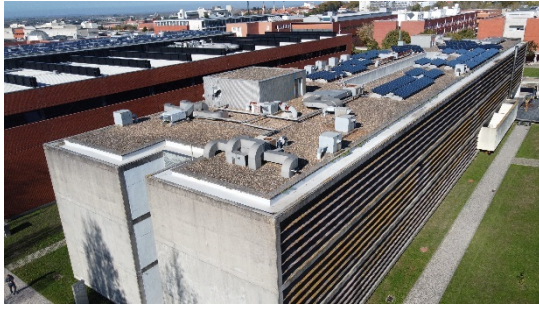
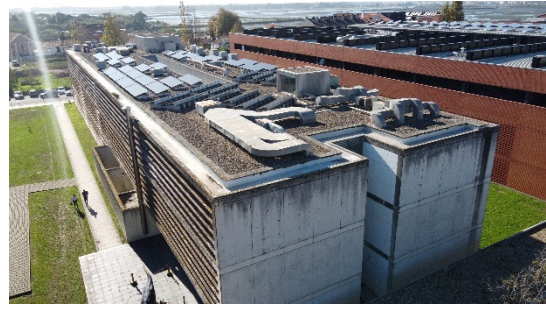
The department has a rectangular geometry with two entrances in the Northeast and Southwest facades. Figures 1 and 2 present the building under study.

**Figure 1:** Geosciences department of Aveiro's University - South façade

**Figure 2:** Geosciences department of Aveiro's University - South façade

The coatings are different from the traditional coatings used in the rest of the University building campus. The Northeast and southwest facades of the Geosciences Department of the University of Aveiro are composed of a concrete structures at the sight. Northwest and Southeast facades are composed of walls of concrete at sight that supports the glazed openings in all the extensions of those facades. These facades comprise a shading breezes system of pink marble supported by a metallic structure fixed to the concrete structure.

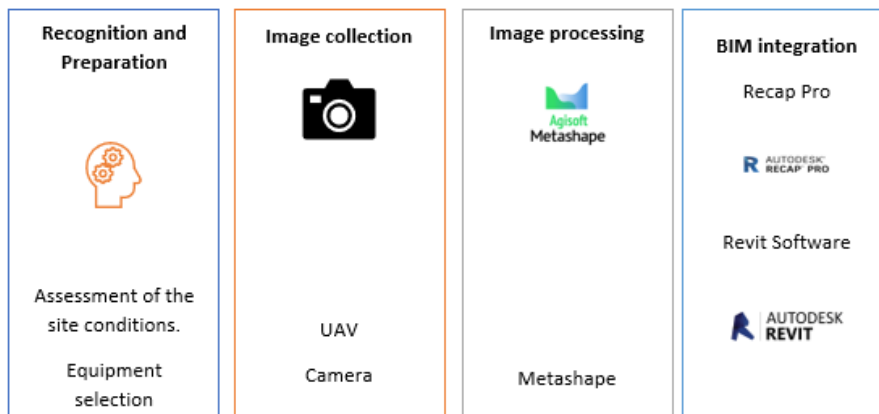
Afterwards, the building digitalization was the next step, which was supported by the Photogrammetry technique to obtain the building point cloud. For this process, a set of steps were considered, as presented in Figure 3.

**Figure 3:** Steps to the digital processing

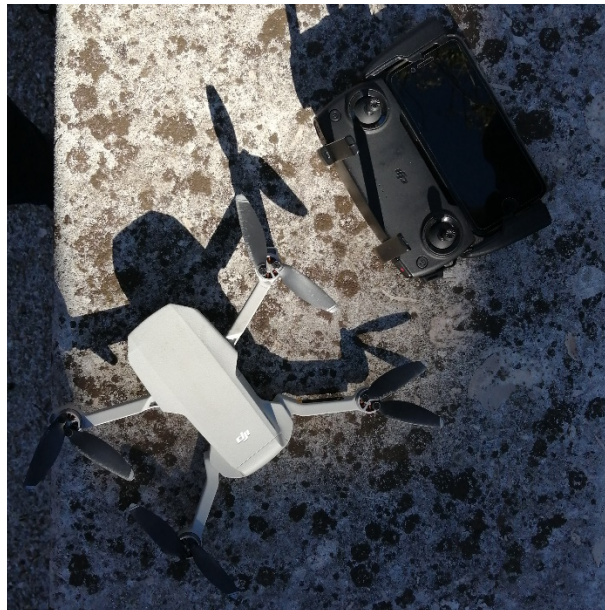
**Figure 4:** Drone DJI MAVIC MINI

Mavic Mini supports 12 MP aerial photos and 2.7K Quad HD videos. A 3-axis motorized gimbal provides superior camera stability and ensures clear ultra-smooth footage. The MAVIC MINI drone was used because it was the equipment available from the University, however, it is considered to be one of the best pieces of equipment for the desired purpose in terms of cost-effectiveness.

The photos were shot with an UAV, a so-called drone, and a Digital Single-Lens Reflex (DSLR) camera. The specifications of these products are described in Table 1 and presented in Figure 4.

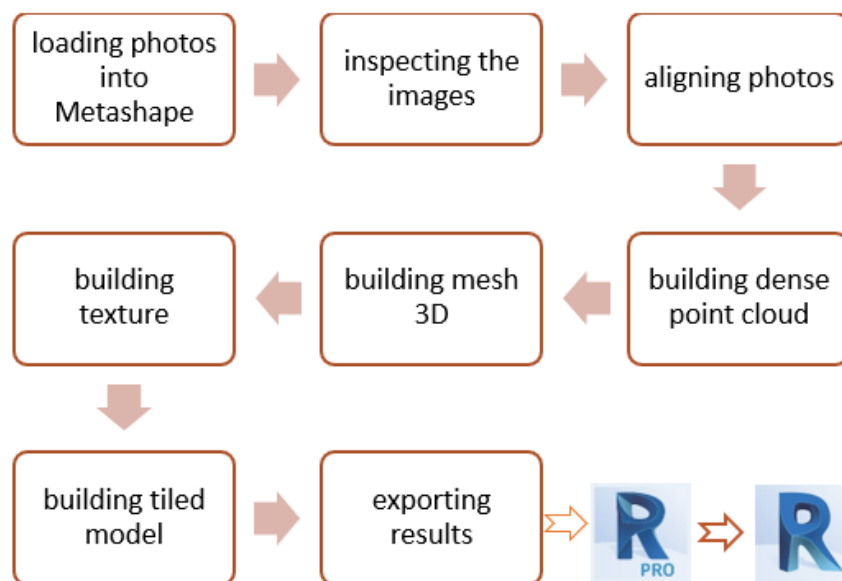
The photos were uploaded on Agisoft Metashape, which is a software that performs photogrammetric processing of digital images. In this software, the process was done according to Figure 5.

**Figure 5:** Steps of processing images in Agisoft Metashape

After the photos processing in Metashape according to Figure 5, it is possible to obtain the building point cloud with the geometric building information (Figures 6 and 7). The Point Cloud was exported from Metashape by the format .e57, which is not a compatible format to import to Revit. So, the file .e57 was transformed to .rpt by Autodesk Recap Pro and then imported to Autodesk Revit.

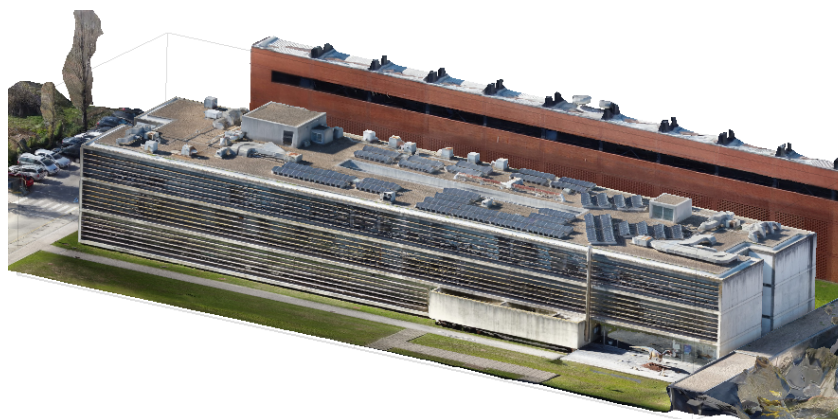
Figure 7: Point cloud in building texture – SE façade in Metashape

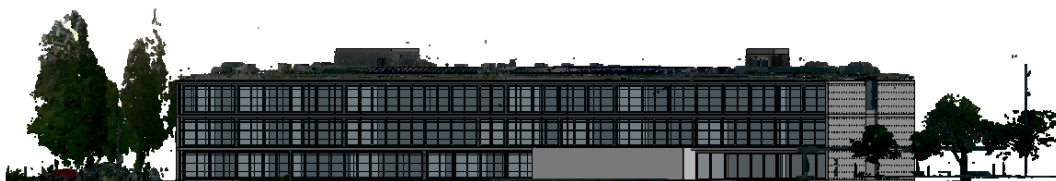
After being imported to Autodesk Revit, the building geometry was modelled in overlap with the point cloud, which facilitated the modelling process, becoming a swift and prompt process (Figure 8).

Figure 8: Steps of processing images in Agisoft Metashape

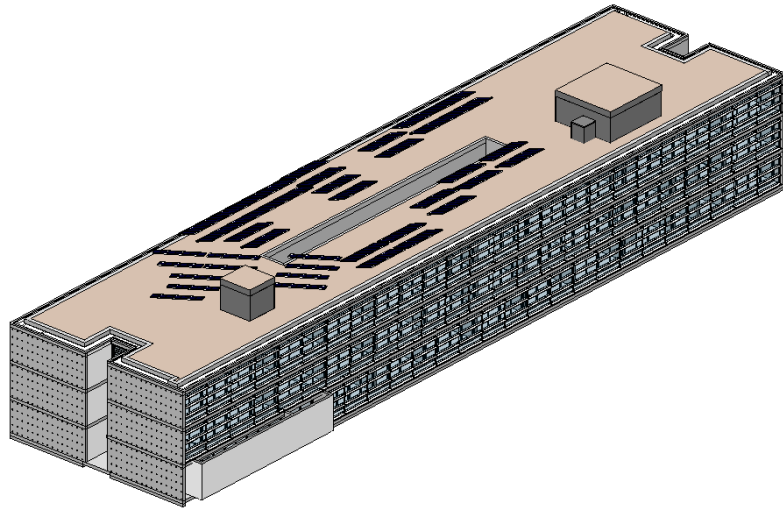
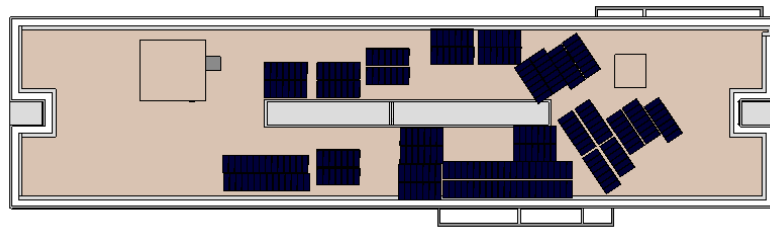
In the building modelling, the concrete facades at sight were modelled, as well as the customized glass openings. The shading breezes system and the solar panels were modelled as families of objects

**Figure 9:** Building Modelling in Autodesk Revit

**Figure 10:** Building Modelling in Autodesk Revit – roof plan

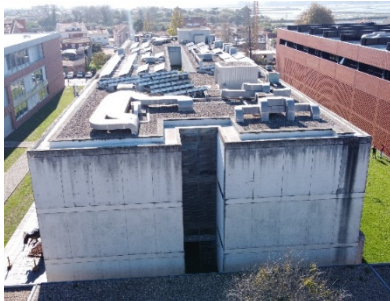
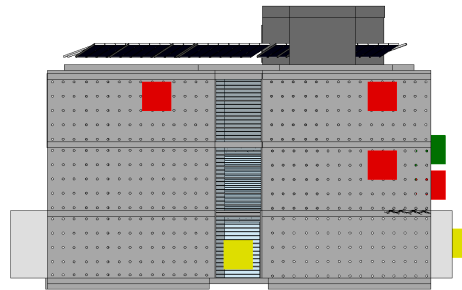
Figures 12 and 13 present the Northeast face of real photography and the 3D modelling with the placeholders, being the NE facade evaluated with a poor condition and represented with the red placeholders since the concrete façade has wide-spread anomalies. Besides that, cracks were also represented in the model by means of a family.

**Figure 12:** Northeast façade - photography

**Figure 13:** Northeast façade – 3D model with place-holders and cracks

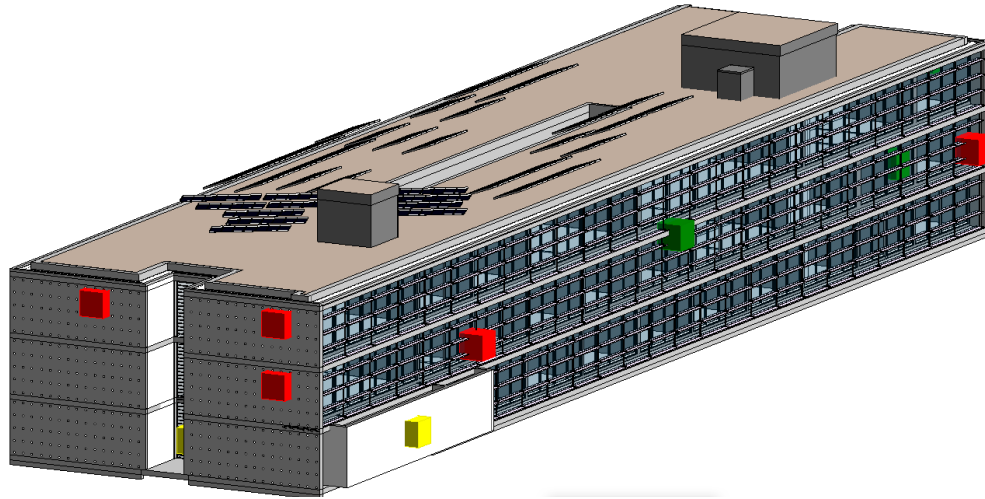
Figure 14 presents the complete building model with the placeholders translating the elements' conditions, which allows for prioritizing maintenance actions.

**Figure 14:** Building model in Revit with placeholders and cracks
