6.0 RE-USABLE SOLID ROCKET MOTOR

7.0 SOLID ROCKET BOOSTER

8.0 SPACE SHUTTLE MAIN ENGINE

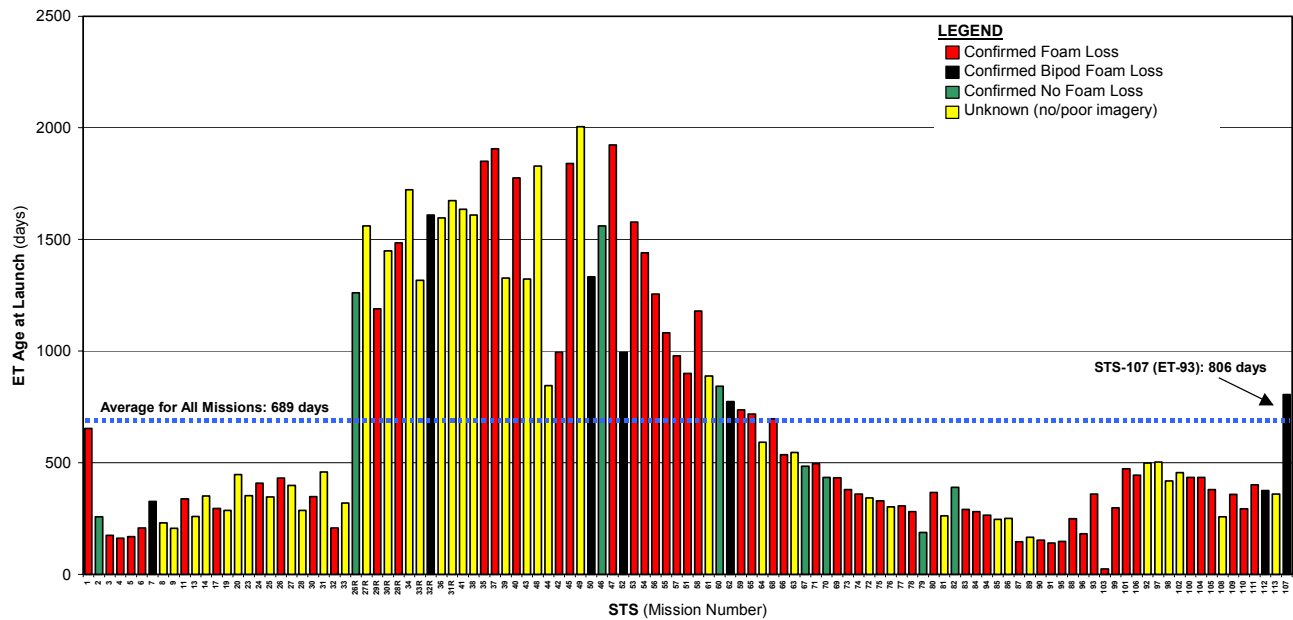
Figure 9-1. ET age for all STS missions

The ET age was compared for various flights, presented in Figure 9-1. As shown in Figure 9-2, the ET age for STS-107/ET-93, 806 days, falls above the 95% confidence interval upper limit for the average age of all tanks, mean value 689 days, as well as the average age for all tanks with known bipod foam loss. STS-107/ET-93 also falls within the 95% confidence limit for missions with known bipod foam loss. Although the upper bound of the 95% confidence interval of the age of missions with bipod foam loss appears to be greater than the other groups in Figure 9-2, the 95% confidence interval limits of the different groups overlap each other. Therefore, data are inconclusive as to whether a correlation can be drawn about ET age and bipod foam loss.

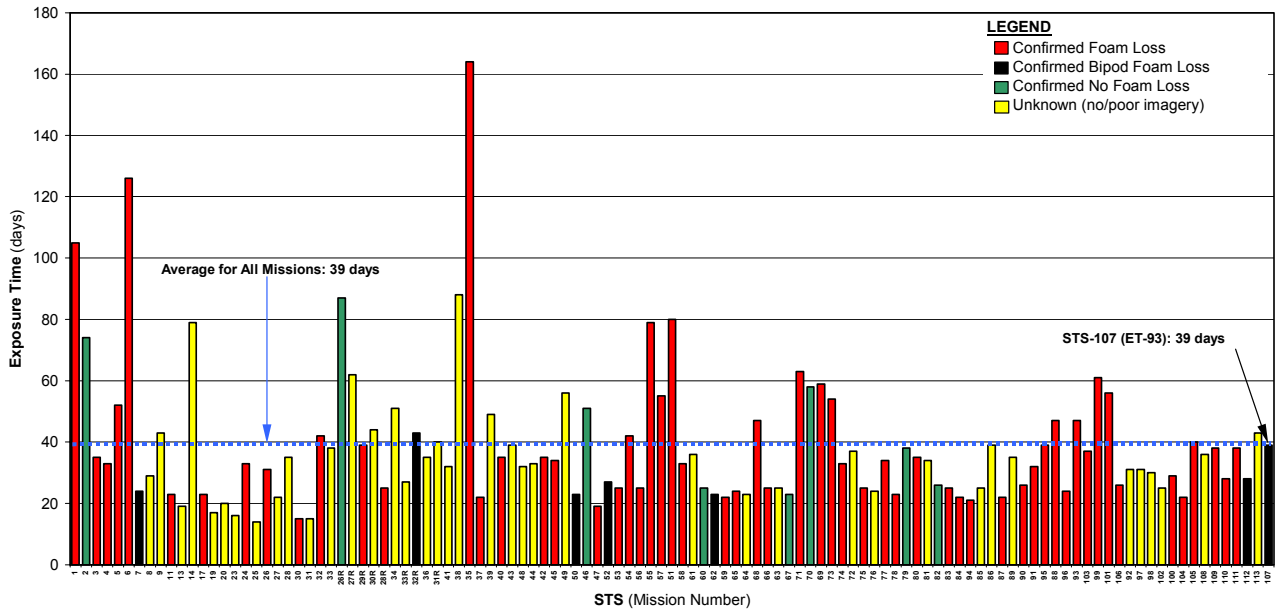
Figure 9-3. ET exposure time (to weather) prelaunch for all STS missions

A similar comparison was made relating ET exposure time and bipod foam loss across the flight history, shown in Figure 9-3. Note that the STS-107/ET-93 exposure time, 39 days, is the same as the mean value for all STS flights. As shown in Figure 9-4, the STS-107/ET-93 exposure time falls within the 95% confidence limit of all missions' ET exposure time, as well as the time confidence limits for flights with or without known bipod foam loss. The STS-107/ET-93 exposure time is larger than the 95% confidence upper bound for missions with known bipod foam loss. However, as stated above when discussing ET age, the 95% confidence limits of the different groups in Figure 9-4 overlap each other, and data are inconclusive as to whether ET exposure time and bipod foam loss can be correlated.

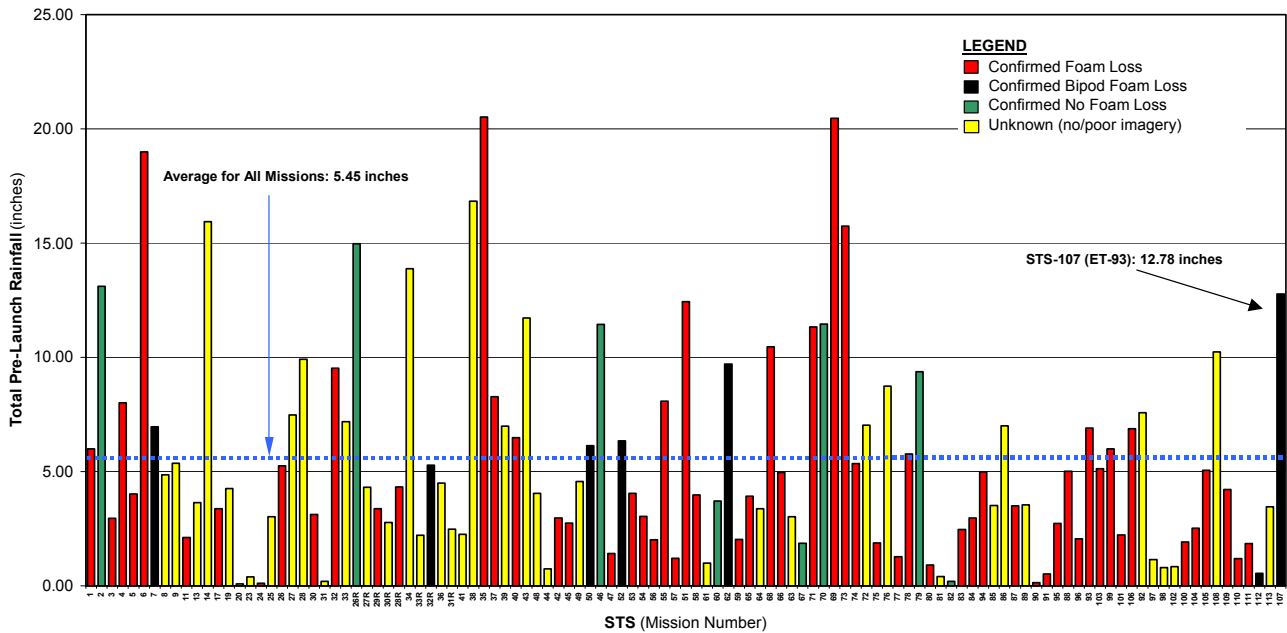
Figure 9-5. Total prelaunch rainfall for all STS missions

An extensive review of the relevant weather at Kennedy Space Center (KSC) was conducted in order to determine if a correlation could be derived for the weather conditions impact on ET bipod foam loss. The precipitation review examined total rainfall, maximum one-day rainfall, average daily rainfall, launch day rainfall, and L-5 days through liftoff total rainfall. Figure 9-5 shows the total prelaunch rainfall for all STS missions. As shown in Figure 9-6, although the STS-107 value for total prelaunch rainfall, 12.78 inches, is greater than the mean value for all mission, 5.45 inches, the data are inconclusive as to whether a correlation can be made for ET bipod foam loss as a function of total rainfall prelaunch. The 95% confidence limit of the missions with ET bipod foam loss overlaps the confidence interval for all missions, as well as missions with no foam loss.

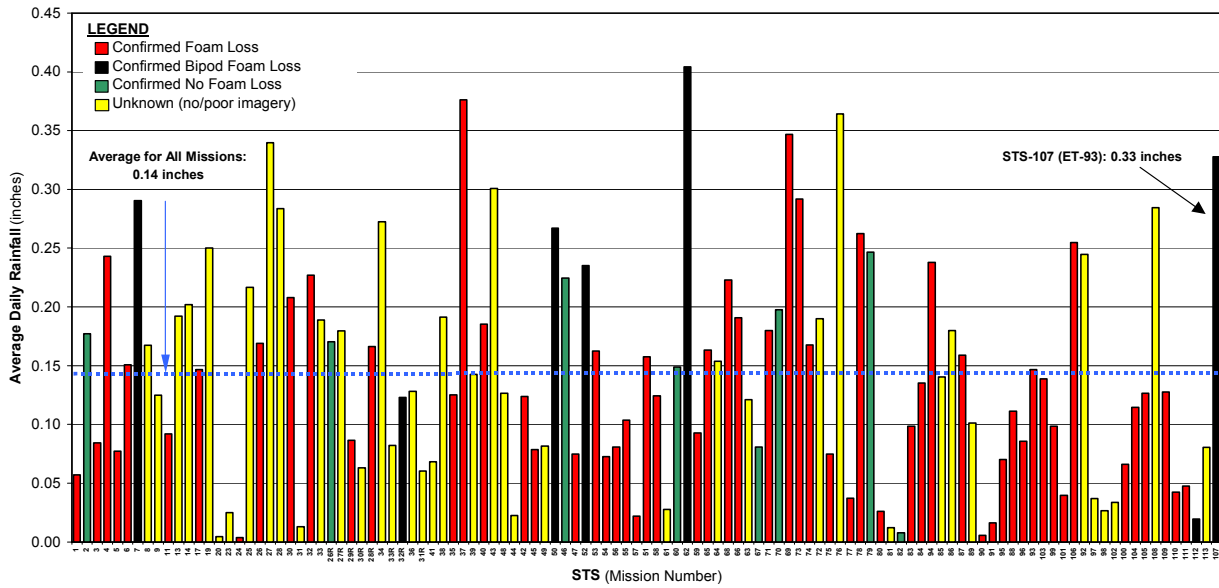
Figure 9-7. Average daily rainfall prelaunch for all STS missions

Similarly, the other rainfall parameters studied (e.g., average daily, day-of-launch) reveal no correlations for ET bipod foam loss. Figure 9-7 and Figure 9-8 show the data correlation for average daily prelaunch rainfall. The STS-107 value, 0.33 inches, and the mean value for missions with bipod foam loss are greater than the average mission value, 0.14 inches. However, the confidence intervals overlap each other, and the data are inconclusive as to whether average daily rainfall and ET bipod foam loss can be correlated.

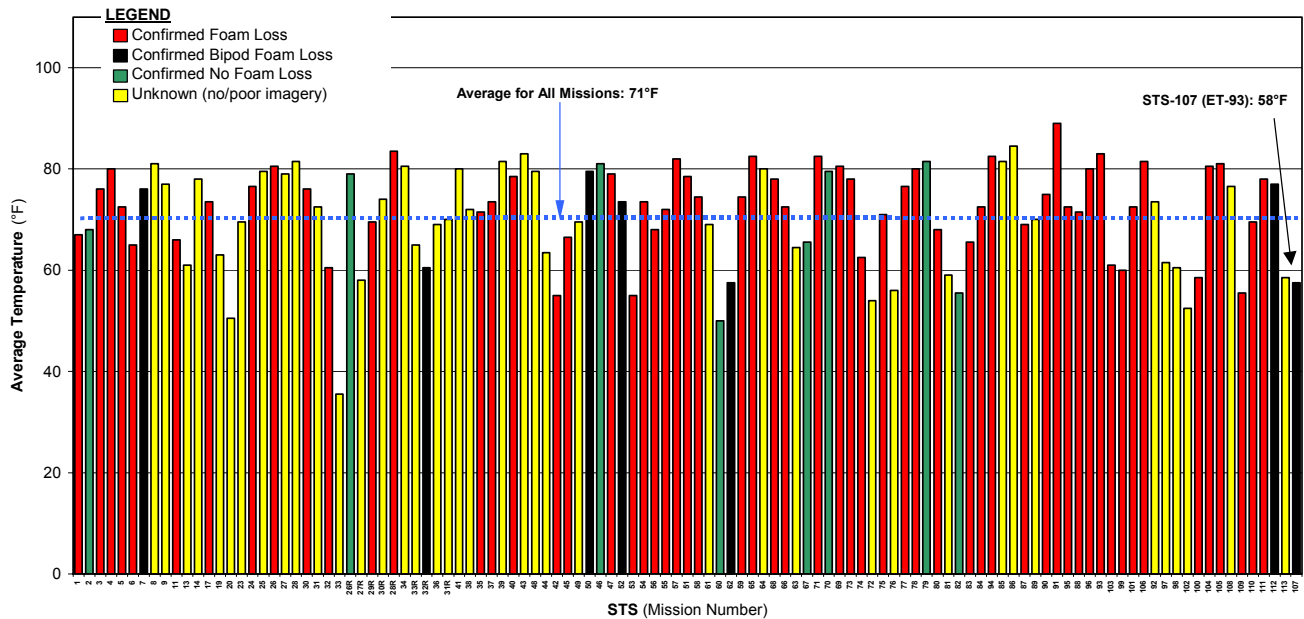
Figure 9-9. Day-of-launch average temperature for all STS missions

In addition to rainfall, the study also reviewed average, minimum, and maximum temperature, dew point, and humidity for both prelaunch and day of launch. Figure 9-9 shows the day-of-launch average temperature. The STS-107 day-of-launch average temperature, 58 °F, was less than the mean value for all missions, 71 °F, but no correlation can be made between day-of-launch average temperature and ET bipod foam loss. Similar comparisons made for other temperature samplings, dew point (Figure 9-10), and humidity (Figure 9-11), yielded no correlations either.

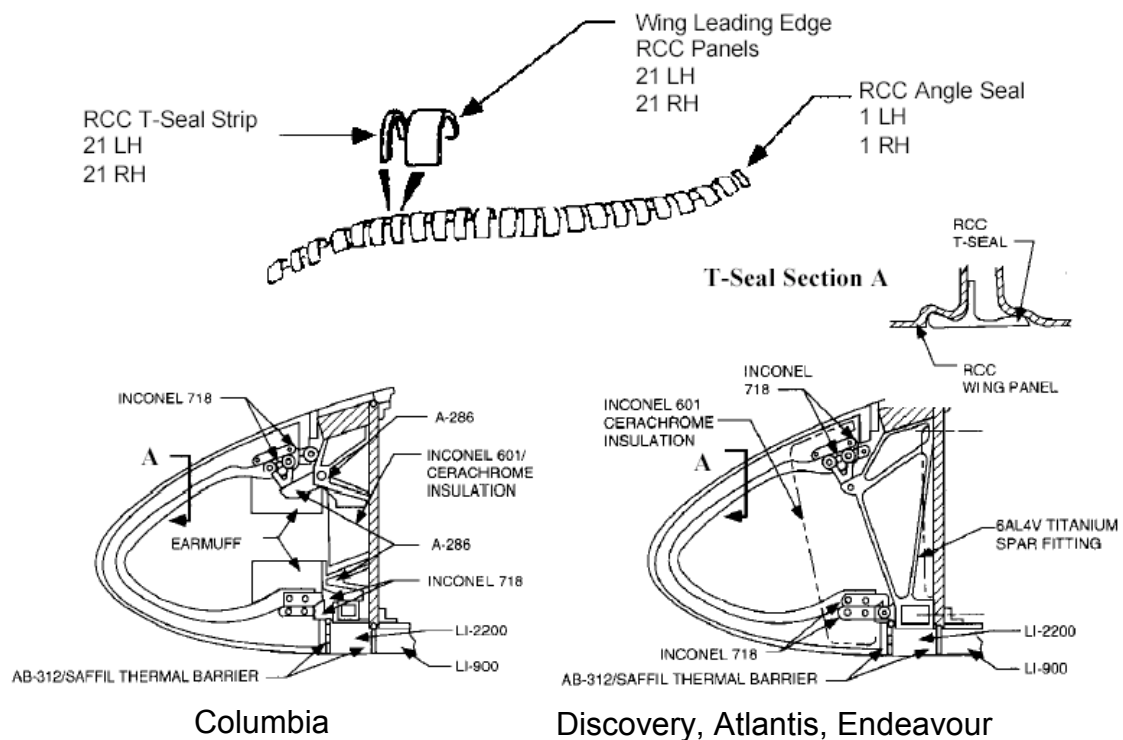
Figure 10-4. Wing leading edge RCC

The angle seal at RCC panel 1 on the left wing leading edge (see Figure 10-4) was removed to support the evaluation of the horse collar gap filler between the adjacent tiles. During the removal attempt, the upper bushing remained bound with the shipside clevis. During subsequent attempts, the angle seal was manually manipulated to try and remove the preload. During the KSC paper review, structures engineers realized that the load applied to the angle seal was specified to be kept below 20 pounds, but was never recorded in the paper. The RCC specification requires that RCC panel loads be kept below 30 pounds. Subsequent tests at KSC verified that the angle seal load was below the 30-pound requirement. The LESS prevention and resolution team is addressing the issue of how to measure the load and how to support the seal in future operations. Work continued on the elevon flipper doors. Flipper door 1 blade seal was not making contact with the rub channel, potentially leading to excessive venting from the elevon cove area. This issue surfaced twice during this flow and was Material Review (MR) accepted to fly as is. Modification was made to the Inconel trailing edge seal and bulb seal on the elevon. Additional work was performed on the elevon cove corrosion protection again to reduce the excessiveness of the application.

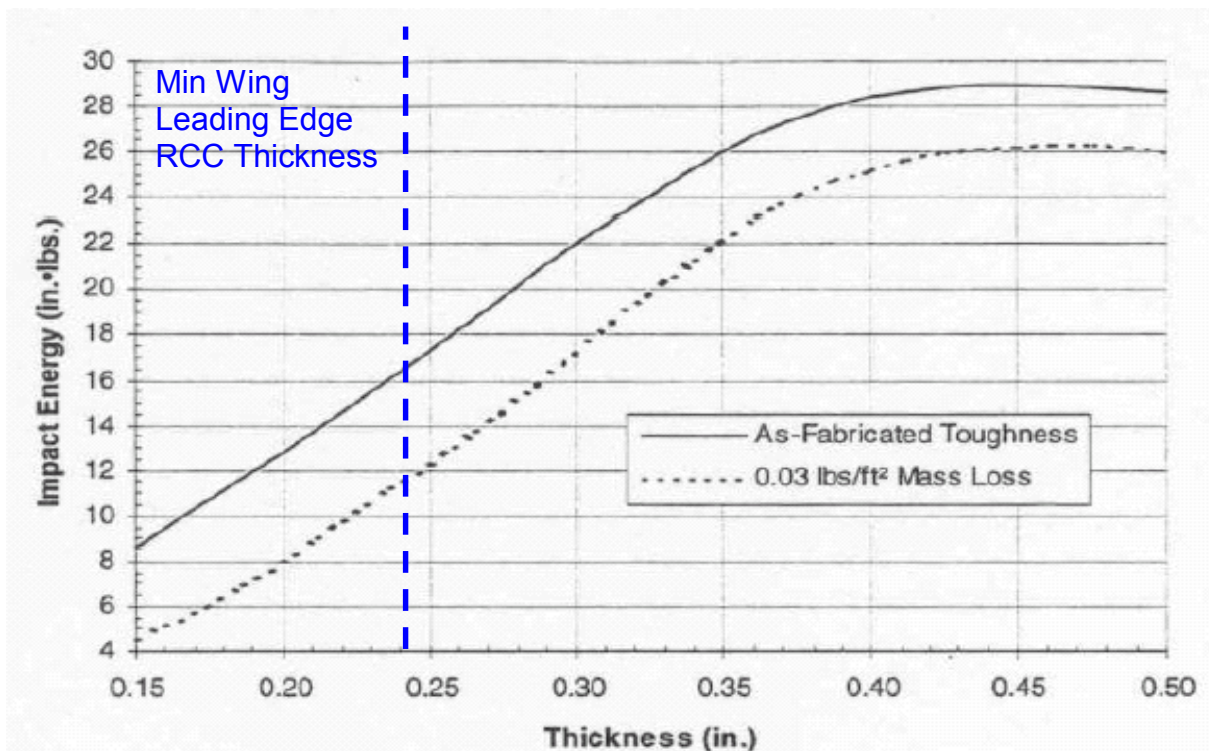
Figure 10-6. RCC impact resistance

The RCC was not considered part of the TPS for the purposes of impact resistance. The TPS was designed to accommodate particle impacts, such as from hail, rain, runway debris, etc., whose impact energy did not exceed 0.006 foot-pounds to the surface. The wing leading edge RCC impact resistance allowed no damage to the RCC with the application of up to 16 inch-pounds of energy. Figure 10-6 shows RCC impact resistance ranging from 4 to 26 inch-pounds depending on the increasing thickness of the RCC element. Different tests including low velocity and hypervelocity tests have been conducted to determine the actual impact resistance of the RCC. Test projectile materials have included nylon, glass, aluminum, steel, lead, and ice and have taken shapes of spheres, bullets, and cylinders. The test results vary widely and appear to be significantly dependent on impact velocity, projectile type, and angle of incidence of impact. Because of the variability of the test results, no actual impact resistance could be defined.

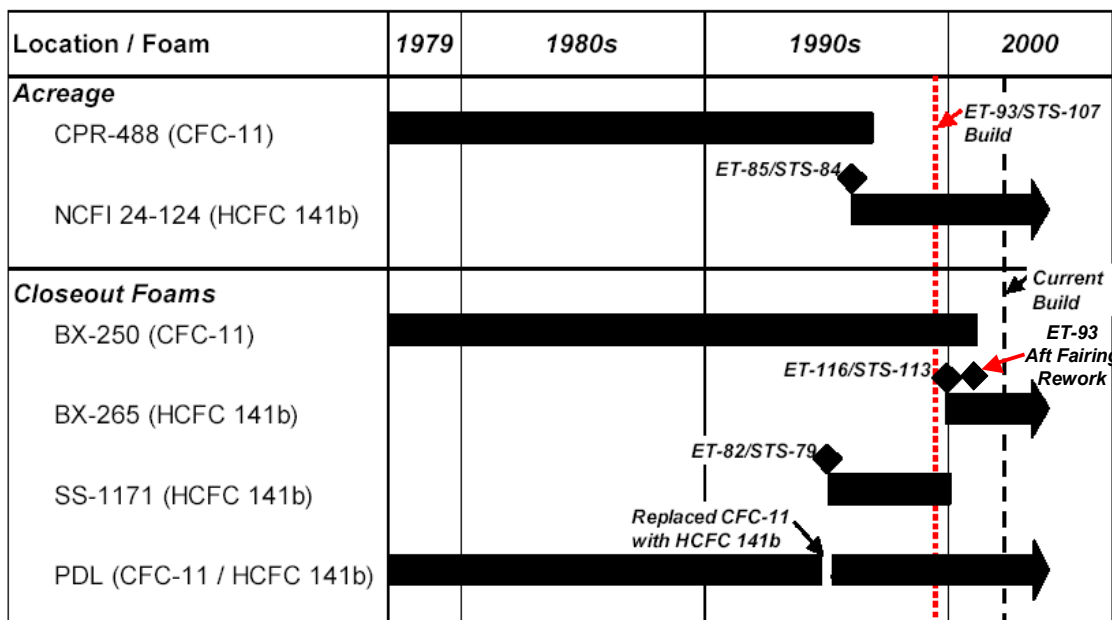
Figure 11-1. History of foam changes. Blowing agent shown in parentheses, no changes to SLA

The ET TPS history is marked by multiple material and configuration changes resulting from ET TPS and ice loss events, design enhancements, environmental regulations (especially blowing agent changes), and supplier changes. The history of foam changes is outlined in Figure 11-1, and Table 11-1 lists the ET flight history, as well as age and exposure data. Thousands of tests have been conducted to develop and qualify the ET TPS. There were no first time ET TPS changes on STS-107/ET-93 except for rework of the TPS on the upper aft ET/Solid Rocket Booster (SRB) fitting fairing (following SRB demate) using BX-265. Basic bipod TPS materials had not changed from the beginning of the program until after ET-93. The bipod TPS configuration has been stable since 1983, when with ET-14 the ramp angle was changed. At ET-76 in 1995, there was one minor change to the ramp intersection with the ET intertank area. At ET-116 in 2002, the bipod material was changed to BX-265, but ET-93 had been constructed with BX-250. No indication has been found that any specific ET TPS foam change or any combination of historical ET TPS foam changes alone caused the bipod foam loss on STS-107/ET-93.

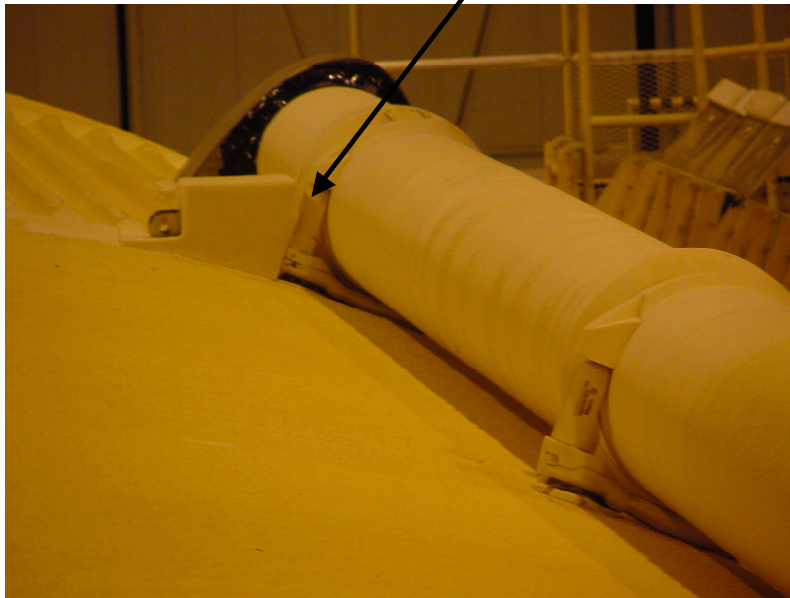
Figure 11-2. Right (+Y) bipod ramp

There is no flight or test data to explain why the -Y (left) bipod loses foam and the +Y (right) does not. The Shuttle Program only provides the -Y ramp air loads as a worst case for ET project analysis. There are several bipod configuration differences that may contribute to foam not coming off the +Y ramp. First, the foam ramp is configured slightly differently to accommodate the inboard strut for the LO2 feed line support structure (see Figure 11-2). Second, the proximity of the right bipod to the LO2 feedline could potentially influence local surface pressure causing a lower internal to external pressure differential (see Figure 11-3). Finally, the outboard and aft facing surface of the -Y bipod may experience lower surface pressure due to flow separation and other local effects relative to the +Y side. If the internal ramp pressure was high due to adverse “as-built” features in the ramp, this could lead to a higher differential pressure on the -Y versus the +Y ramp. However, the aerodynamic loads analysis reviewed in Section 3.5 shows that the loads on both ramps are below their design requirements.

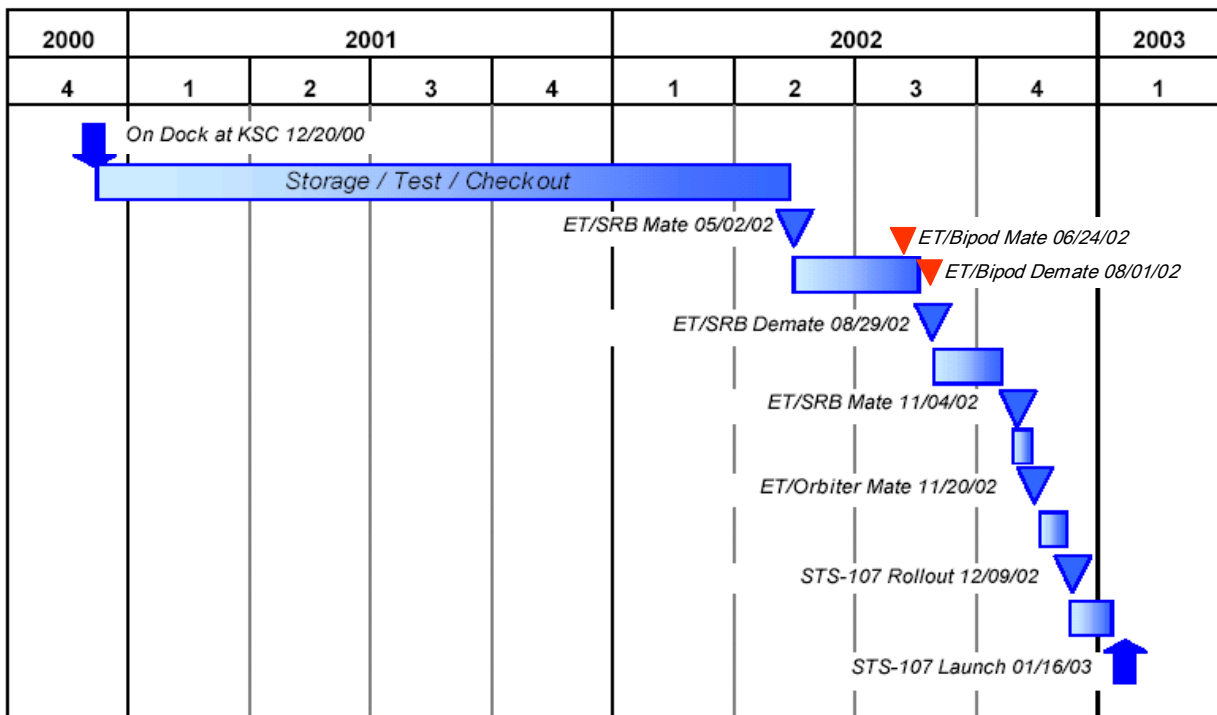
Figure 11-4. ET-93 processing timeline at KSC

The shuttle flight manifest was delayed due to cracks found during inspections of Main Propulsion System feedline flow liners on Atlantis in June 2002. The final manifest moved STS-112 and STS-113 ahead of STS-107. ET-93 was de-mated from SRBs BI-114/RSRM-86 and later mated to SRBs BI-116/RSRM-88, and SRBs BI-114/RSRM-86 were used for STS-113. All mate/de-mate operations were carried out in accordance with standard procedures, and are outlined in Figure 11-4. There are no indications that KSC ET processing (ET shipping, handling, and processing) contributed to the bipod foam loss on STS-107/ET-93.

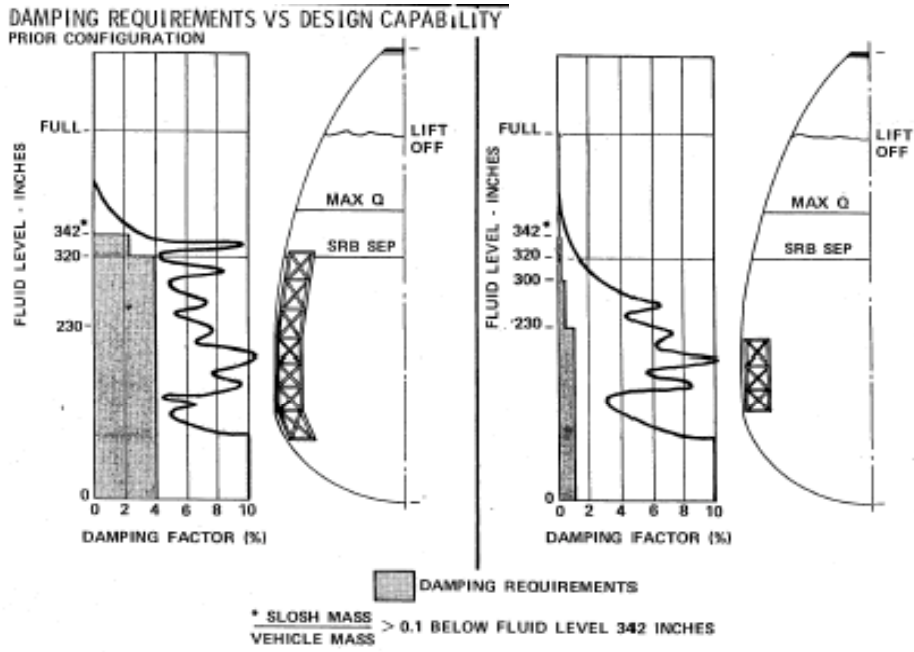
Figure 11-5. ET LO2 slosh baffle changes – ET-14

Eight ET LO2 slosh baffles were used until ET-14 in 1983. Vehicle stability analysis based on development flight instrumentation confirmed minimum LO2 sloshing disturbances and Space Shuttle Program LO2 damping requirements were subsequently reduced. Analysis and sub-scale test showed the baffle count could be reduced from eight to two and still maintain margin, but a reduction to four was selected as a trade off between cost benefit and weight reduction (see Figure 11-5).

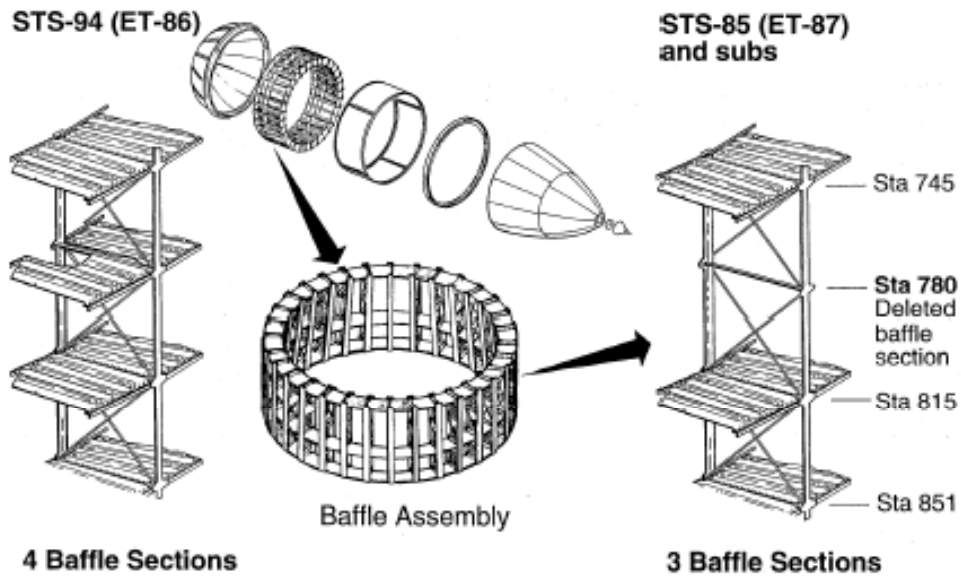
Figure 11-6. ET LO2 slosh baffle changes – ET-87

One weight saving feature of the SLWT is the removal of one more slosh baffles section, as shown in Figure 11-6. This gives a predicted performance gain of 92 pounds. This feature was incorporated into the LWT at ET-87 in 1996 to reduce weight and diminish the number of first time configuration changes for the subsequent first flight of the SLWT. Dynamics analysis showed available damping remained within requirements and propulsion and stress analysis also remained within requirements. Data are inconclusive as to whether the ET LO2 slosh baffle configuration alone caused bipod foam loss on STS-107/ET-93.

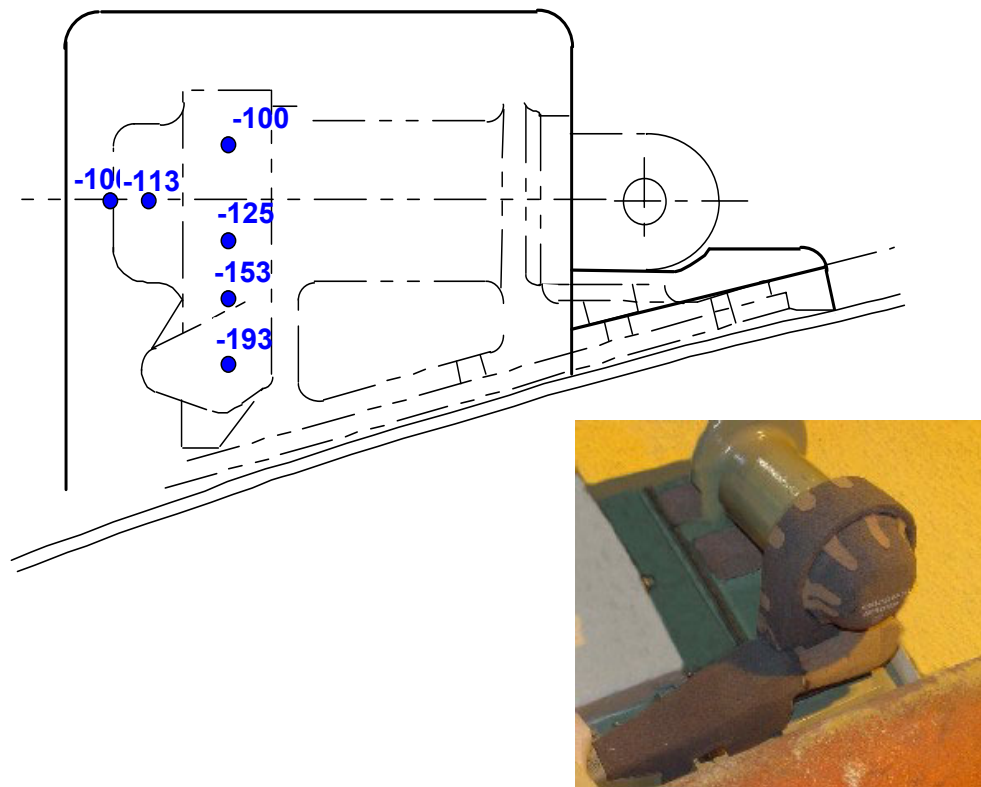
Figure 11-10. Max bipod SLA temperatures (80 seconds MET), °F.

The maximum SLA temperatures possible at 80 seconds were analyzed to determine maximum worst-case multi-event material loss. No cryopumping or cryo ingestion was assumed in order to calculate temperatures as high as possible. STS-107 ambient environments were used. Results showed the maximum SLA temperature possible at 80 seconds MET is less than or equal to -100°F , as shown in Figure 11-10. Tension testing shows BX-250 fails before SLA at temperatures less than or equal to -100°F .
