COLUMBIA

ACCIDENT INVESTIGATION BOARD

REPORT VOLUME II
OCTOBER 2003

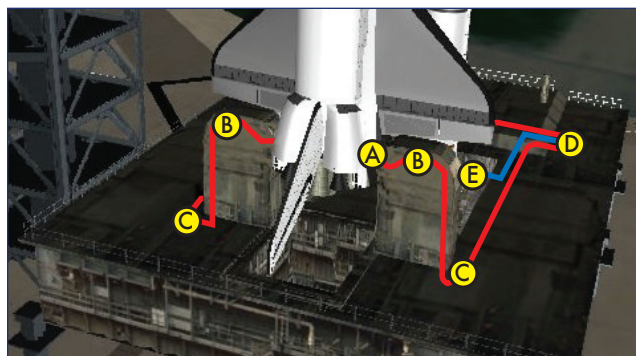
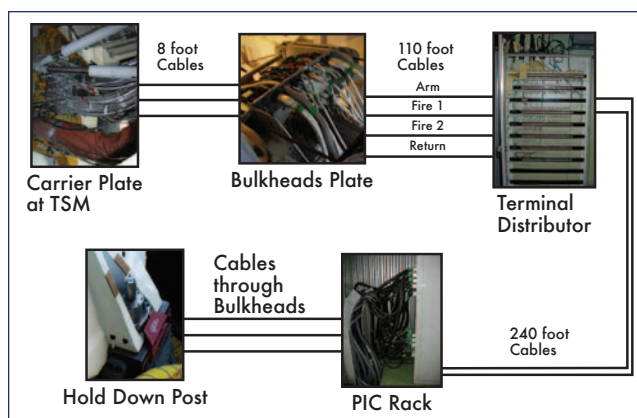
Figure S-1: Hold-Down Post/External Tank Vent Arm Systems diagram with nomenclature below (Note: This figure was not included in the final report Section 10.9; it is provided here for clarity.)

The signal to fire the HDP/ETVAS begins in the General Purpose Computers and goes to both of the Master Events Controllers (MECs). (See Figure S-1 for system routing.) MEC 1 communicates this signal to the A system cable, and MEC 2 feeds the B system. The cabling then goes through the Mobile Launch Platform mast to the Pyrotechnics Initiator Controllers (PICs; there are 16 PICs for A and B Hold-Down Posts, and 4 for A and B External Tank Vent Arm Systems); it then goes to each Solid Rocket Booster and Hold Down Post External Tank Vent Arm System. The A system is hard-wired to one of the initiators on each of the four nuts (eight total) that hold the Solid Rocket Booster to the Mobile Launch Platform. The B system cabling is hard-wired to the secondary initiator on each nut. The A and B systems also send a duplicate signal to the External Tank Vent Arm System. Either Master Events Controller will operate if the other or the intervening cabling fails. To verify cabling integrity, a continuity and ohms check is performed before each launch.

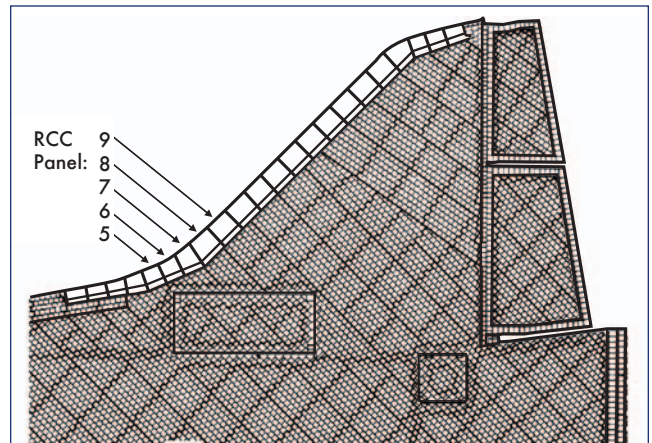
Several approaches were taken to assess the area of left wing damage. The efforts included launch video and photograph analysis, review of launch MADS data, debris transport analysis, forensic analysis of debris found in Texas, wire bundle burn through analysis, and aero/thermal modeling of the entry. The data indicate that the area of the highest probability of damage to the left wing was between RCC panels 5 and 9, with the most likely damage occurring on the lower side of RCC panel 8 or an adjacent Tee seal. The damage was most likely equivalent in size to a 6 to 10 inch diameter hole or area broken from the RCC panel or an adjacent Tee seal. Figure 3-4 shows the area of highest probability of wing damage and Table 3-1 shows the methods used to determine the damage.

Figure 3-4. Area of most likely wing damage.

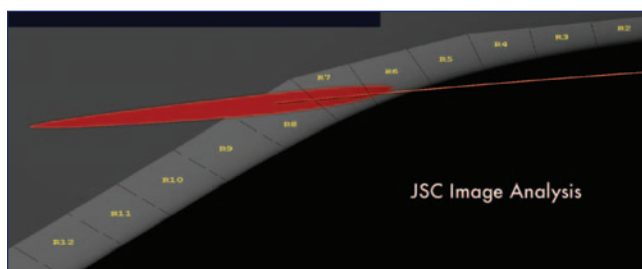
Video and Computer-Aided Design (CAD) analysis determined that the most likely impact location was leading edge RCC panels 6 through 8 (Figure 3-5). Due to the foam size, RCC panels 5 and 9 must also be included in this impact zone. The best estimate of the foam size, based on imagery measurements, is 21 to 27 inches long and 12 to 18 inches

Figure 3-5. Multiple analyses determine foam impacted lower RCC panels 6 through 8 area.

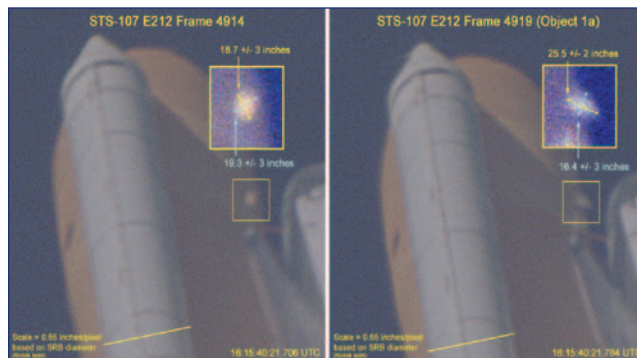
wide. The precise foam shape and thickness cannot be determined from the available imagery; however, a reasonable estimate is that it was a plate-like shape and several inches thick. The foam tumbled at a minimum rate of 18 times per second based on the imagery, although the actual rate may never be known more accurately. Figure 3-6 illustrates a portion of the photographic analysis techniques used to determine the size of the foam.

Figure 3-6. Photographic analysis techniques determined foam size: debris appears almost circular in frame 4914 and elongated in frame 4919.

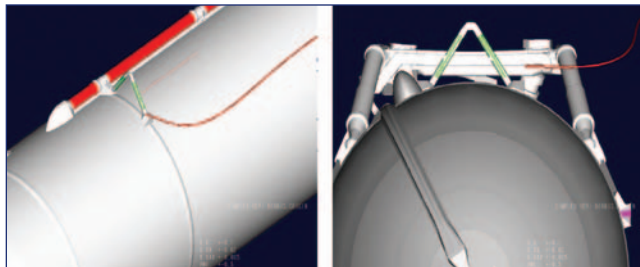
There is significant visual and debris trajectory information to implicate the left bipod ramp area as the source of debris. In Figure 3-9, the red line depicts the estimated foam trajectory as it moved from the bipod ramp area toward the left wing. In addition to locating the impact in the RCC panels 6 through 8 region, the video analysis has also shown that the impact was below the apex of the RCC panels since no foam or post impact debris was observed to traverse over the top of the wing. This is indicative of an impact below the wing leading edge aerodynamic stagnation line (Figure 3-10). The stagnation line, or dividing streamline, is the line along the leading edge of the wing where the airflow comes to rest; above this line, airflow moves over the upper wing surface and below this line, the airflow moves over the lower wing surface.

Figure 3-9. Multiple analyses indicate foam is from ET left bipod area. Red line depicts the estimated foam trajectory as it moved from the bipod ramp area toward the left wing.

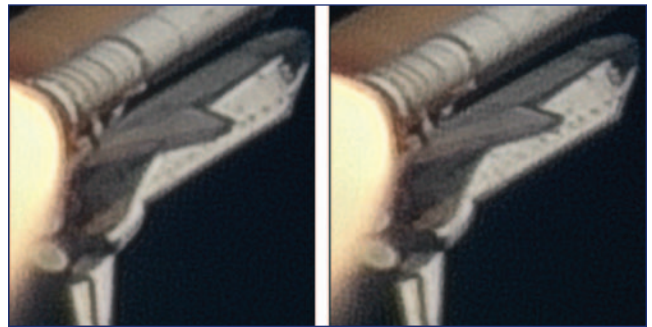
Enhancements of the ascent video indicated there was no discernable damage to the orbiter wing leading edge or lower tile surface. Figure 3-11 is a sample of these video enhancements. The figure compares 30 pre-impact integrated video fields with 21 post-impact integrated video fields. Based on these enhancements, photo experts have been unable to determine or quantify any damage to any portion of the orbiter vehicle as a result of the impact.

Figure 3-11. Pre-impact vs. post-impact shows no observable damage within the resolution limits.

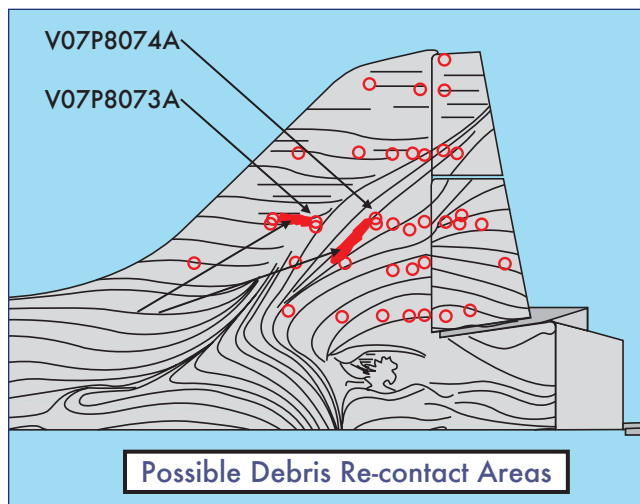
There are two other indications that the foam impact occurred in the panels 6 through 8 area. Two Modular Auxiliary Data System (MADS) lower surface pressure measurements behaved anomalously immediately after the time of the impact. Figure 3-13 shows the location of these measurements along with possible areas for post-impact debris re-contact in the vicinity of the sensors. The unusual behavior of one of the sensors is shown in Figure 3-14.

Figure 3-13. CFD surface flow with lower left wing pressure sensors.

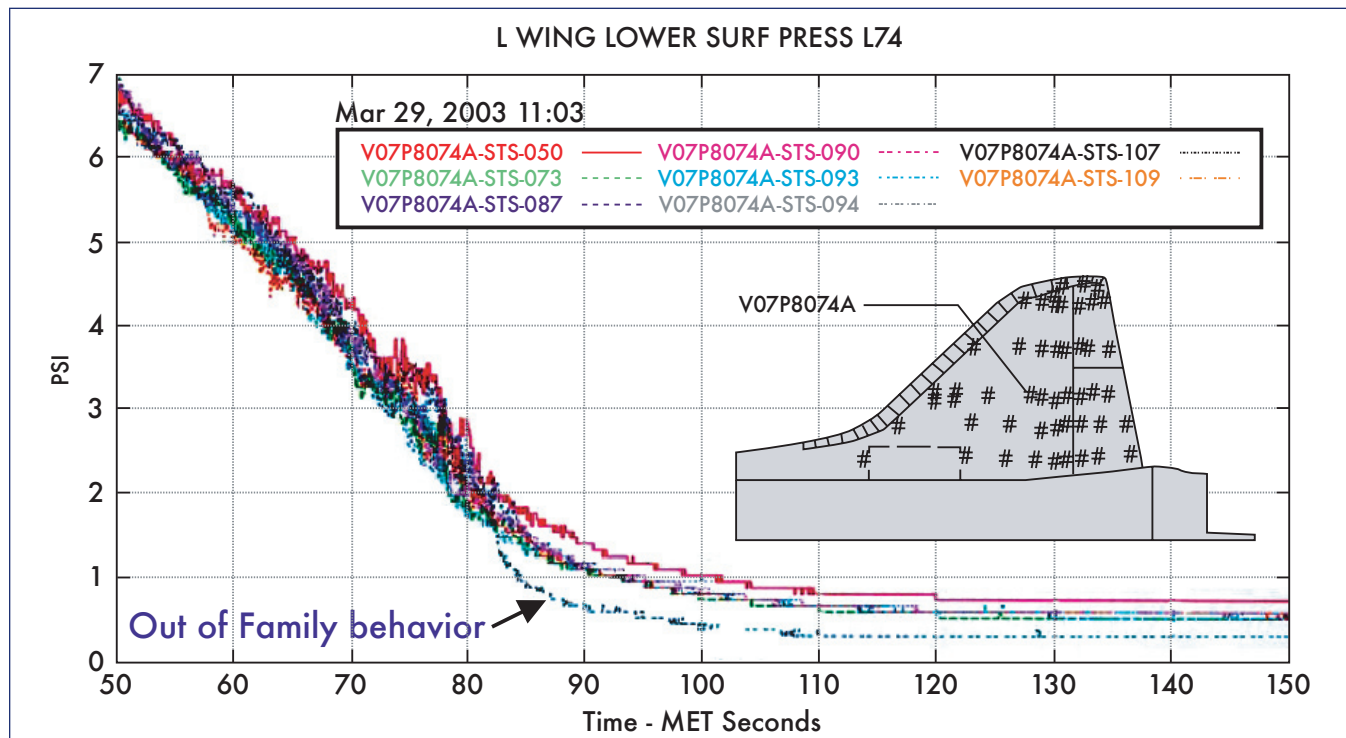
Figure 3-14. Unusual behavior of pressure sensor V07P8074A.

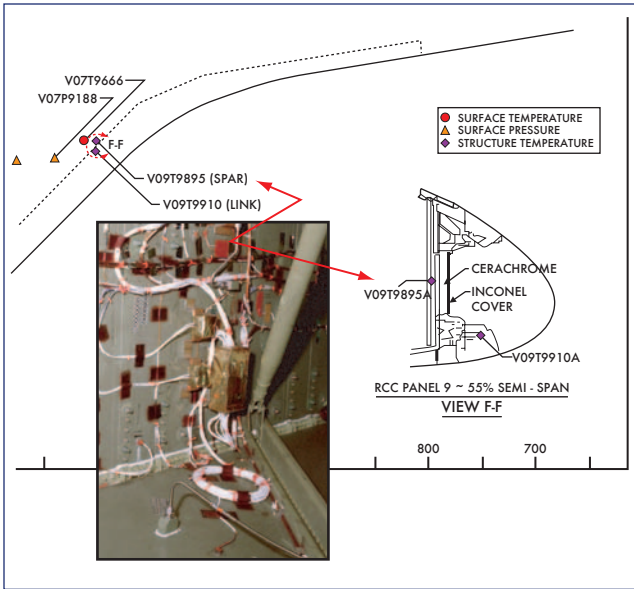
Additionally, there is another MADS measurement that had an off-nominal signature during the ascent timeframe. The temperature sensor on the leading edge spar behind RCC panel 9 showed a slightly higher temperature rise than seen on any previous *Columbia* flight. Figure 3-15 shows the location of the temperature sensor behind the wing leading edge spar inside the wing. The slight temperature rise can be seen in Figure 3-16. Note that most flights show a small rise in this temperature during ascent due to aerodynamic heating.

Figure 3-15. Close-up photo shows RCC panel 9 wing leading edge temperature measurement.

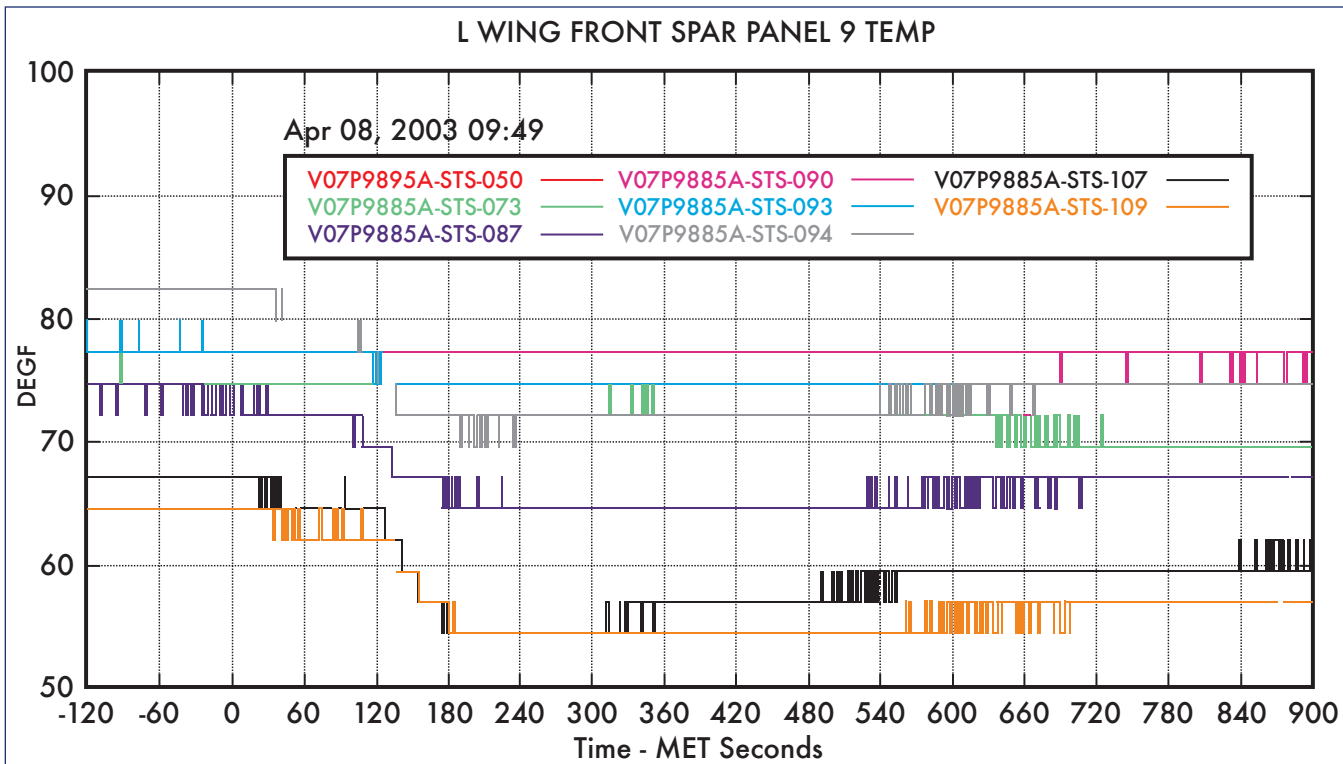
Figure 3-16. Three-bit rise (7.5 degrees F) on MADS wing leading edge spar temperature measurement (V09T9895A) during ascent.

STS-107 had a 7.5 degree Fahrenheit rise that started very early during ascent (five to six minutes after launch). Although the data do not prove that the RCC was breached during ascent, the data are consistent with a possible flow path into the RCC cavity via damage in the RCC panels 6 through 8 area. A simplified thermal math model was constructed and verified with flight data from STS-5. The model was then correlated to the flight data from STS-107. Assuming the equivalent heating from a 10 inch diameter hole in RCC panel 8, this model nearly predicts both the ascent and entry temperature profiles for the wing leading edge spar temperature sensor. Figure 3-17 compares the model with

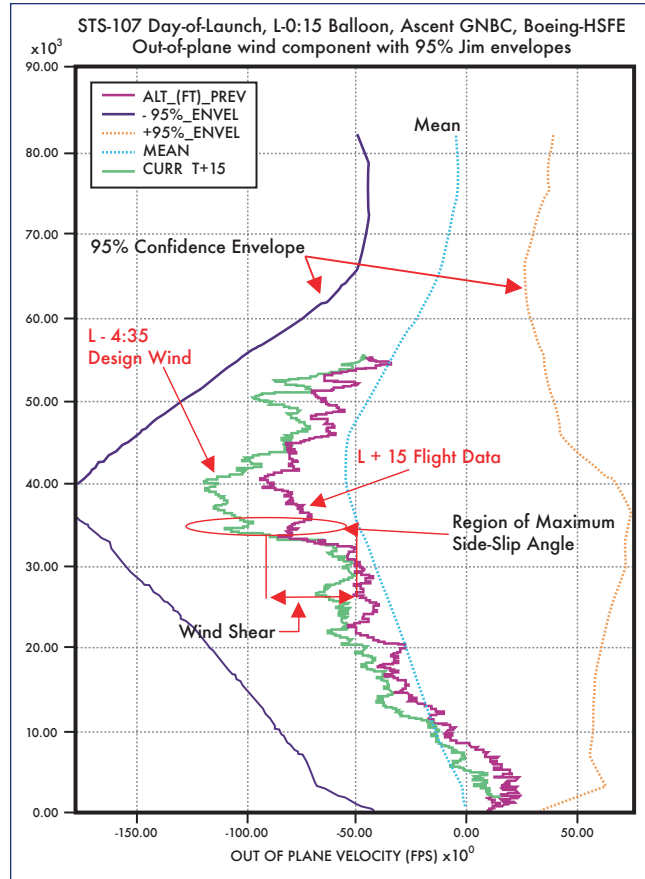
STS-107 experienced a wind shear during the period of maximum dynamic pressure starting at 57 seconds MET (Mach 1.27). The wind shear was due to a rapid change in the out-of-plane wind velocity of -37.7 feet per second over a 1200 foot altitude range starting at approximately 32,000 ft (as shown in Figure 3-21). Immediately after the vehicle flew through this altitude range, its side-slip angle began to increase in the negative direction, reaching a value of approximately -1.75 degrees at 60 seconds. This value of side-slip angle is a new flight experience value for MET 60 seconds (as shown in Figure 3-22). Post-flight data indicates that the new flight experience side slip event was not the result of the wind shear itself. Instead, it was the direct result of a difference in the L - 4:35 minutes balloon measurement, upon which orbiter guidance commands were updated on launch day, and the actual winds flown through by the orbiter during launch and ascent. Figure 3-21 highlights the difference in these two winds in this altitude region (a 25 foot per second increase in out-of-plane magnitude pre-launch compared to a 12 foot per second reduction in magnitude as experienced by the vehicle).

Figure 3-21. Out-of-plane wind velocity.

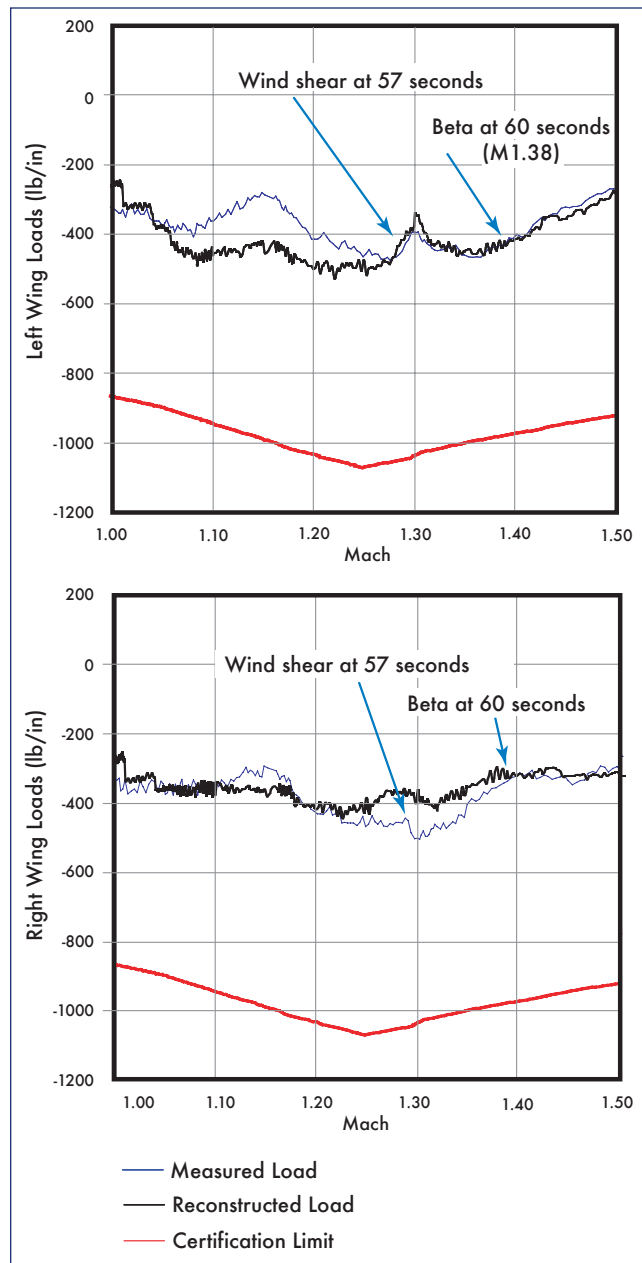
generate the loads on the orbiter wings during ascent. The assessment demonstrated that all orbiter wing loads were 50 to 60% of their design limit, or less, throughout the ascent. This includes the wind shear event at 57 seconds MET, and subsequent side-slip angle at 60 seconds MET (as shown in Figure 3-23).

Figure 3-23. Wing loads during wind shear and side-slip angle.

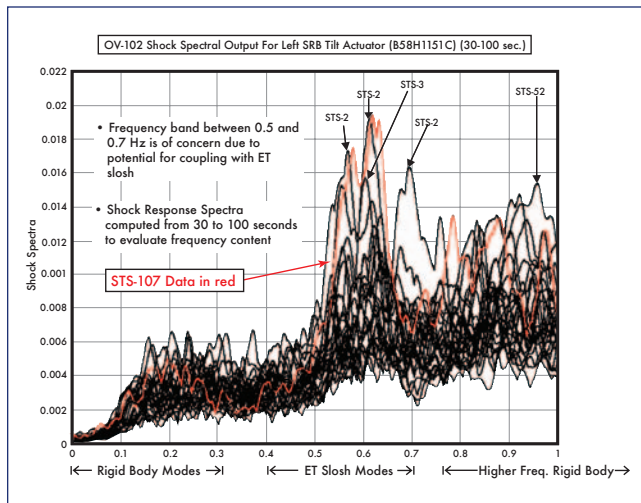
The STS-107 ascent data indicate a 0.6 Hz actuator oscillation frequency that peaks in amplitude at 55 seconds, and again at 77 seconds MET and continues through SRB separation. The peaks directly correlate to peaks in 0.6 Hz wind content. A 0.6 Hz oscillation in the Flight Control System output is of interest since it can couple with the ET Liquid Oxygen (LOX) slosh mode. Slosh refers to the repeated side-to-side movement of the center of gravity of the liquid oxidizer propellant in the external tank. The slosh mode frequency and amplitude cannot be measured directly through vehicle data. In order to determine if ET LOX slosh is present, a post-flight process of reviewing the vehicle SRB and SSME actuator frequency content must be conducted, as well as that of the launch wind. When this post-flight process was conducted for STS-107, it revealed that this flight experienced more than typical 0.6 Hz frequency content in the SRB tilt actuators with moderate content in the rock actuators. Figure 3-29 illustrates this point with the results of the SRB left tilt actuator frequency response as compared to previous *Columbia* flight history.

Figure 3-29. STS-107 SRB tilt actuators experienced more than typical 0.6 Hz content.

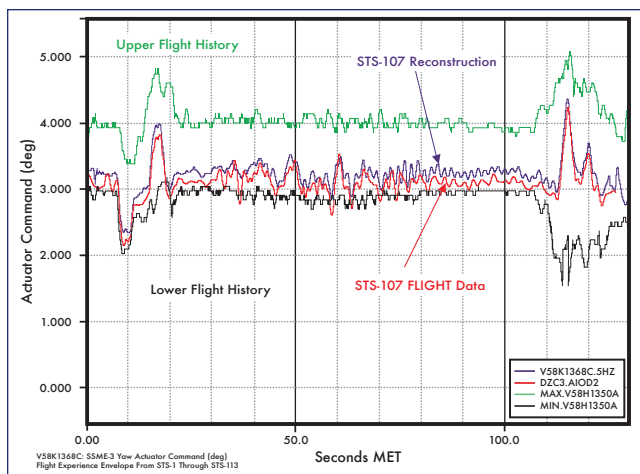
Figure 3-32. Right SSME yaw position.

A review of the STS-107 ascent data identified two discrete points in time when the SRB and SSME nozzle positions exceeded the flight experience envelope for those respective times in the ascent profile. The first event occurred when the center and right SSME yaw deflections exceeded the previous flight experience envelope during the period of maximum dynamic pressure, as a result of the differences between predicted and actual flight wind conditions (as shown in Figure 3-31 and Figure 3-32).

The large offset in the Center and Right SSME yaw positions at 62 seconds MET was the reaction of the flight control system to the wind shear event and day-of-launch wind differences as compared to the DOLILU design. The nozzle motion was within the capability of the Shuttle flight control system, and the system operated as designed. As discussed in Section 3.5.1, the reconstruction loads analyses indicate that the ascent environment-induced loads alone did not cause the ET bipod foam loss.

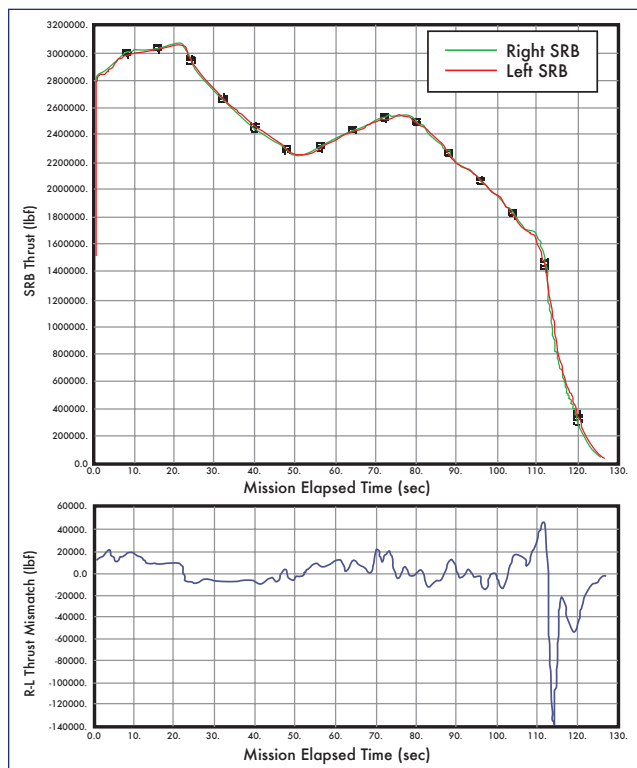
Figure 3-34. SRB thrust mismatch.

The SRB thrust mismatch observed during tail-off was well within the design margin of the flight control system, and similar occurrences have happened numerous times during previous flights.

The data indicate that the SRB thrust mismatch on STS-107 was a direct result of SRB burn rate differences between the left and right SRB. The thrust mismatch observed on STS-107 and the new flight experience nozzle positioning occurred after the foam shedding event. The SRB thrust mismatch occurred on the majority of flights in both families of flights, including those that did not shed foam.

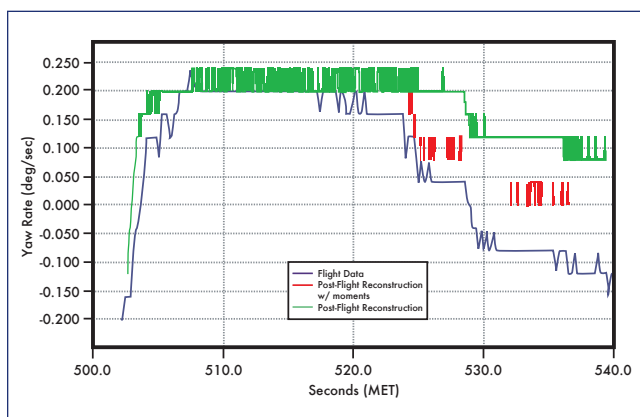
Figure 3-36. ET separation yaw rate.

A higher than typical negative yaw rate was observed at ET separation during STS-107. The yaw rate, shown in Figure 3-36, was approximately -0.12 deg/sec and near the edge of the flight experience envelope. The negative yaw rate is noteworthy because it does not correspond to the flight control system's thruster activity, known vent forces, or any other explained mission activity. Furthermore, the rate appears at the time of physical separation between the orbiter and external tank, which indicates that it is related to the structural release between the two objects. Although the negative yaw rate was unusual, it was well within the design and certification envelope for ET separation. This rate was also well within the flight limits (± 0.7 deg/sec) for ET separation to occur.

A fault tree analysis narrowed down the cause of the negative yaw rate to a release of strain energy at ET separation due to either (1) a misalignment of the orbiter and external

Data indicate that the yaw rate at ET separation did not result in re-contact between the orbiter and the ET after separation. This observation is based on high rate telemetry (25 Hertz) orbiter body rate data, and MADS accelerometer data analyzed post-flight. The yaw rate was within the expected range of vehicle body rates when taking into account all known error sources, including rate sensor noise. The data indicates that no correlation exists between observed yaw rate at ET separation and bipod ramp foam loss.

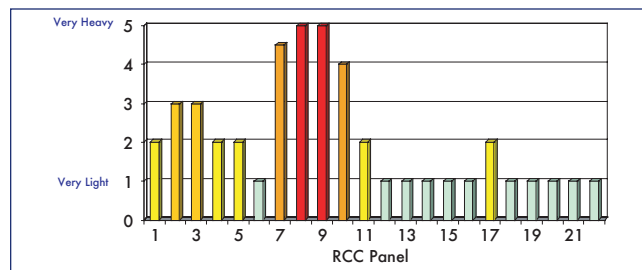
Figure 5-2. Slag deposition in the RCC panel 8/9 area relative to the other parts of the left wing leading edge.

The forensic data indicate that the panel 8/9 area was subjected to extreme entry heating over a long period of time leading to RCC rib erosion, severely slumped carrier panel tiles, and a substantial slag deposition on the upper portion of RCC panels 8 and 9. Figure 5-2 shows the slag deposition (both metallic and oxide) in the RCC panel 8/9 area relative to the other parts of the wing leading edge, and Figure 5-3 shows samples of the severe slag deposition on the panel 8 rib. A review of all recovered debris indicates that this is the most probable area of a breach into the wing since there are no other debris pieces that exhibit the unique characteristics observed in this area.

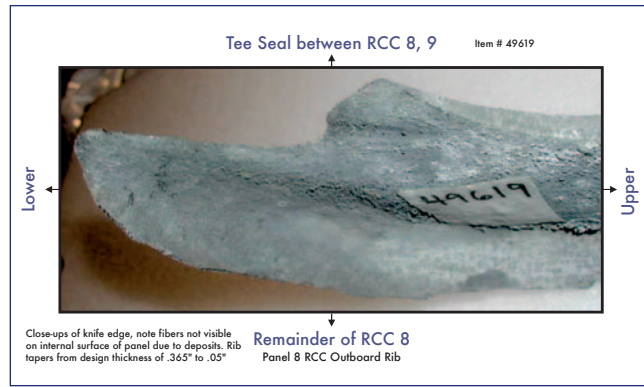
Figure 5-4. Example of rib erosion.

ure 5-4 and Figure 5-5 show an example of the rib erosion and the flow on the lower carrier panel 9.

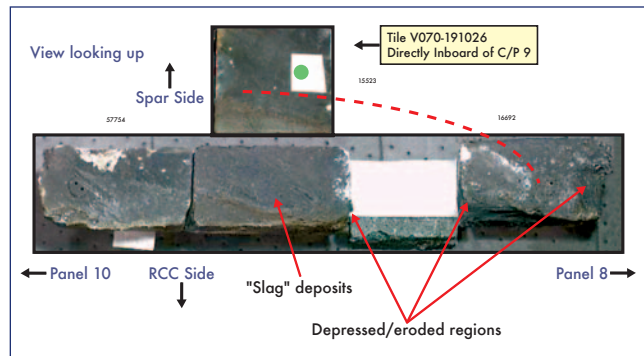
Figure 5-5. Flow on the lower carrier panel 9 tiles.

Analysis of the slag deposition on the lower carrier panel 9 tiles was also performed. Materials on these tiles are consistent with wing leading edge materials (Aluminum, Inconel, Nickel alloy, and Carbon) indicating an outflow from the panel 8 area across the tiles. Tile slumping in this area is indicative of temperatures in excess of 3000 °F. The upper carrier panel 8 tile was also analyzed and the results were similar to lower carrier panel 9 except that this tile appeared to have more Cerachrome and Nextel fiber deposits. These materials are consistent with the insulator that protects the wing leading edge spar and with flow moving toward the upper wing surface through the vent between the upper carrier panel and RCC.

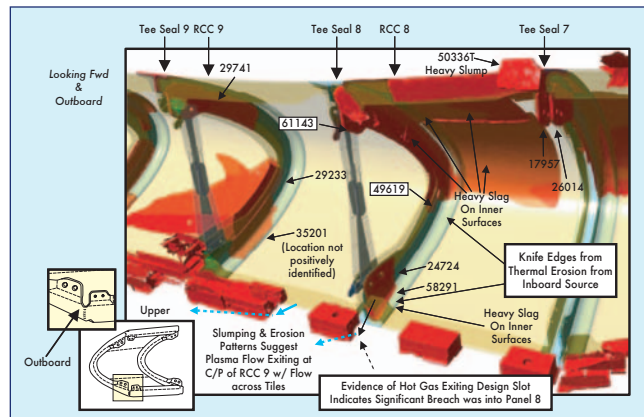
Figure 5-6. CAD drawing of the recovered debris showing overall slag deposition and erosion patterns.

Figure 5-6 is a CAD drawing of the recovered debris showing overall slag deposition and erosion patterns. The drawing is a view from behind the RCC panels since this provides the best view of the erosion and slag deposition. Three full Tee seals can be seen in this drawing; the leftmost, Tee seal 9, divides panel 9 and 10; Tee seal 8 in the center divides panel 8 and 9; the rightmost, Tee seal 7, is the division between panel 7 and 8. The drawing shows the heavy slag deposition of the upper portion of panel 8 indicating that the probable breach area was the bottom of panel 8. The severely eroded RCC ribs are also visible near the RCC panel 8/9 Tee seal. The heavy slag on these inner surfaces indicate flow from the panel 8 direction toward panel 9. This is also consistent with the knife-edge erosion shown in Figure 5-4. The proposed flow direction leading to the erosion and slag deposition on the lower carrier panel 9 tiles can be seen in this view as well. The detailed flow, erosion, and deposition are best viewed in Figure 5-5. The last significant feature in Figure 5-6 is the heavy slumping that is observed on the upper carrier panel 8 tile (50336T) in the upper right portion of the drawing.

The data shown in Figure 5-6 is important when combined with the analysis of the slag deposition. The slag deposition on the upper RCC panel 8 was analyzed using sophisticated cross sectional optical and scanning electron microscopy, microprobe analysis, and x-ray diffraction to determine the content and layering of the slag deposition. This analysis indicated that the materials in this area were exposed to extremely high temperatures, since Cerachrome insulation was deposited first and its melting temperature is greater than 3200 degrees Fahrenheit. The analysis also showed no presence of Aluminum 286 in the slag indicating that the RCC attach fittings were not in the direct line of the breach and that the Inconel 718 spanner beam was one of the first internal items to be subjected to heating. Inconel slag was prevalent in much of the analyzed slag indicating melting of the spanner beam, foil, and associated insulation. Aluminum was found in the last deposited layer indicating the wing honeycomb spar was the last area to be subjected to hot gas flow.

patterns, the breach was in an area that caused the flow to impact the spanner beam associated with Tee seal 8 and create the knife edge erosion shown in this area in Figure 5-6.

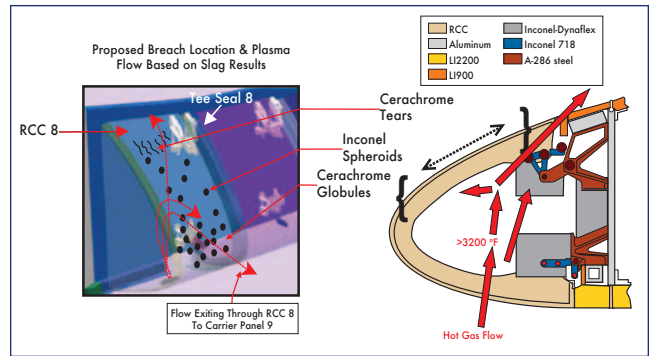
Figure 5-7. Analysis results show possible flow direction and deposition of metals.

As time progressed, the Cerachrome and Inconel wing spar insulators were eroded, and eventually hot gas flow impinged on the wing leading edge, burning through the honeycomb spar. Figure 5-7 depicts the possible flow direction and deposition of various metals as determined by this analysis.

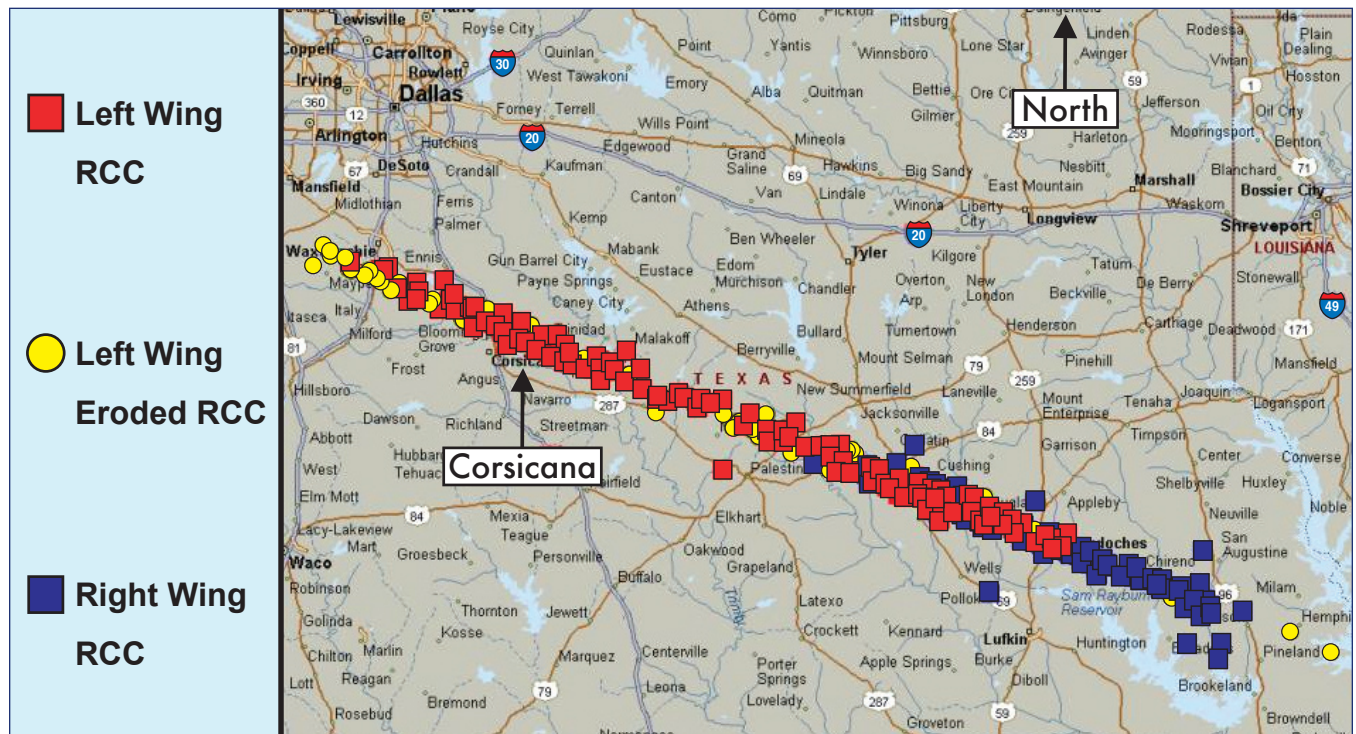
Figure 5-8. RCC panel debris location.

In addition to the slag deposition and flow analysis, there are two other significant pieces of data that point to a breach in the RCC 8/9 area as the initial damage. The first item is the location of the leading edge RCC in the debris footprint. Figure 5-8 shows the recovered RCC for both the left and right wing and its location in the debris footprint. The eroded RCC pieces from panels 8 and 9 are found in the westernmost part of this debris footprint near Waxahachie, Texas, along with other pieces of RCC panel 8. Left wing RCC panel 9 and other aft panels appear to have been lost relatively early in the break-up sequence since their footprint spans the western to center part of the footprint. This is indicative of a left wing breach in the panel 8/9 area. The forward portion of the RCC panels on both the left and right wings (panels 1 through 7) are found from the center to eastern part of the debris footprint possibly indicating that these were lost in a secondary aerodynamic break-up.

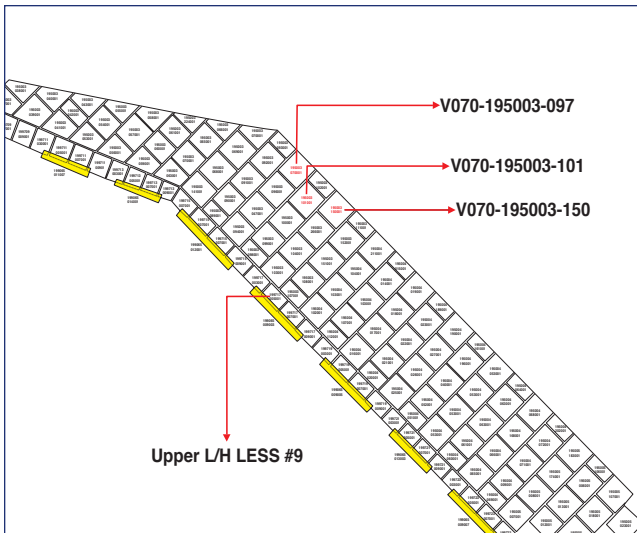
Figure 5-9. Three possible orbiter locations of the Littlefield tile on left wing.

ground track. This tile is the westernmost piece of debris that has been found to date in the debris recovery efforts. Due to the unique features of the tile (thickness, shape, paint, etc.), the tile must be from the upper wing area in the RCC panel 9 area. Figure 5-9 shows the only three possible locations for this tile.

The tile departed the orbiter more than one minute prior to final break-up due to prolonged internal heating of the upper wing skin in the area shown in Figure 5-9. The tile shows indications of backside heating and an RTV debond. It was not a failure in the densification layer, which would have been caused by mechanical loading. This piece of recovered debris is not very significant on its own merit; however, it is consistent with the previously discussed forensics data (rib erosion, carrier panel 9 tile slumping, etc.) and other events that will be discussed later in Section 5.4.

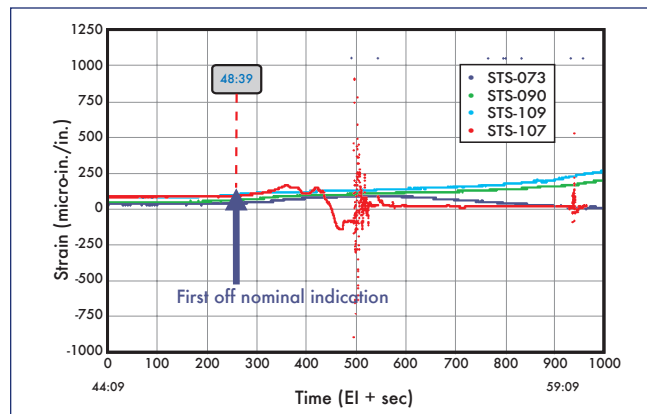
Figure 5-11. Left wing RCC panel 9 strain gauge is first measurement to indicate an off-nominal event. Note that EI was at 8:44:09 EST.

At approximately 8:48:39 EST (EI + 270 sec.), a left wing leading edge spar strain gauge began a small off-nominal increase. Figure 5-11 shows the STS-107 response of this

strain measurement along with three other previous *Columbia* missions. Figure 5-12 shows the location of this sensor (WLE Strain V12G9921A) and others on the wing leading edge. The damage in lower RCC panel 8 is believed to be the cause of this strain increase. The breach allowed hot gas intrusion onto the panels 8 through 9 wing leading edge spar area leading to extreme heating and thermally induced strain. The strain increase grew over time and reached a maximum at approximately 8:50:09 EST (EI + 360 sec.). Thermal and structural analyses indicate that a breach would need to be within approximately 15 inches of the strain gauge to create the observed strain increase.

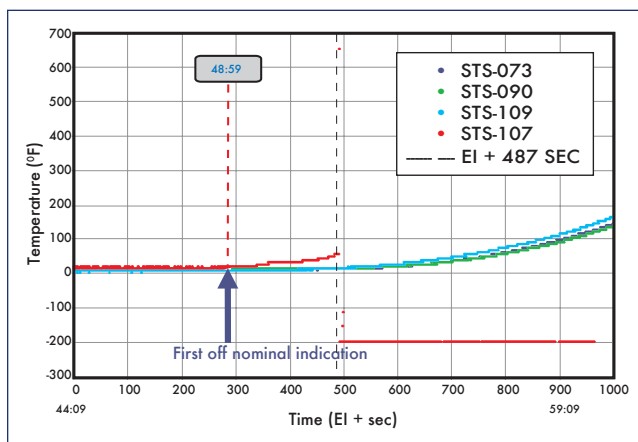
Figure 5-13. Left wing RCC panel 9/10 clevis temp sensor is second measurement to indicate an off-nominal event.

Twenty seconds later at 8:48:59 EST (EI + 290 sec.), the left wing lower attach clevis temperature sensor (between RCC panel 9 and 10) began an early off nominal temperature trend. Figure 5-13 shows the abnormal temperature response when compared to other *Columbia* missions. This temperature rise is consistent with an early entry of hot gas into the RCC cavity. This Modular Auxiliary Data System (MADS) measurement (V09T9910A) is the only temperature measurement located in the RCC cavity along the left wing leading edge. It is positioned on the lower attach fitting between panel 9 and 10 and is well protected thermally by Inconel foil insulation. The sensor is also thermally isolated since it sits on the attach fitting away from other structure as shown in Figure 3-12. In order to get an early temperature rise for this sensor, unlike that observed on any other flight, there must be a path in the RCC cavity to allow hot gas to reach the sensor.

A thermal analysis was performed with heating rates from various hole sizes in the bottom of RCC panel 8 in an attempt to match this temperature rise. The analysis used a thermal math model of the wing leading edge (Inconel Cerachrome insulation, Inconel 718 and A-286 steel attach fittings, and aluminum honeycomb spar). The results indicated that the heating equivalent of a 6 to 10 inch diameter hole with a 10 percent “sneak flow” around the insulation would be required to match the thermal response of the clevis temperature. In the same timeframe several MADS lower surface temperatures on the left wing showed a slight off nominal early temperature rise when compared to previous flights of *Columbia* of the same inclination.

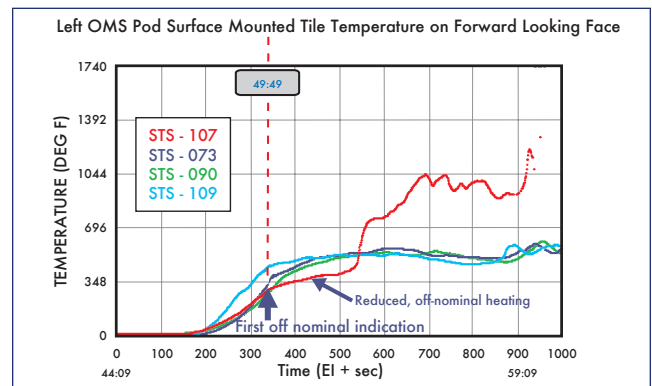
Figure 5-14. Typical off-nominal OMS pod thermocouple (V07T9220A).

Columbia executed a nominal roll to the right at 8:49:32 EST (EI + 323 sec.) as the entry guidance software began to actively control energy (i.e., closed loop guidance) to land at KSC. This initial roll command is also timed to ensure atmospheric capture by reducing the lift on the vehicle. Within 17 seconds of this maneuver, at 8:49:49 EST (EI + 340 sec.), four left OMS pod surface temperature measurements showed an off-nominal trend with lower temperature rises when compared to similar *Columbia* missions. A sample of these measurements compared to other *Columbia* missions is shown in Figure 5-14, and the location of these measurements on the left OMS pod forward face can be found in Figure 5-15.

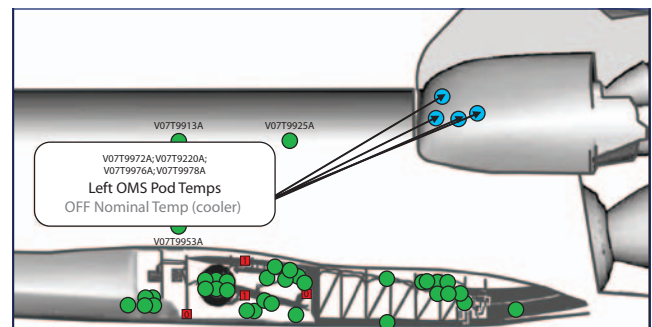
Figure 5-15. Location of OMS pod thermocouples off-nominal low.

The reduced heating is not completely understood since the weak aerodynamic flow field on the upper surface of the orbiter is difficult to model and is extremely sensitive to disturbances. The best explanation for this reduced heating is that flow into the RCC cavity was venting through to the upper surface of the wing through an existing 0.1-inch vent between the RCC and upper surface carrier panels. This vent exists all along the leading edge from RCC panel 1 through panel 22 and has an approximate area of 66 square inches. This upper surface RCC venting and the flow disturbance created by the panel 8 and upper carrier panel 8 damage caused the vortices from the canopy or area where the wing

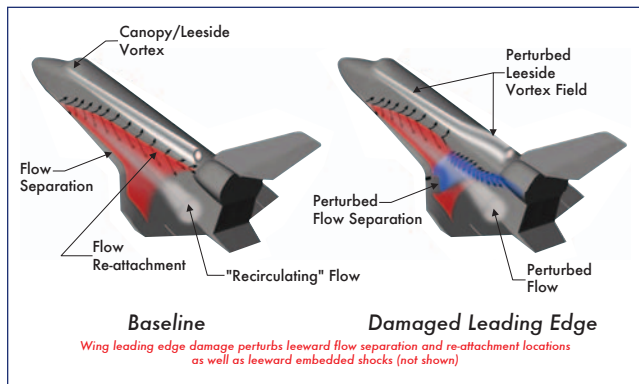
Figure 5-16. Postulated orbiter leeside flow field associated with wing leading edge damage.

meets the orbiter fuselage to move from their normal positions, thus reducing the heating on the OMS pod. Figure 5-16 depicts the change in the upper wing surface vortices and the weak upper surface flow.

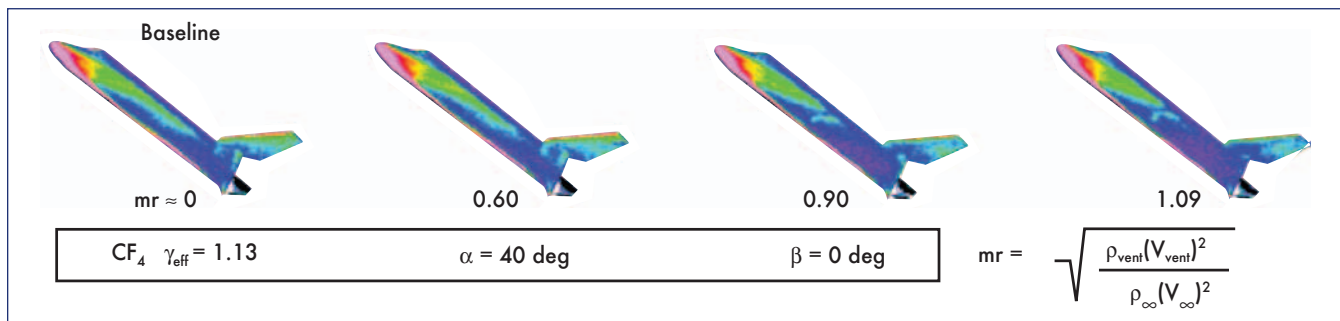
Figure 5-18. Wind tunnel model results for sensitivity of orbiter side fuselage and OMS pod heating patterns to mass addition along WLE leeside vent gap.

the RCC upper surface vent. Figure 5-18 shows the change in heating as the vent velocity is altered.

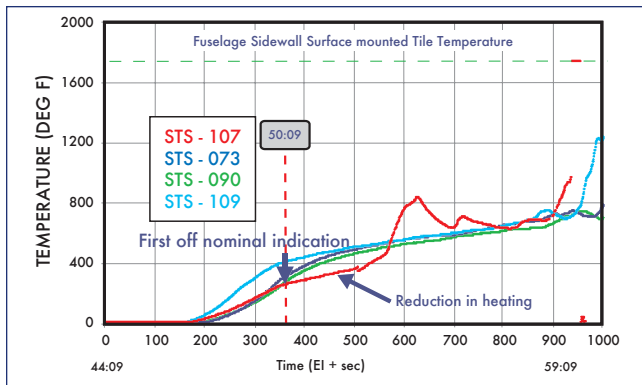
Figure 5-20. Off-nominal temperature indication on the left sidewall.

In the same timeframe, at 8:50:09 EST (EI + 360 sec.), a left payload bay fuselage MADS surface temperature measurement (Figure 5-19) showed an off-nominal temperature trend. This trend is a reduced rise rate when compared to other previous *Columbia* missions, as shown in Figure 5-20. The previously discussed theory of venting and or disturbed flow due to panel 8 damage, causing a shift in the vortices on the upper surface of the wing, is also believed to be the cause of this off-nominal behavior. The flow field and venting on the upper surface rate are constantly increasing since the mass flow rate into the RCC breach is increasing as the orbiter descends lower into the atmosphere.

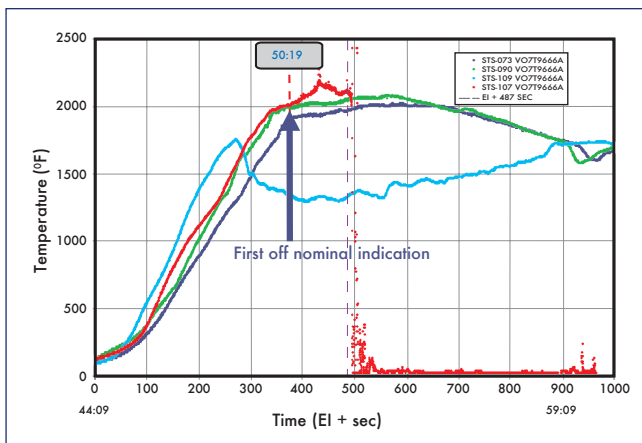
Figure 5-21. Temperature rise on tile surfaces aft of RCC panel 9.

panel 8 will cause increased heating to the lower wing surface. As previously discussed, the eroded lower carrier panel tiles on panel 9 indicate this strong flow from panel 8. This is consistent with flow patterns observed on many recovered lower surface wing acreage tiles along the flow lines aft of the RCC panel 8 area. Figure 5-21 shows this temperature response as compared to other *Columbia* missions. The location of the sensor can be seen in Figure 5-22.

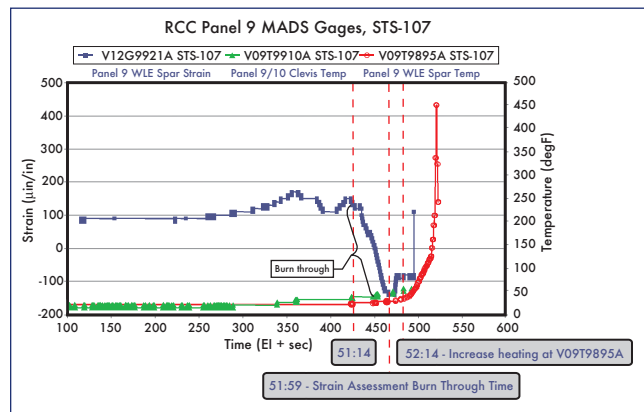
Figure 5-23. RCC panel 9 MADS strain and temperature measurements, STS-107.

By 8:51:14 EST (EI + 425 sec.), the wing leading edge spar temperature began an early, off-nominal rise, shown in Figure 5-23. At the same time, the clevis temperature in the RCC panel 9/10 region continued to increase. The initial spar temperature rise was relatively slow and was caused by

The first technique used the strain response, shown earlier in Figure 5-23. On this plot, the initial strain rise that began at about 8:49:09 EST (EI + 300 sec.) is due to thermal elastic strain. It appears that the spar structural softening occurs at approximately 8:50:09 EST (EI + 360 sec.), followed by loss of the structural integrity, or breach, at approximately 8:51:14 EST (EI + 425 sec.). This appears to be completed by approximately 8:52:00 EST (EI + 471 sec.). A detailed structural model that attempted to reproduce the thermal strain response observed during this timeframe confirmed this timing. This analysis determined that the location of the spar breach must be within about 15 inches of the spar strain measurement. This would locate the spar breach near the intersection of panel 8/9, as shown in Figure 5-29. The flow through the RCC breach maintained some directionality although it was influenced by the shape of the hole, remaining RCC structure, attach hardware, and leading edge insulators. Overall, this strain response is consistent with an RCC breach in the lower part of panel 8 as previously discussed in Section 5.3. Although it is difficult to pinpoint a precise location of the RCC breach, this analysis supports the argument that the breach was closer to the panel 8/9 intersection and Tee seal 8.

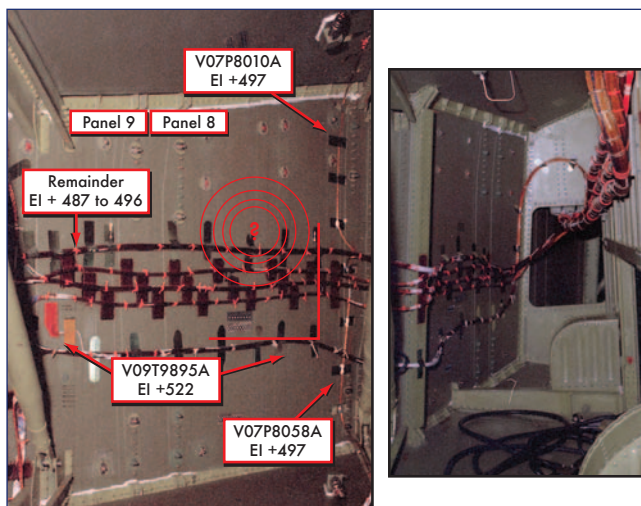
Figure 5-29. Cable routing on wing leading edge and wheel well wall.

The final technique used was an examination of the wire failures on the wing leading edge spar. These wire runs are shown in Figure 5-29. The first measurement loss was a MADS upper left wing pressure measurement, which failed at approximately 8:52:16 EST (EI + 487 sec.). This measurement is contained in the upper wire bundle in the left photo in Figure 5-29. The combination of these three separate and distinct analyses results in a range of wing spar breach times as early as 8:51:14 EST and as late at 8:52:16 EST (EI + 425 to 487 sec.).

Immediately after the breach, hot gas inside the wing began to heat the remaining wire bundles that contained real-time telemetry and the recorded MADS measurements. Figure 5-29 shows an inside-the-wing view of the approximate breach location based on this wire failure analysis. The view on the left is of the panel 8/9 spar location. This area is not visible in the right photo, which contains the transition spar and a view of the three wire bundles along the outside of the wheel well wall. Figure 5-31 shows the overall spar breach location with respect to the rest of the wheel well. The distance from the spar to the wheel well wall in this area is approximately 56 inches, as shown in Figure 5-32. Figure

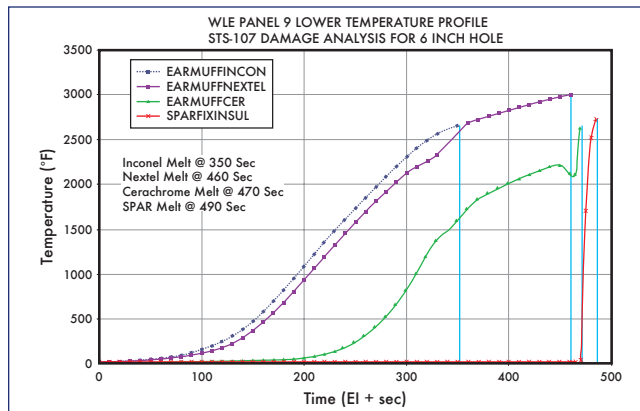
Figure 5-30. Thermal model prediction of wing spar burn through.

The second technique used a detailed thermal model to determine the time required to burn through the various insulations immediately in front of the wing leading edge spar (Inconel, Nextel, Cerachrome) and then the honeycomb spar. This model assumed the equivalent heating of a six-inch diameter hole in the bottom of RCC panel 8. Using the expected aero heating rate and the various material properties, the spar burn through occurred at 8:52:19 EST

(EI + 490 sec.). This time would be accelerated slightly for a larger diameter hole. The results of this thermal model are shown in Figure 5-30.

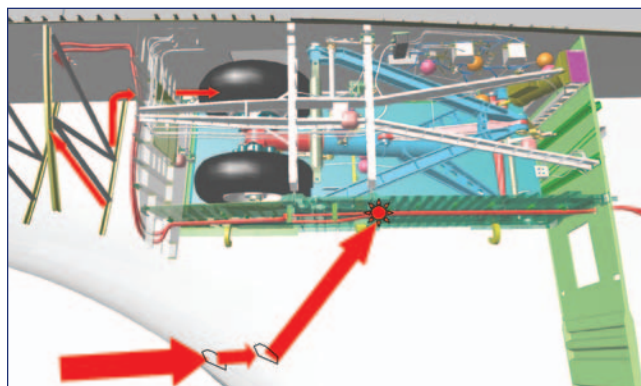
Figure 5-31. Hot gas begins to fill left wing.

5-33 shows a sketch of the venting of the left wing into the payload bay, driving the direction of the internal flow depicted in Figure 5-31. Note the 142 square inch vent into the midbody fuselage located forward of the wheel well.

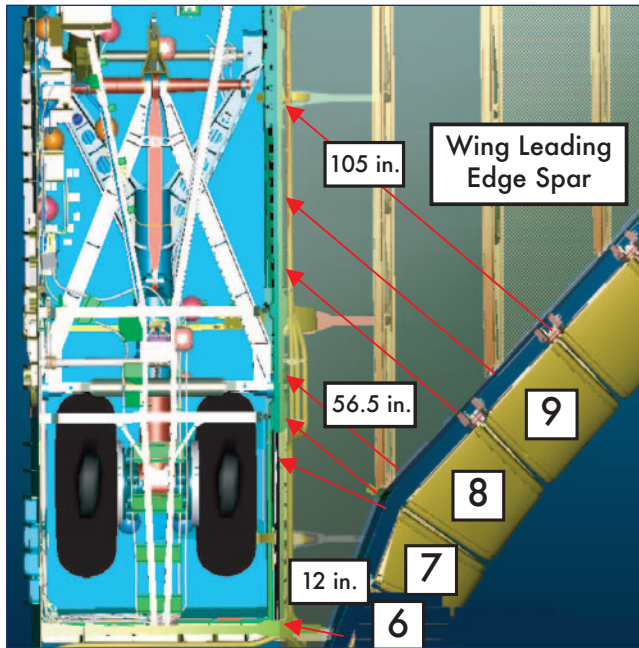
Figure 5-32. Columbia LH wing and wheel well geometry.

wheel well spar. The fact that these measurements are available until loss of data are important indicators that the RCC breach could not be forward on the panel 6 area since these measurements would have been lost as well (see Figure 5-32). These measurements also record key changes in strain that help indicate some of the changes that the left wing underwent as the remainder of the entry events unfolded.

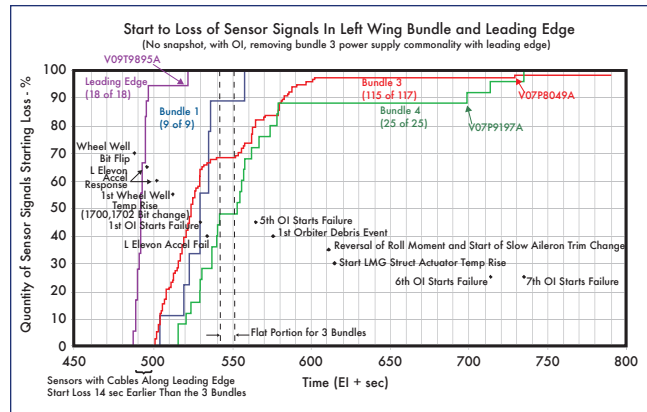
Figure 5-34. MADS data failure due to wire burning.

One hundred sixty-three other measurements failed very quickly over the next two minutes. Figure 5-34 is a plot of the percentage of measurements lost as a function of time from EI. The first measurements to fail are all located on the wing leading edge spar as shown by the purple line on the plot. Bundles 1, 3, and 4 along the wheel well (shown in Figure 5-35) began to fail about 14 seconds after the first spar measurements.

Four additional measurements failed after 8:54:16 EST (EI + 605 sec.) with the last starting to fail at 8:56:24 EST (EI + 735 sec.). This last measurement failure took over a minute to fail completely. Figure 5-34 and Figure 5-35 show the measurement loss timing and the wire bundle runs along the wheel well. Although almost all measurements internal to the wing failed, two strain measurements on the 1040 spar (forward of the wheel well) were unaffected and produced data until loss of all MADS data at 9:00:13 EST (EI + 964 sec.). Figure 5-36 shows the location of the sensors on the forward
