COLUMBIA

ACCIDENT INVESTIGATION BOARD

REPORT VOLUME II
OCTOBER 2003

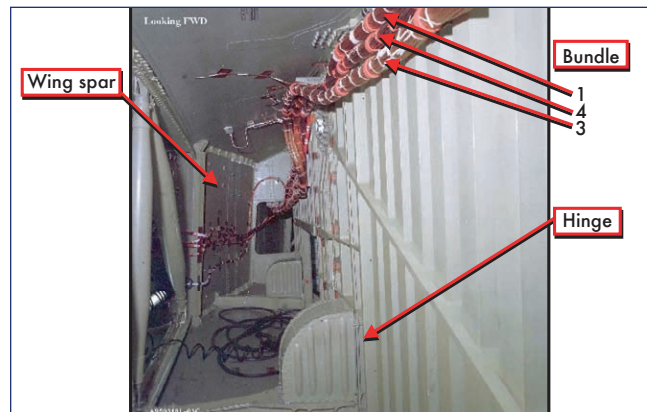
Figure 5-35. View of cables running along outside of wheel well cavity bulkhead.

One hundred sixty-three other measurements failed very quickly over the next two minutes. Figure 5-34 is a plot of the percentage of measurements lost as a function of time from EI. The first measurements to fail are all located on the wing leading edge spar as shown by the purple line on the plot. Bundles 1, 3, and 4 along the wheel well (shown in Figure 5-35) began to fail about 14 seconds after the first spar measurements.

Four additional measurements failed after 8:54:16 EST (EI + 605 sec.) with the last starting to fail at 8:56:24 EST (EI + 735 sec.). This last measurement failure took over a minute to fail completely. Figure 5-34 and Figure 5-35 show the measurement loss timing and the wire bundle runs along the wheel well. Although almost all measurements internal to the wing failed, two strain measurements on the 1040 spar (forward of the wheel well) were unaffected and produced data until loss of all MADS data at 9:00:13 EST (EI + 964 sec.). Figure 5-36 shows the location of the sensors on the forward

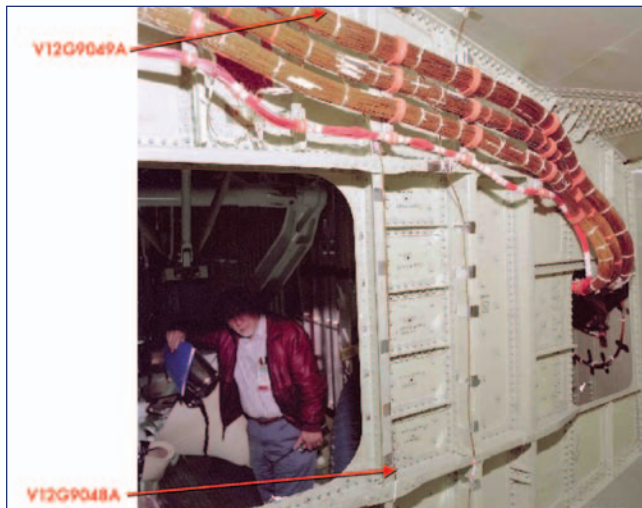
Figure 5-36. Strain measurements on 1040 spar.

wheel well spar. The fact that these measurements are available until loss of data are important indicators that the RCC breach could not be forward on the panel 6 area since these measurements would have been lost as well (see Figure 5-32). These measurements also record key changes in strain that help indicate some of the changes that the left wing underwent as the remainder of the entry events unfolded.

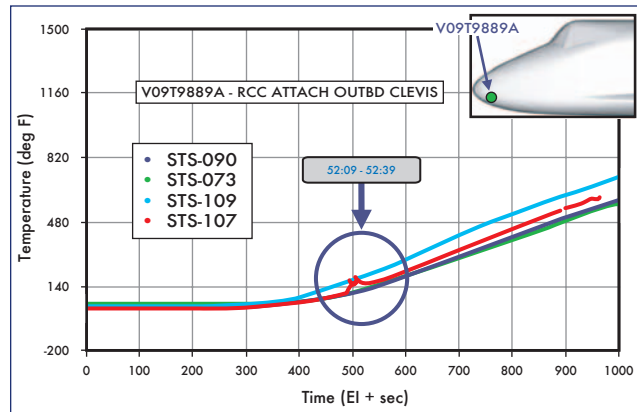
Figure 5-37. Off-nominal temperature rise rate in nose cap RCC attach clevis.

Coincident with the spar breach at approximately 8:52:09 EST (EI + 480 sec.), the nose cap RCC attach clevis temperature had an off-nominal change in rise rate when compared to previous missions. This rise rate was abnormal for approximately 30 seconds and ended at 8:52:39 EST (EI + 510 sec.). The exact cause of this abnormal temperature rise is not known, but the timing is coincident with the breach of the wing leading edge spar. An explanation is that the abnor-

mal rise is an instrumentation anomaly caused by multiple wire failures in this timeframe. This measurement response is shown in Figure 5-37 along with the same measurement for several other *Columbia* missions. This figure also shows the location of this internal nose cap measurement on the very forward portion of the left fuselage.

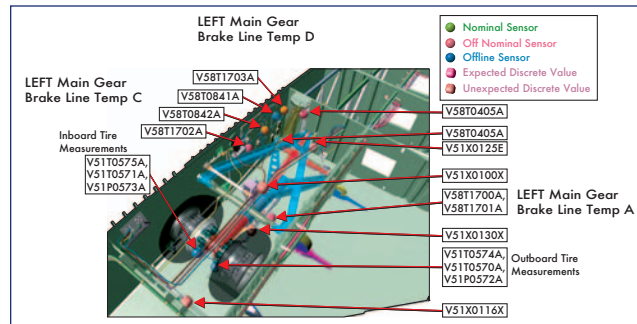
Figure 5-38. Location of sensors in the LH wing wheel well.

nominal. The first indication of any anomalous Operational Instrumentation (OI) was a small increase in the left main gear brake line temperature D measurement at this time (see Figure 5-38). Within one second of this time, there is a lower 1040 spar (forward wall of the wheel well) strain measurement that shows an off-nominal increase in strain (see Figure 5-39). These are both indications that the breach in the wing leading edge spar had allowed hot gas to reach the wheel well area, most likely through vent paths around the hinge covers, which allowed hot gas into the wheel well cavity.

At the same time as the stress was relieved on the lower 1040 spar, two left main gear outboard tire pressures began trending toward an off-scale low reading. This was preceded by a slight upward trend at 8:57:19 EST (EI + 790 sec.) for both pressure measurements. This is an indication of extreme heating of both the left outboard tire and the surrounding instrumentation. The tire has significant thermal mass and substantial heating would be required to produce the slight temperature rise. By 8:58:56 EST (EI + 887 sec.), all left main gear inboard and outboard tire pressure and wheel temperature measurements were lost indicating a rapid progression of damage or wire burning inside of the wheel well. Figure 5-38 shows the location of these pressure sensors.

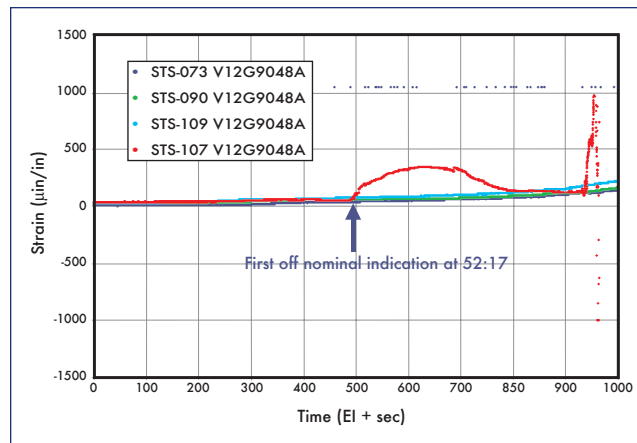
Figure 5-39. Strain rise in lower 1040 spar cap.

ous Figure 5-39). The upper strain measurement continued to increase during this timeframe indicating that the heating was different on the upper and lower portions of the wheel well and 1040 spar. Although the response of the 1040 spar strain is not completely understood, structural analysis indicates that the strain response can be completely explained by thermal stresses caused by severe heating of the wheel well wall and internal wing components.

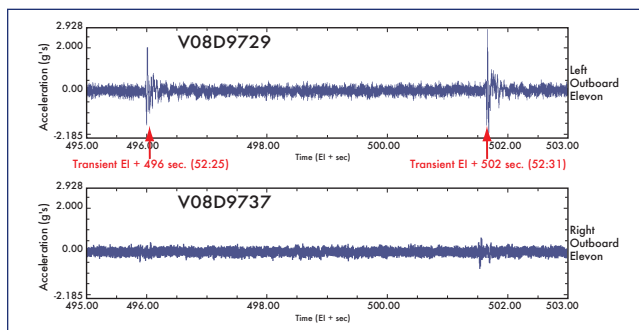
Figure 5-40. Outboard elevon accelerometer responses at 8:52:25 and 8:52:31 EST (EI + 496 and 502 sec.).

At approximately 8:52:25 EST (EI + 496 sec.), the left outboard elevon wideband accelerometer showed an unusual 2 g peak-to-peak acceleration (see Figure 5-40). This is consistent with the timing of the many wire failures within the left wing and the timeframe when the spar breach occurs. Additionally, there are two unexplained communication dropouts in this same timeframe. Another 3 g peak-to-peak acceleration anomaly was observed at 8:52:31 EST (EI + 502 sec.). Additional temperature measurements (left main gear brake line temp A and C) in the wheel well area (see Figure 5-38) began an off-nominal rise at 8:52:41 EST (EI + 512 sec.).

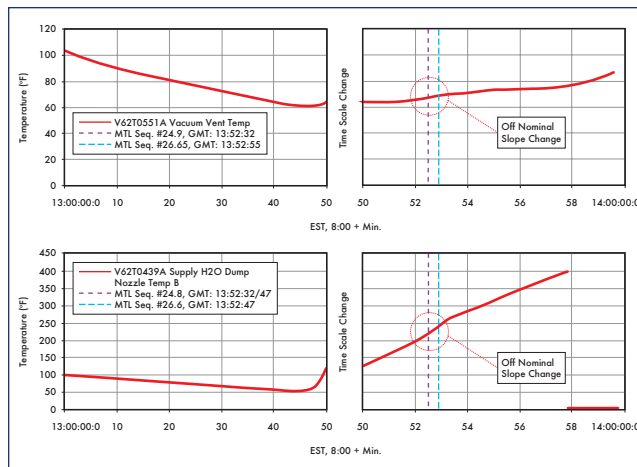
The elevon response event was followed by a change in the rise rate for two supply nozzle temperatures and the vacuum vent nozzle temperatures at 8:52:32 EST (EI + 503 sec.). The off-nominal rise rate occurred for approximately 15 seconds for the supply nozzle temperatures and 23 seconds for the vacuum vent temperatures. The location of these nozzles on the left side of the fuselage is shown in Figure 5-41, and the arrow indicates that they could have been located along a line of disturbed flow. The short, abnormal rise rate is unexplained, has not been observed on any previous Shuttle missions, and may not be associated with the upper wing disturbed flow caused by the leading edge damage. Unlike the RCC nose cap clevis temperature, the instrumentation appears to have been valid for both nozzles. Plots of this off-nominal temperature rise for one of the supply nozzle temperatures and the vacuum vent nozzle are shown in Figure 5-42.

Figure 5-42. Off-nominal temperature for supply nozzle and vacuum vent nozzle.

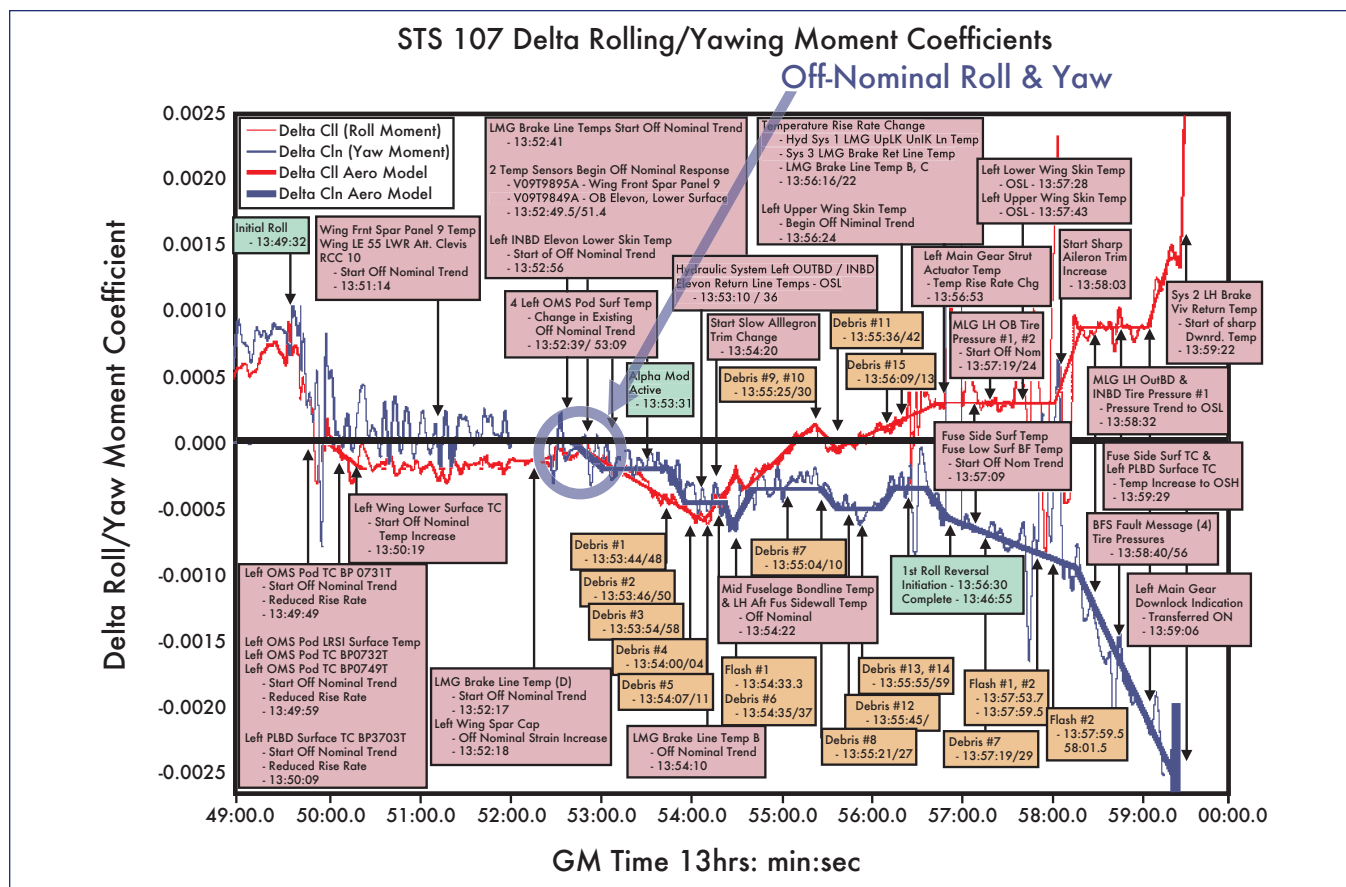
Immediately following these events, at 8:52:44 EST (EI + 515 sec.), the aerodynamic roll and yaw coefficients that have been extracted from the flight data showed a slight negative trend (see Figure 5-43). This is indicative of more drag and decreased lift on the left wing.

Hypersonic wind tunnel tests indicate that both the slight negative roll and yaw deltas can be explained by leading edge damage in the lower half of RCC panel 8. This will be discussed in more detail in Section 5.4.5.

Figure 5-43. First noted off-nominal aero event.

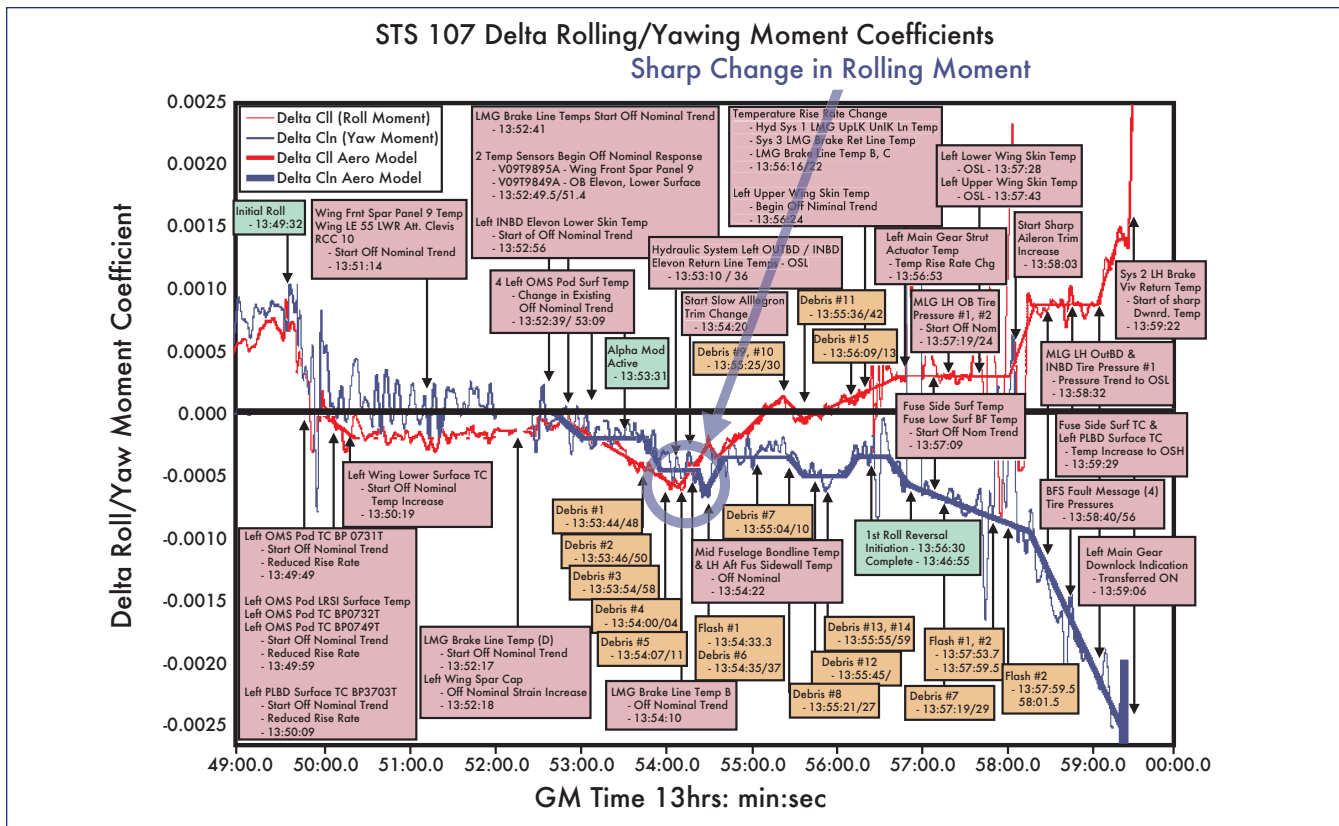
In the 8:54:10 to 8:54:35 EST (EI + 601 to 626 sec.) timeframe, several key events occurred. The first event at 8:54:10 EST (EI + 601 sec.) was an indication that the temperatures in the wheel well had a greater rise rate, indicating the sneak flow or breach into the wheel area had increased. The roll moment trend changed sign at 8:54:11 EST (EI + 602 sec.) almost simultaneously with the change in wheel well temperature rise rate as shown in Figure 5-44, followed by a debris flash event at 8:54:33 EST (EI + 624 sec.). A large debris item, labeled debris event six, was seen leaving the orbiter two seconds later. This debris event and the roll moment trend change are believed to be created by growing damage to *Columbia*’s left lower wing.

There are several theories that attempt to explain this response including a change in the wing camber or shape due to deformation and a lower wing recession, caused by the loss of much of the support structure internal to the wing. Wing recession here is in reference to structural deformation of the wing surface. In this case, one or more areas on the lower wing form a more concave shaped depression of wing skin and tiles as a result of the structural support in those areas being weakened or lost. A structural analysis of both wing deformation due to the loss of three ribs internal to the wing, and the wing recession concept was performed.

Figure 5-44. Sharp change in rolling moment.

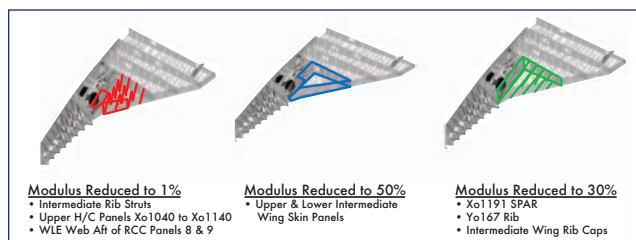
Structural and aerodynamic analysis of wing deformation was performed without any type of recession in the wing lower surface. An assumption of 70 pounds per square foot was used for wing loading. Heat transfer coefficients were updated from previous coupled venting and thermal models for the left wing. A structural model was used along with the heating equivalent of a 10 inch diameter breach in the wing spar beginning at 8:52:16 EST (EI + 487 sec.) assuming 100 percent of the energy from this hole was transferred to the wing interior. Two different cases were analyzed: one with no breach in the upper wing skin and another with a 5 inch diameter breach in the upper skin at 8:54:37 EST (EI + 628 sec.) when a significant visual flash event was observed. Both cases showed that the temperatures of the wing skins, wing spars, and the wheel well wall were high enough by 8:58:19 (EI + 850 sec) that significant damage to the wing structure would occur. Figure 5-45 shows the potential area of damage and that significant deformation of the intermediate wing area and/or a recession in the lower surface is possible.

Figure 5-45. Modeling results show potential area of damage and that significant deformation of the intermediate wing area and/or a recession in the lower surface are possible.

Based on the structural analysis, it appears feasible that a wing recession occurred and resulted in the large positive slope in the delta rolling moment. The recession was caused by severe prolonged heating internal to the left wing that melted many of the support struts. Once the struts were lost, the wing skin lost structural support, a concave cavity developed, and some lower surface tiles may have been lost.

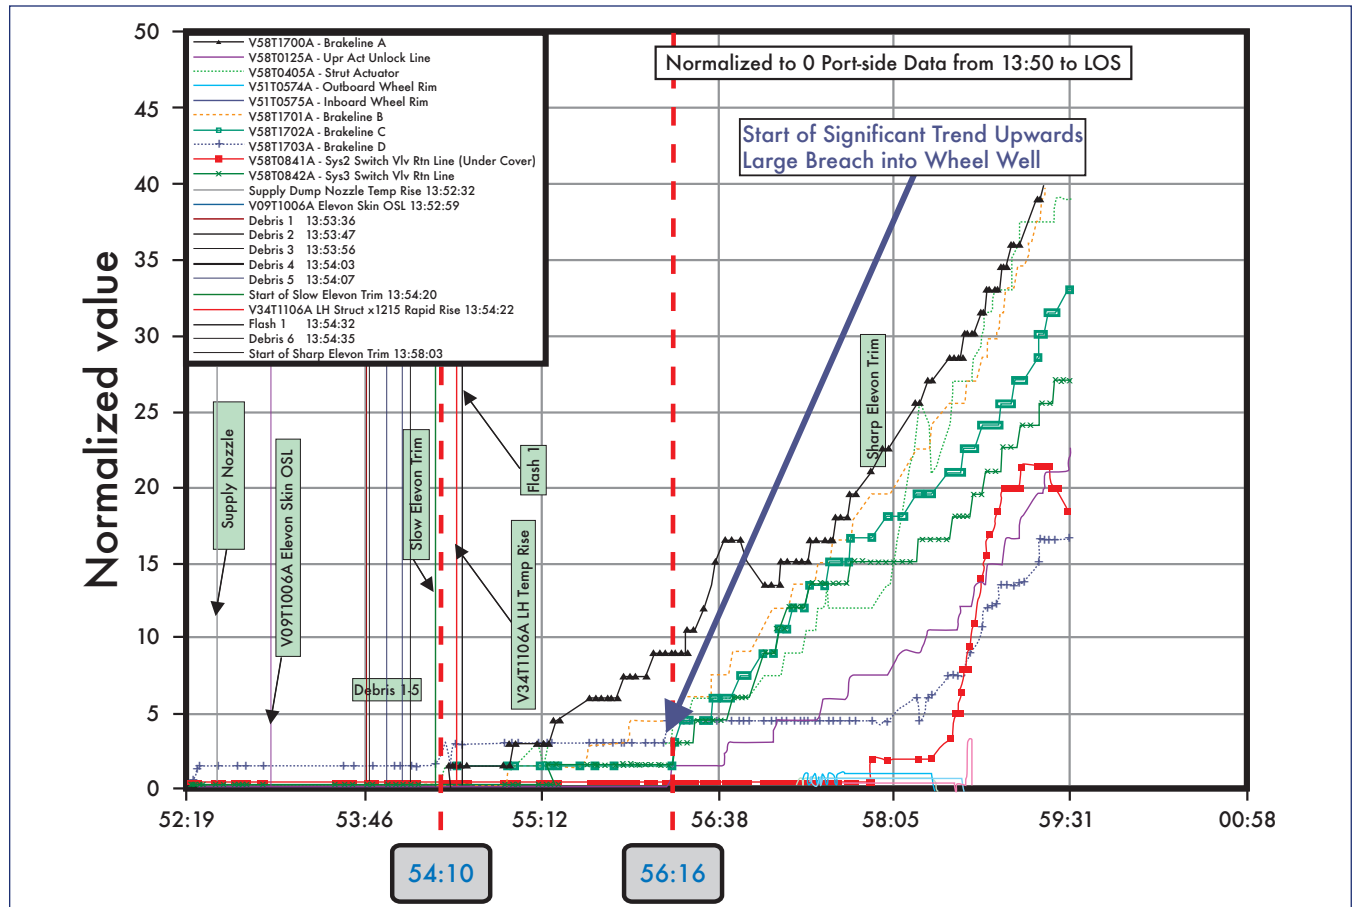
By 8:56:16 EST (EI + 727 sec.), hot gas had penetrated the wheel well wall as indicated by off-nominal rise rates in several hydraulic line temperatures (see Figure 5-46). Preliminary analysis indicates that it is feasible to have had some gas intrusion into the wheel well area as early as 8:52:39 EST (EI + 510 sec.) since a honeycomb access panel

Figure 5-46. Temperature data in left wheel well trends up.

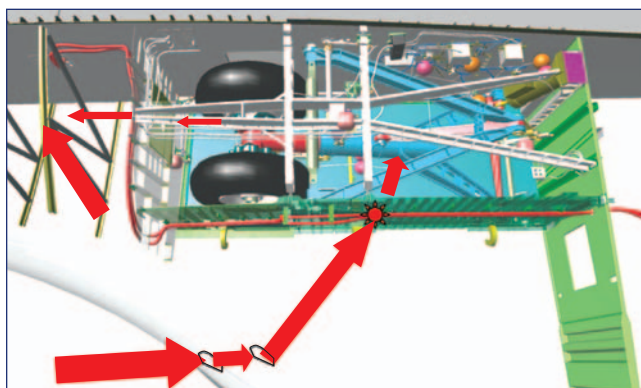
Immediately after the wheel well wall was breached, a hot gas plume began to flow on to the left main gear strut (depicted in Figure 5-47), leading to excessive strut erosion. A wheel well wall breach in this area is consistent with the erosion pattern observed on the recovered left main gear strut. Even after damage had significantly progressed into the wheel well, the orbiter initiated the first roll reversal at 8:56:30 EST (EI+741 sec.). The maneuver was completed by 8:56:55 EST (EI+766 sec.), and the vehicle was in a normal left bank. The guid-

Figure 5-47. Hot gas breaches the wheel well.

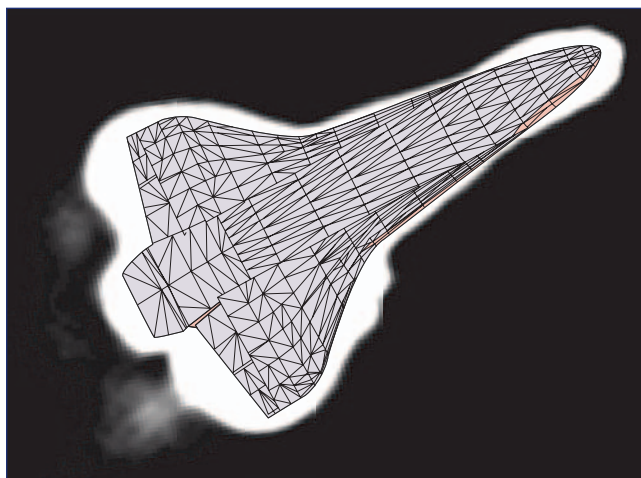
Imaged at 8:57:14 EST (EI + 785 sec.), the Kirtland photo could indicate a flow disturbance on the leading edge of the left wing and/or flow leaving the leading edge of the left wing (see Figure 5-48). It also appears to show a disturbed flow leaving the trailing edge of the left wing. Other images, not shown here, also show disturbed flow on the upper side of the left wing, indicating that the damage and venting through the upper RCC vent was deflecting the flow upward. The Kirtland photo is a digital still image taken by off-duty employees of the Starfire Optical Range at Kirtland Air Force Base, New Mexico, during the STS-107 entry using a 3.5 inch telescope through a computer controlled 1 meter rotating mirror.

Figure 5-48. Kirtland photo with superimposed Orbiter outline.

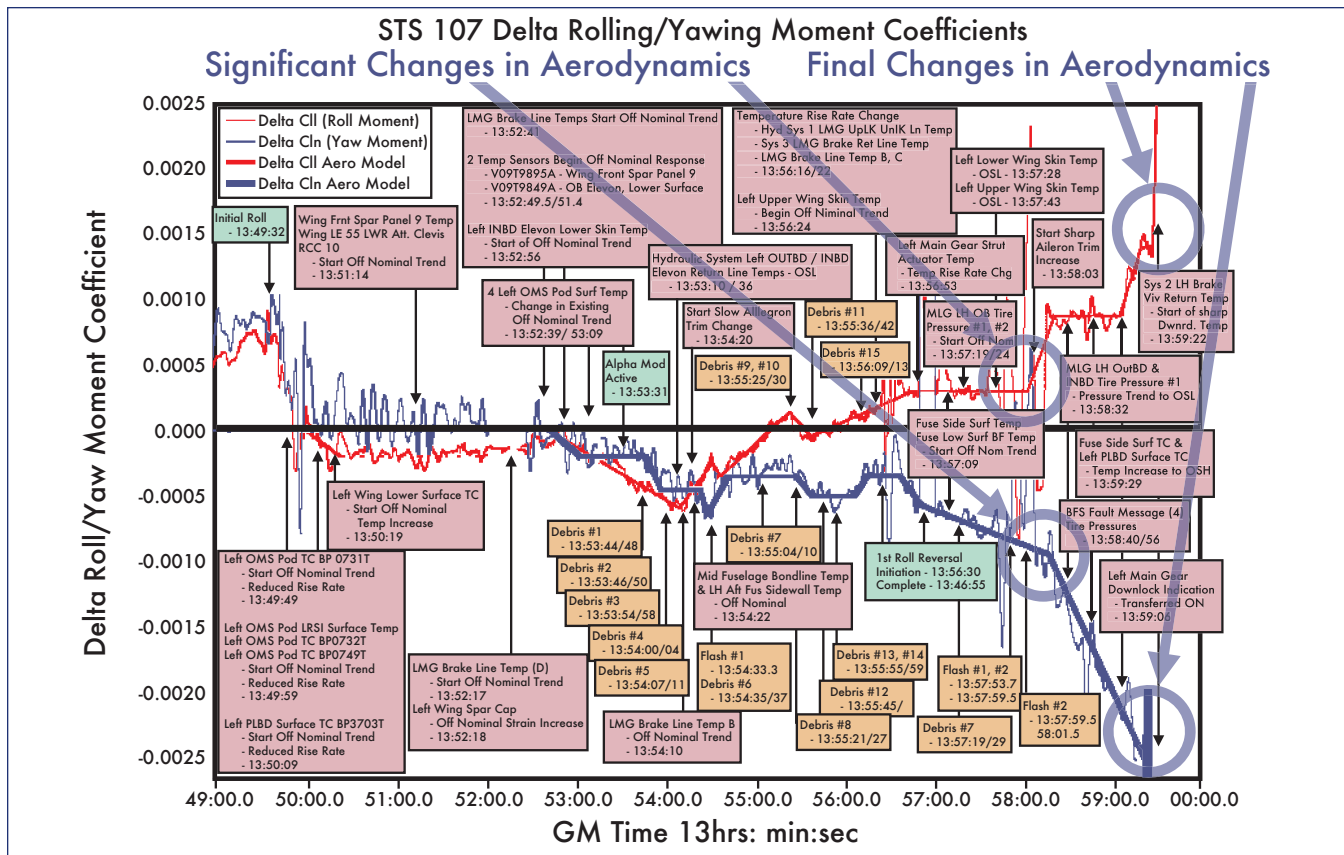
As shown in Figure 5-49, this strain response appears to be consistent with another sharp change in the slope of the derived delta rolling moment coefficient that occurred slightly earlier at 8:58:03 EST (EI + 834 sec.), along with several additional debris events. The vehicle responded to this event with a sharp change in the aileron trim. These events indicate that there was another significant change to the left wing configuration at this time. Wing deformation and an increase in the lower surface recession along with a loss of additional bottom tiles are possible explanations for this behavior.

As shown in Figure 5-49, there was another abrupt change in the vehicle aerodynamics caused by the continued progression of left wing damage at 8:59:26 EST (EI + 917 sec.). This change was a significant increase in the positive delta roll moment and negative delta yawing moment, indicating increased drag and lift from the left wing. *Columbia* attempted to compensate for this by firing all four right yaw jets. By this point the MCC had lost all telemetry data at 8:59:23 EST (EI + 914 sec.). Even with all four right yaw jets and a maximum rate of change of the aileron trim, *Columbia* was unable to control the side-slip angle that was slightly negative (wind on the left side of the fuselage) during much of the entry. The side-slip angle changed sign at 8:59:36 EST (EI + 927 sec.) indicating that vehicle loss of control was imminent (side-slip angle is an aerodynamics term for the angle between the relative wind velocity and the vehicle direction of motion, or velocity vector).

Figure 5-49. Increased wing deformation and wing recession leads to significant vehicle aerodynamic changes.

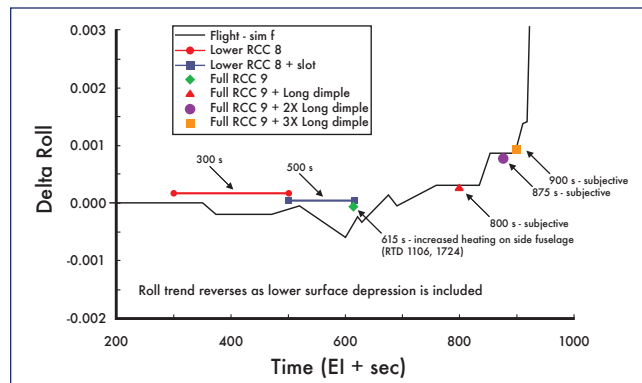
Figure 5-50. Wind tunnel testing configurations that match delta roll moment data.

the wing leading edge and flow through a slot onto the upper carrier panel is consistent with the first observed aerodynamic response, which occurs at 8:52:29 EST (EI + 500 sec.). This can be observed in Figure 5-50 and Figure 5-51 as a slow negative trend in delta roll and yaw. Figure 5-55 shows the wind tunnel test results for three different cases: missing lower RCC panel 8, missing panel 8 combined with a 4 inch diameter hole in the upper carrier panel 8, and missing RCC panel 8 with a slot through the upper carrier panel. The slot was shown to produce the increased delta yaw observed during flight as well as the upper surface flow disturbances on the OMS pod and left side fuselage, which were also observed during flight by abnormal temperature rise rates.

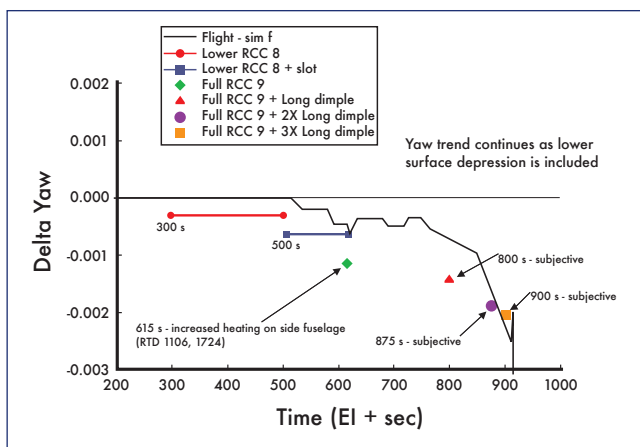
Figure 5-51. Wind tunnel configurations that match delta yaw moment data.

Initially, the recessed area would have been relatively small; however, it would gradually grow over time to cause the delta roll moment to increase. By 8:57:29 EST (EI + 800 sec.) wind tunnel testing showed that the depression has to be on the order of 20 feet long, two feet wide, and 5.3 inches deep along with panel 9 missing in order to duplicate the delta roll coefficient shown in Figure 5-50. This configuration provides a delta yaw moment that is slightly larger than was observed, but is consistent with a decreasing negative delta yaw moment observed in this timeframe (Figure 5-51).

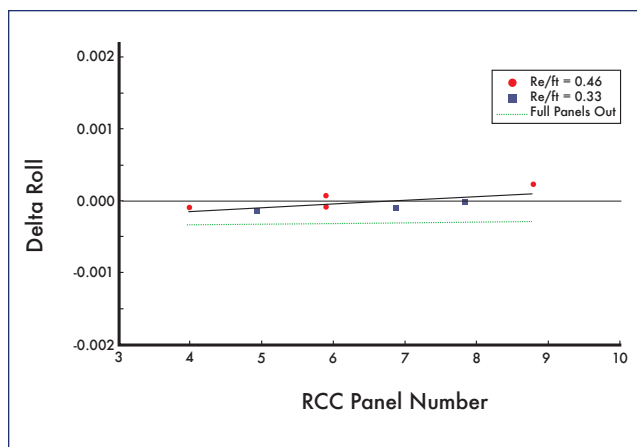
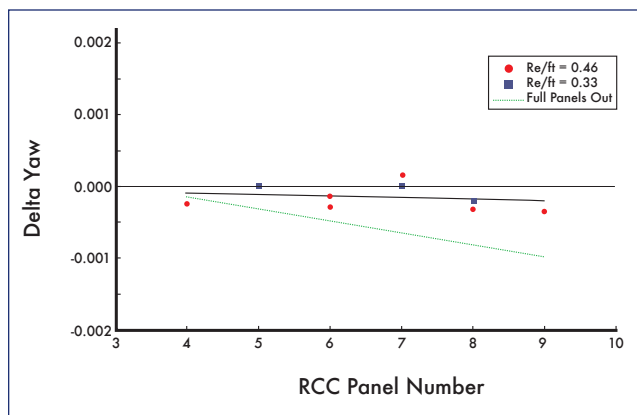
Figure 5-53. Delta roll for lower half and full panel RCC panel missing.

Figure 5-54. Delta yaw for lower half and full panel RCC panel missing.

As discussed previously, the reconstructed aerodynamic moments showed little to no change due to damage through 8:52:29 EST (EI + 500 sec.). Based on the forensics data discussed in Section 5.3, the most likely region of initial damage was in the lower part of RCC panel 8. Wind tunnel testing in the Langley Research Center (LaRC) CF4 tunnel indicated that a missing bottom part of RCC panel 8 (from the apex to the lower carrier panel) matches the initial aerodynamic increments, which show a minimal effect on the overall vehicle aerodynamics. In fact, even a full missing panel 8 produces only a small change to the roll and yaw aero moments. Figure 5-53 and Figure 5-54 show the results of this LaRC evaluation.

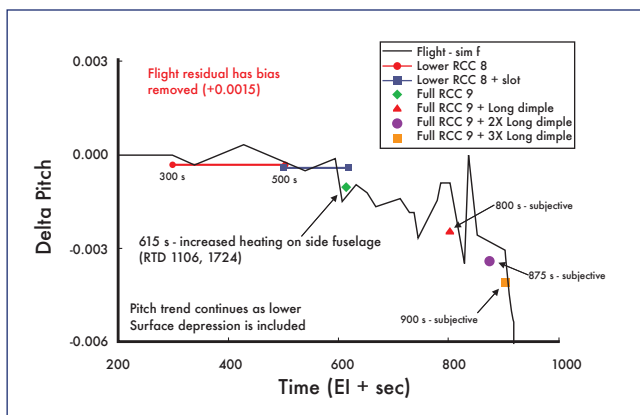
Figure 5-52. Wind tunnel configurations that match delta pitch moment data.

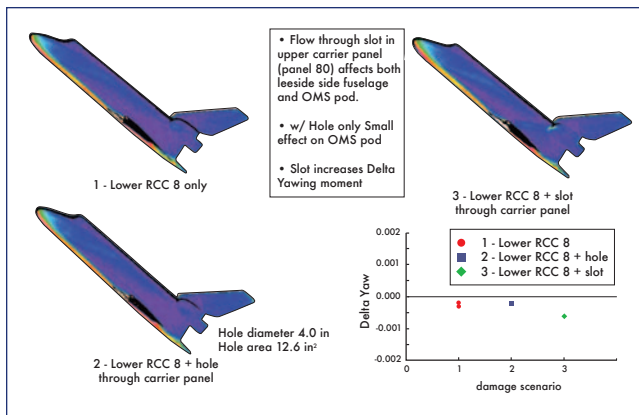
It is possible that a hole through the upper wing developed in the 8:54:11 EST (EI + 600 sec.) to 8:54:31 EST (EI + 630 sec.) timeframe. This is consistent with a lull in the measurement failure rate in the wire bundle along the wheel well that was discussed earlier in Section 5.4.3. Wind tunnel testing and CFD analysis have shown that sizable holes through the wing have little to no effect on the aerodynamics and heating on the left side of the fuselage and OMS pod. A representative sample of this work is shown in Figure 5-55 as damage scenario number 2.

Figure 5-55. Wind tunnel testing results for missing lower carrier panel 8 and a slot and hole through wing.

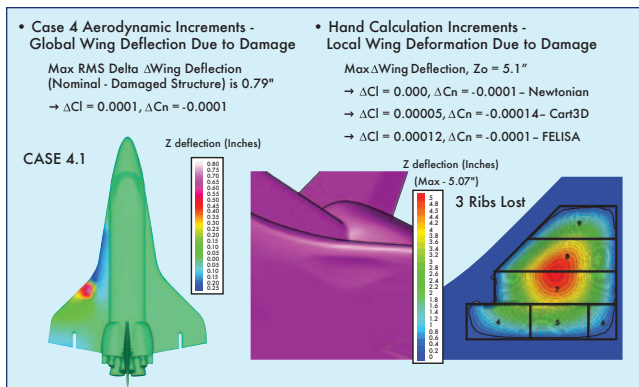
The next significant aerodynamic event occurred at 8:54:11 EST (EI + 602 sec.) when a dramatic reversal of the aero rolling moment trend occurs. By this time hot gas and an internal plume environment had severely degraded the structural integrity of some of the intermediate wing support structure leading to wing deformation. Three different configurations were tested to validate the theory of wing deformation. The first involved global wing deflection of up to 0.79 inches due to damage and is depicted in Figure 5-56. CFD analysis of this configuration showed extremely small aero moment response for yaw and roll that does not match the flight derived data. More substantial local wing skin deformation with a maximum deflection of 5.1 inches due to three ribs missing along with other internal wing damage was examined using CFD tools. Again, these results produced only small aerodynamic moment changes, which did not match the flight-derived data.

Figure 5-56. CFD analysis of wing deformation.

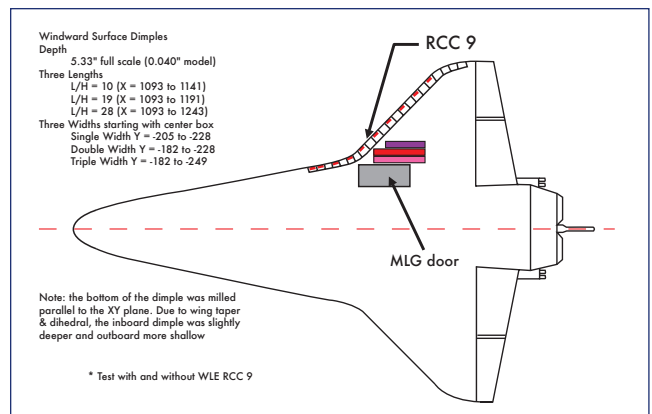
The third and final configuration that was tested was a depression in the lower surface of the wing caused by the significant structural damage caused by the hot gas plume environment internal to the wing. A previous section (5.4.5) discussed the internal structural damage that was most probable in this timeframe. LaRC wind tunnel testing and CFD analysis were performed for several different configurations of lower surface recessions shown in Figure 5-57. The data shows that it is feasible for a recession to cause

Figure 5-57. LaRC wind tunnel testing of lower surface depressions.

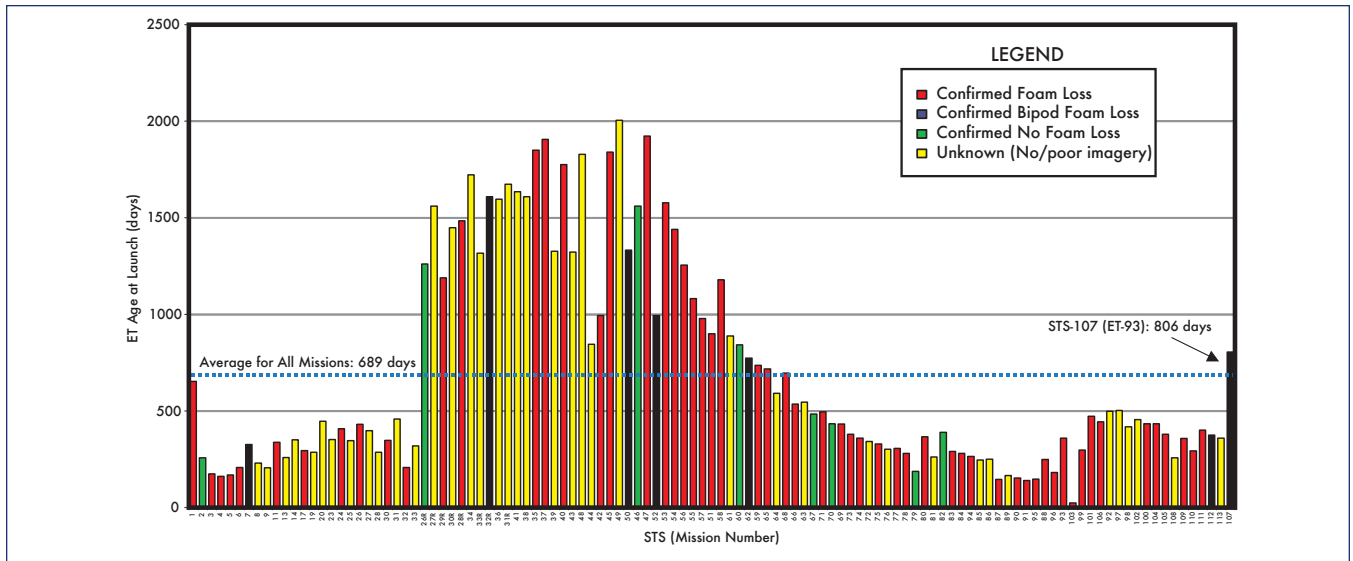
Figure 9-1. ET age for all STS missions.

The ET age was compared for various flights, presented in Figure 9-1. As shown in Figure 9-2, the ET age for STS-107/ET-93, 806 days, falls above the 95% confidence interval upper limit for the average age of all tanks, mean value 689 days, as well as the average age for all tanks with known bipod foam loss. STS-107/ET-93 also falls within the 95% confidence limit for missions with known bipod foam loss. Although the upper bound of the 95% confidence interval of the age of missions with bipod foam loss appears to be greater than the other groups in Figure 9-2, the 95% confidence interval limits of the different groups overlap each other. Therefore, data are inconclusive as to whether a correlation can be drawn about ET age and bipod foam loss.

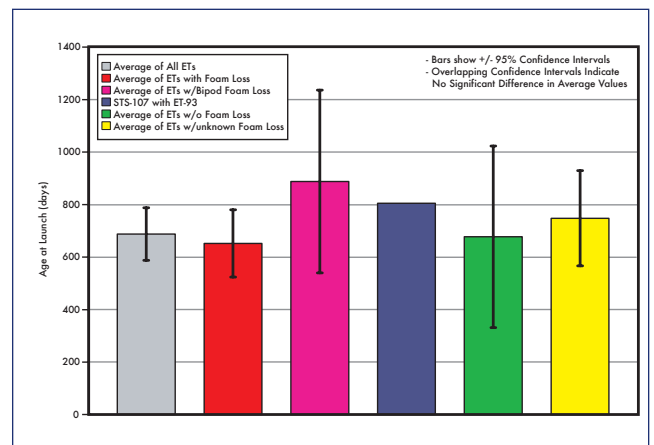
Figure 9-2. ET age for STS-107 compared to ET age for missions with and without bipod foam loss.

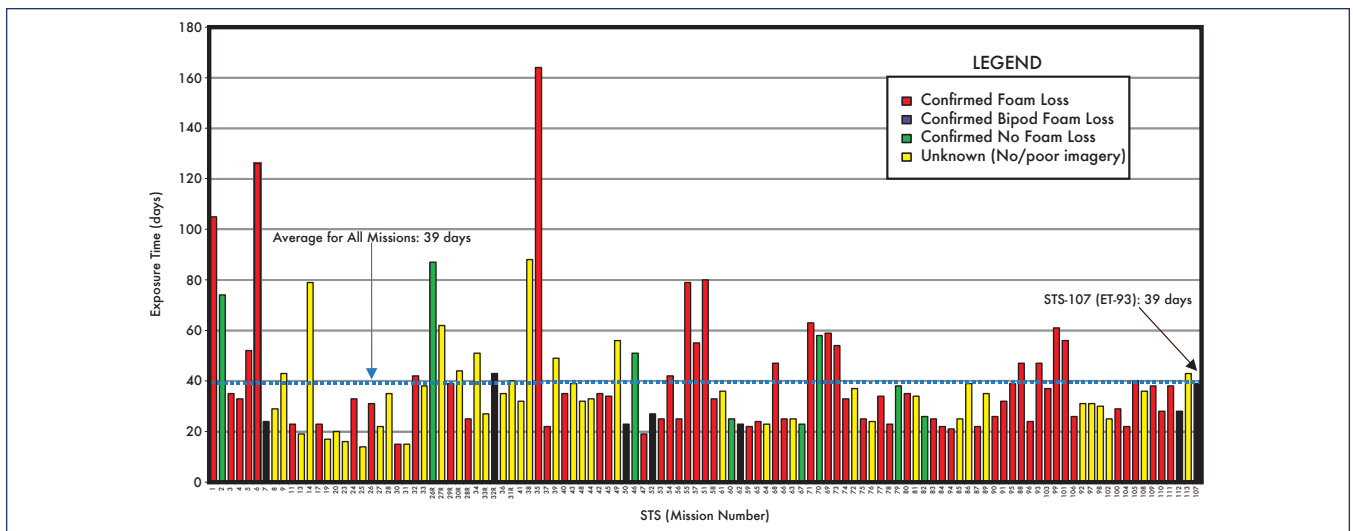
Figure 9-3. ET exposure time (to weather) prelaunch for all STS missions.

Note that the STS-107/ET-93 exposure time, 39 days, is the same as the mean value for all STS flights. As shown in Figure 9-4, the STS-107/ET-93 exposure time falls within the 95% confidence limit of all missions' ET exposure time, as well as the time confidence limits for flights with or without known bipod foam loss. The STS-107/ET-93 exposure time is larger than the 95% confidence upper bound for missions with known bipod foam loss. However, as stated above when discussing ET age, the 95% confidence limits of the different groups in Figure 9-4 overlap each other, and data are inconclusive as to whether ET exposure time and bipod foam loss can be correlated.

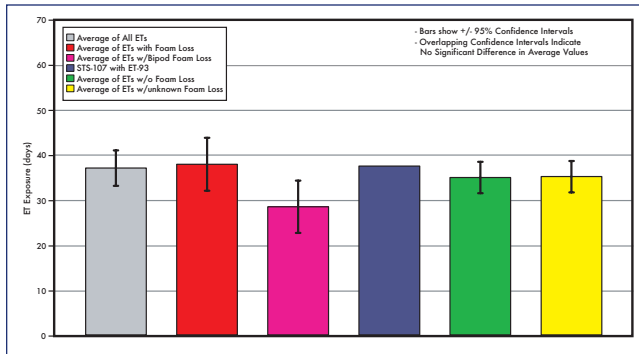
Figure 9-4. ET exposure time (to weather) for STS-107 compared to ET exposure time for missions with and without bipod foam loss.

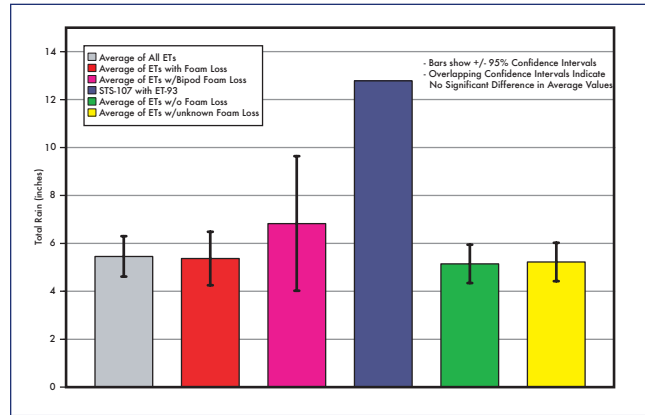
examined total rainfall, maximum one-day rainfall, average daily rainfall, launch day rainfall, and L-5 days through lift-off total rainfall. Figure 9-5 shows the total prelaunch rainfall for all STS missions. As shown in Figure 9-6, although the STS-107 value for total prelaunch rainfall, 12.78 inches, is greater than the mean value for all mission, 5.45 inches, the data are inconclusive as to whether a correlation can be

Figure 9-6. Total rainfall for STS-107 compared to total rainfall for missions with and without bipod foam loss.

made for ET bipod foam loss as a function of total rainfall prelaunch. The 95% confidence limit of the missions with ET bipod foam loss overlaps the confidence interval for all missions, as well as missions with no foam loss.

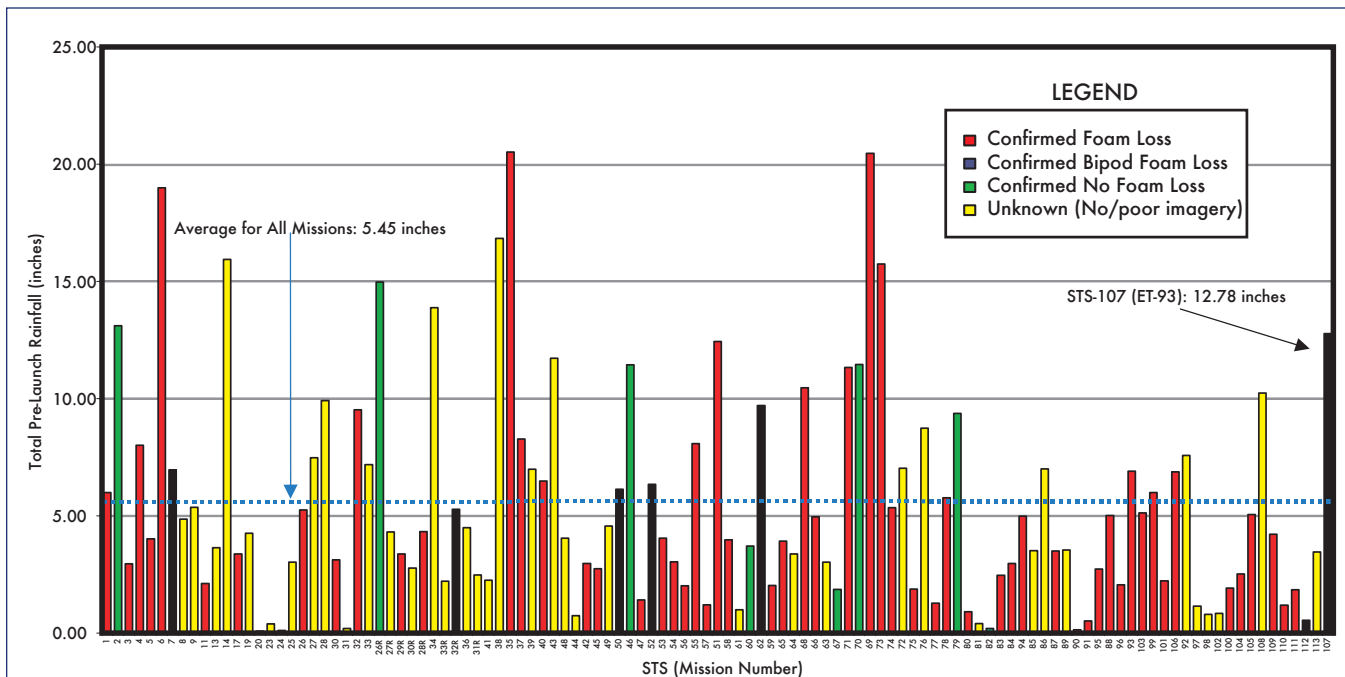
Figure 9-5. Total prelaunch rainfall for all STS missions.

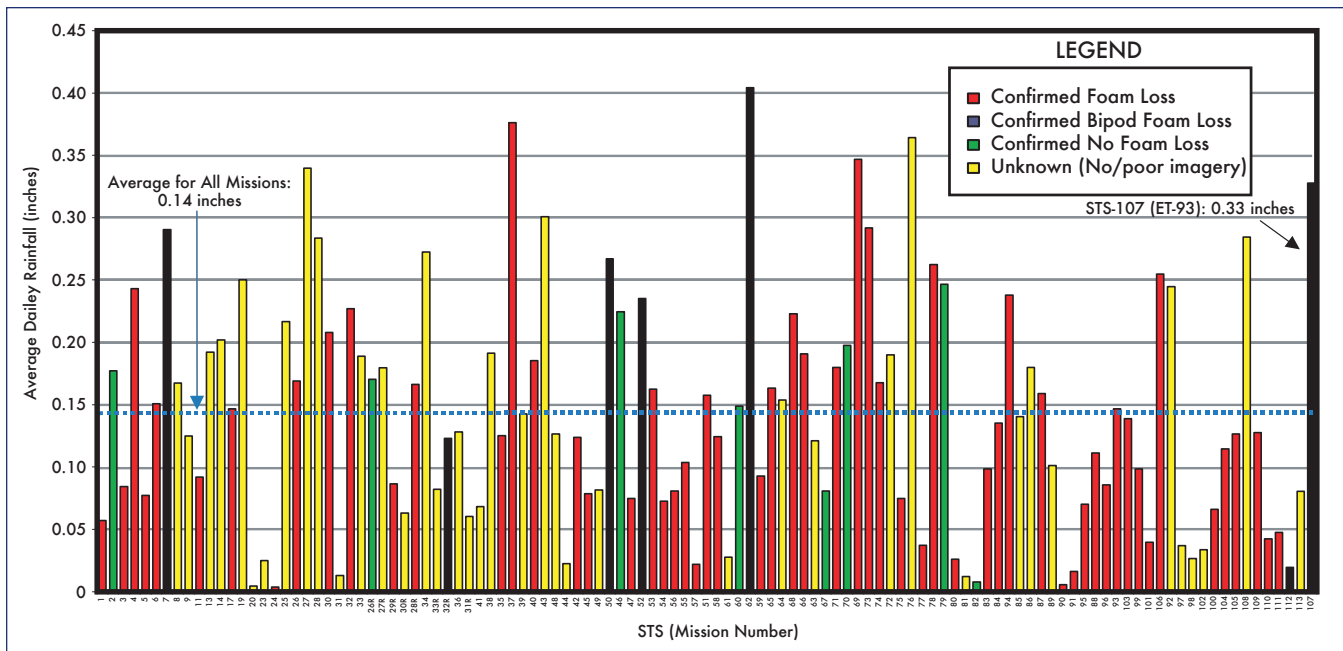
Similarly, the other rainfall parameters studied (e.g., average daily, day-of-launch) reveal no correlations for ET bipod foam loss. Figure 9-7 and Figure 9-8 show the data correlation for average daily prelaunch rainfall. The STS-

Figure 9-7. Average daily rainfall prelaunch for all STS missions (above).

107 value, 0.33 inches, and the mean value for missions with bipod foam loss are greater than the average mission value, 0.14 inches. However, the confidence intervals overlap each other, and the data are inconclusive as to whether average daily rainfall and ET bipod foam loss can be correlated.

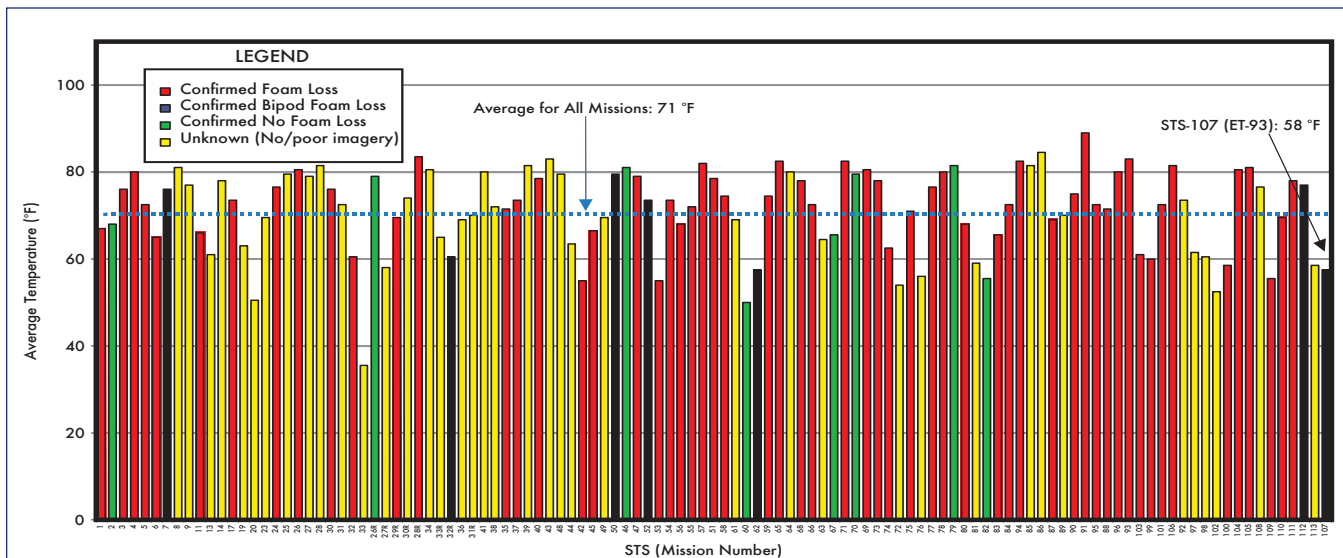
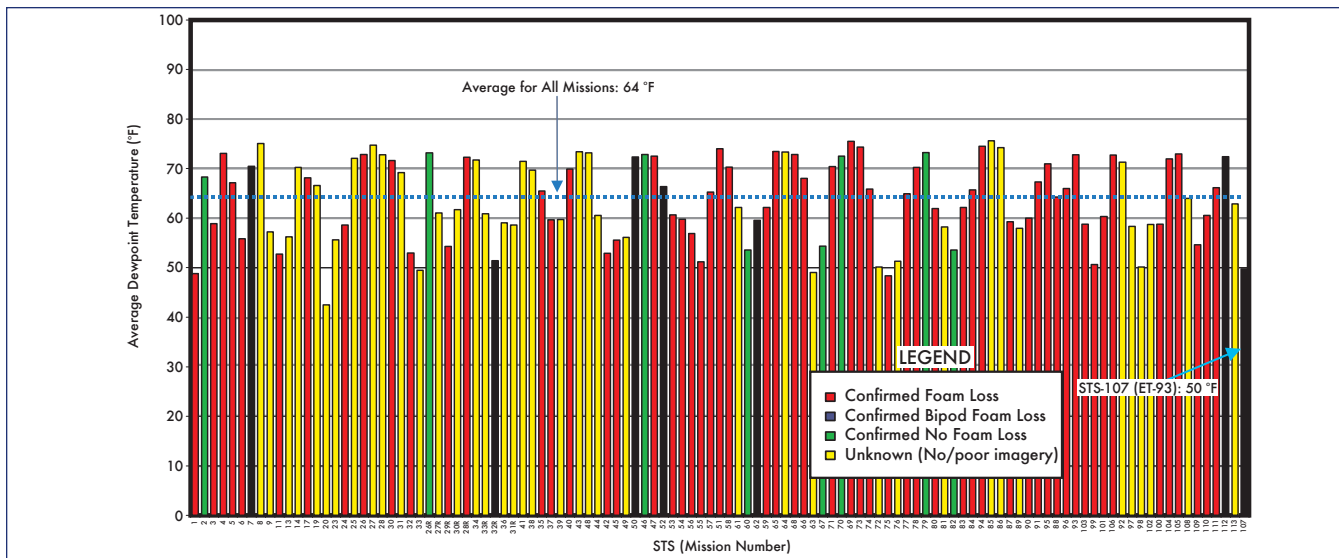
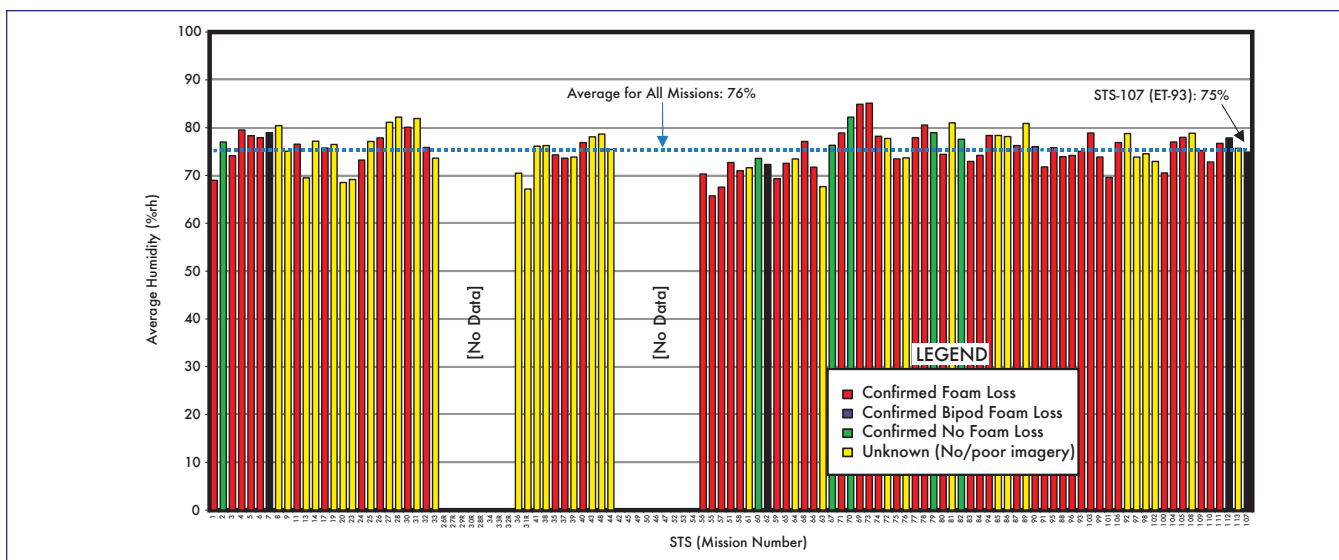
Figure 9-10. Prelaunch average dewpoint for all STS missions (top).
Figure 9-11. Prelaunch average humidity for all STS missions (above).

foam loss. Similar comparisons made for other temperature samplings, dew point (Figure 9-10), and humidity (Figure 9-11), yielded no correlations either.

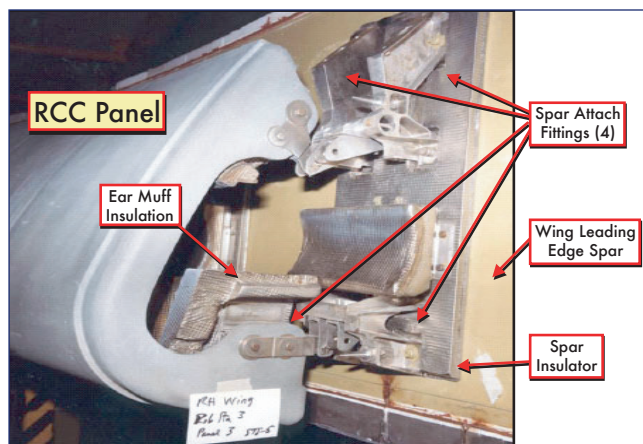
Figure 10-1. RCC components.

All Reinforced Carbon-Carbon (RCC) upper and lower wing Leading Edge Structural Subsystem (LESS) access panels, spar insulators, ear muff insulators, wing leading edge RCC panels, and spar fittings (see Figure 10-1 and Figure 10-2) were removed and inspected for discoloration and damage. Visual pinhole inspections were performed on each RCC panel and the wing leading edge spar was inspected for damage. Oversized pinholes were originally reported in RCC panels 8 and 19, but after further evaluation with an optical comparator, it was determined that the pinholes were acceptable. No other significant damage was noted. Leading edge RCC panels 6 and 13 through 17 were sent to the vendor (Vought) for refurbishment. New shims were installed to accommodate the reinstallation of the spar insulators.

The panels and spar fittings were reinstalled and all step and gap measurements were taken. At that time, gaps were found to be unacceptable in numerous locations. Wing leading edge RCC panels 11, 12, 17, and 18 were removed and additional anomalies were noted, which included insufficient step and gap, spar fitting shims not per design (too small), and the

lower access panel nutplates debonded and/or with low running torque. The low torque was due to a combination of the shim problem and a procedural error on the torque sequence. All 22 RCC panels were removed a second time. The nutplate issues were resolved by removing and replacing the nutplates that were accessible and securing with safety wire those that were not accessible. All anomalies identified were repaired, reworked, or accepted by Material Review (MR).
