COLUMBIA

ACCIDENT INVESTIGATION BOARD

REPORT VOLUME II
OCTOBER 2003

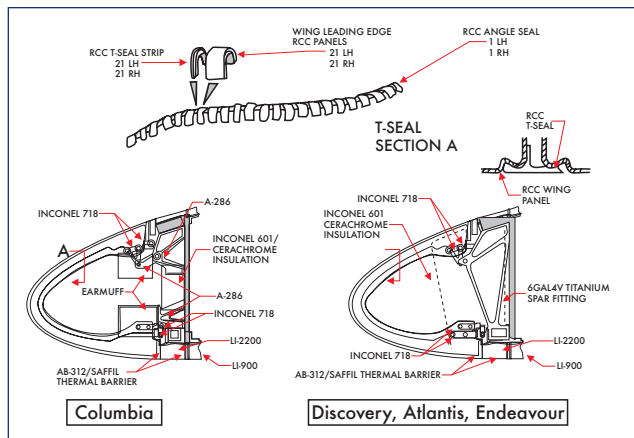
Figure 10-4. Wing leading edge RCC.

The angle seal at RCC panel 1 on the left wing leading edge (see Figure 10-4) was removed to support the evaluation of the horse collar gap filler between the adjacent tiles. During the removal attempt, the upper bushing remained bound with the shipside clevis. During subsequent attempts, the angle seal was manually manipulated to try and remove the preload. During the KSC paper review, structures engineers realized that the load applied to the angle seal was specified to be kept below 20 pounds, but was never recorded in the

paper. The RCC specification requires that RCC panel loads be kept below 30 pounds. Subsequent tests at KSC verified that the angle seal load was below the 30-pound requirement. The LESS prevention and resolution team is addressing the issue of how to measure the load and how to support the seal in future operations. Work continued on the elevon flipper doors. Flipper door 1 blade seal was not making contact with the rub channel, potentially leading to excessive venting from the elevon cove area. This issue surfaced twice during this flow and was Material Review (MR) accepted to fly as is. Modification was made to the Inconel trailing edge seal and bulb seal on the elevon. Additional work was performed on the elevon cove corrosion protection again to reduce the excessiveness of the application.

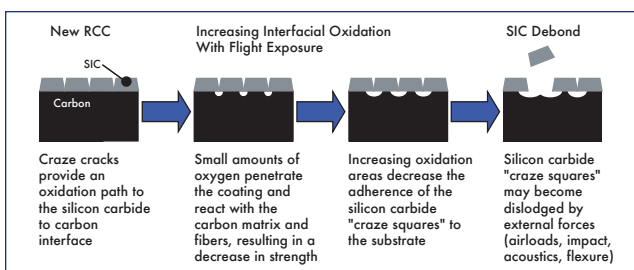
Figure 10-7. RCC corrosion process.

Subsurface oxidation has been discovered beneath the silicon carbide surface cracks in the sealant and coating which allow the oxidation process to thrive. This process is considered to be an impact to RCC mission design life, but is not generally considered to be a safety of flight issue. This oxidation process (Figure 10-7) starts with the breakdown of

the coating due to entry heating. Surface craze cracks allow oxygen to migrate to the subsurface carbon fibers and react with them. This increase in oxidation develops into larger crazed areas, which eventually allow pieces to become dislodged due to vibration, aerodynamic, or thermal loads. Once the pieces dislodge, they leave a large path for the oxidation process to continue.

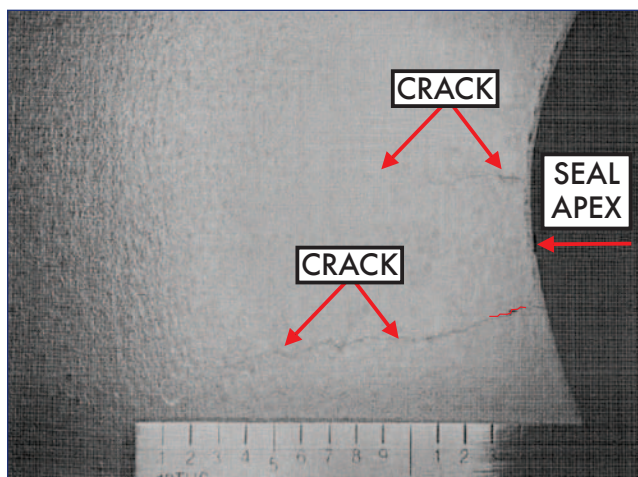
Figure 10-9. Tee seal cracking.

Each wing leading edge RCC panel shares a Tee seal that is used to close the gap between adjacent RCC panels. Following STS-43 (*Atlantis*) in August 1991, routine inspections identified cracks in the web of a Tee seal. The cracks were in the silicon carbide coating and occasionally in the substrate, and were due to normal shrinkage. They were typically less than 1/2 inch long, were not visible to the naked eye, and usually occurred in the web of the seal, on the backside of the seal (Figure 10-8) near the apex rather than on the leading edge. Further examination of the remainder of the shuttle fleet identified 20 (of 132) cracked Tee seals. *Columbia* had 11 Tee seals identified with possible cracks. Detailed inspections determined that all the cracks were typical of the surface craze cracks in the coating. The Tee seal cracks were determined to be caused by warping of the substrate fabric during lay-up during the original build. The Tee seal cracking (Figure 10-9) leads to a reduction in mission life and loss of oxidation protection. All the seals were refurbished with new coating and sealant and were reinstalled. Failure analysis showed that cracks would form after excessive wishbone loading (bending) caused the brittle coating to crack. Crack testing was performed in 1991 on Tee seal 10 (attached to RCC panel 9) from the left wing of *Columbia* to try to determine the crack mechanism. The Tee seal was cycled 400 times in bending up to 70% of its ultimate load and no dis-

cernable damage was noted. After an engineering evaluation was performed on the health and strength of the Tee seal, it was subsequently reinstalled on *Columbia*.

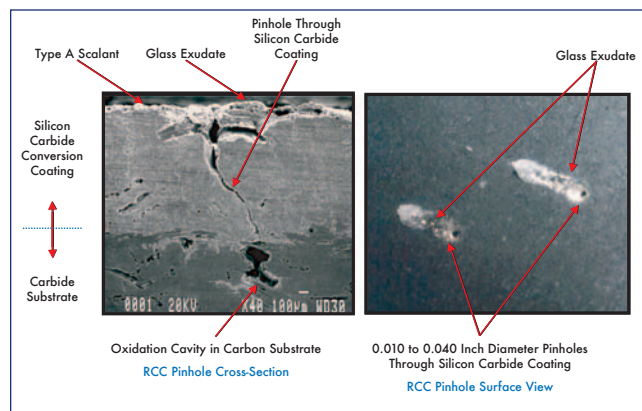
Figure 10-10. RCC pinholes.

Another phenomenon, discovered first on *Columbia* after STS-50 landed, was the existence of pinholes (Figure 10-10) in the RCC panels. The pinholes were found primarily in the wing leading edge RCC and were subsequently identified on all orbiters. Testing has shown that the pinholes are most likely the result of the accelerated oxidation process involving zinc oxide and the silicon carbide coating. The reaction of the zinc oxide and the silicon carbide produces a silica (glass) exudate that flows out of the pinhole area. The presence of zinc oxide is theorized to originate from the paint primer used to recondition the launch pad after each mission and is considered an accelerator to the oxidation process. The zinc-based contamination accumulates on the wing leading edge RCC as rainwater drips off of the launch pad.

This contamination rests on the RCC without reacting to the surface material while at ambient conditions at the pad. All of the damaging oxidation occurs once the RCC is exposed to the high temperatures, pressures, and excess oxygen of re-entry. Only a few pinholes have been observed on the nose cap RCC, most likely because the nose cap remains under a protective cover while at the launch pad. It is also believed that sodium chloride contributes to the oxidation process, but to a much lesser extent than the zinc oxide.

In 1997, pinhole acceptance criteria were established. Pinholes with surface dimensions less than 0.040 inches discovered during routine processing flows are acceptable to fly as is for up to 16 missions unless the carbon substrate is exposed, in which case the panel must be repaired. Pinholes discovered at OMM greater than 0.040 inches are unacceptable. Although the pinholes themselves constitute only a small mass loss, they are not considered to be a safety-of-flight issue by themselves. Analysis has identified that the sustainable thru-hole size in-flight due to orbital debris is 0.25 inches in the lower surfaces of RCC panels 5-13. A hole under 1 inch in diameter anywhere else in the RCC is considered survivable for a single mission.

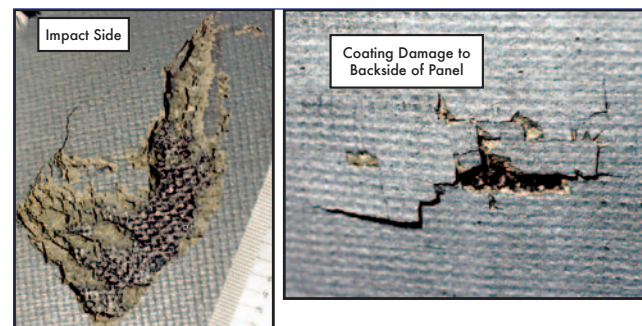
Figure 10-11. RCC impact damage.

There have been damaged RCC panels that were discovered after the vehicle returned from space on various missions. Some of the impact damage was only to the surface, but some even caused damage to the coating on the backside of the panel. In 1992, after STS-45, significant impact damage (overall length of ~1.75 inches) was noted on RCC panel

10R on *Atlantis*. The damage (Figure 10-11) was theorized to come from orbital debris or micrometeorite impacts during the mission. This type of RCC damage is of particular concern in that a significant impact could cause a hole in the RCC large enough to lead to wing spar burn through and subsequent loss of crew and vehicle. At that time, the maximum acceptable hole size (0.040”) criterion was established for processing flows and advanced wing leading edge internal insulation was modified to reduce the risk should hot gas penetrate the RCC.

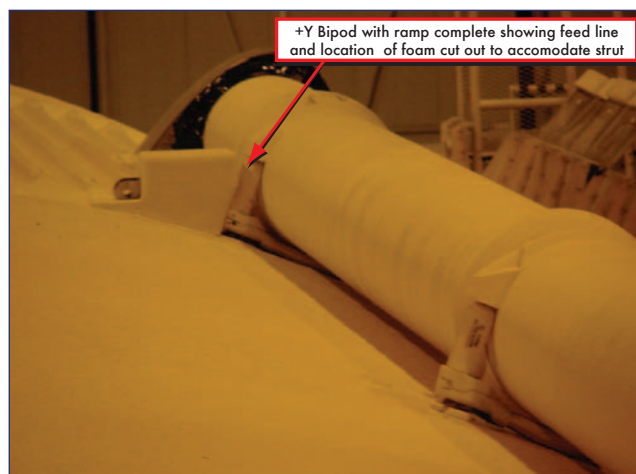
Figure 11-2. Right (+Y) bipod ramp.

TPS loss on the right bipod ramp has never been observed. Launch/ascent imagery from ground assets is less favorable for seeing right bipod foam loss as compared to the left bipod, and post-ET separation crew imagery is random between imaging the left or right bipod ramps.

There is no flight or test data to explain why the -Y (left) bipod loses foam and the +Y (right) does not. The Shuttle Program only provides the -Y ramp air loads as a worst case for ET project analysis. There are several bipod configuration differences that may contribute to foam not coming off the +Y ramp. First, the foam ramp is configured slightly differently to accommodate the inboard strut for the LO2 feed line support structure (see Figure 11-2). Second, the proximity of the right bipod to the LO2 feedline could potentially influence local surface pressure causing a lower internal to

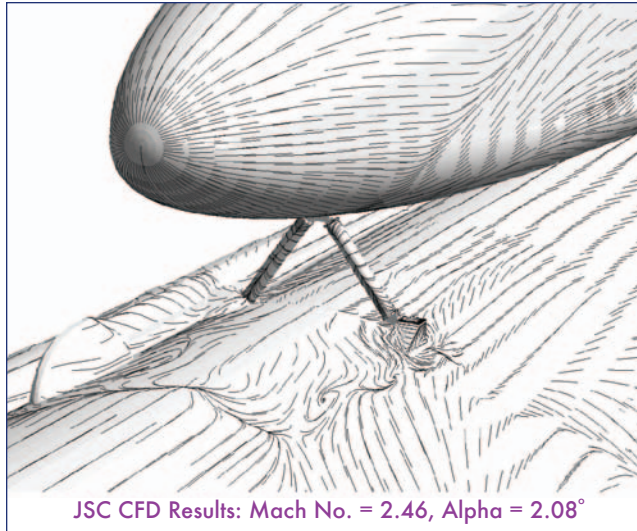
Figure 11-3. Left and right bipod ramp flow differences, CFD results.

external pressure differential (see Figure 11-3). Finally, the outboard and aft facing surface of the -Y bipod may experience lower surface pressure due to flow separation and other local effects relative to the +Y side. If the internal ramp pressure was high due to adverse “as-built” features in the ramp, this could lead to a higher differential pressure on the -Y versus the +Y ramp. However, the aerodynamic loads analysis reviewed in Section 3.5 shows that the loads on both ramps are below their design requirements.

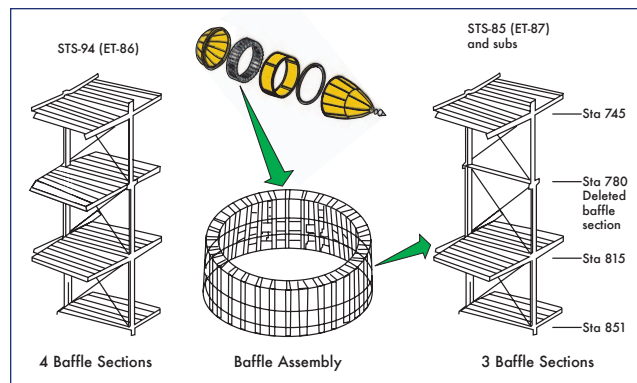
Figure 11-6. ET LO2 slosh baffle changes – ET-87.

One weight saving feature of the SLWT is the removal of one more slosh baffles section, as shown in Figure 11-6. This gives a predicted performance gain of 92 pounds. This feature was incorporated into the LWT at ET-87 in 1996 to reduce weight and diminish the number of first time configuration changes for the subsequent first flight of the SLWT. Dynamics analysis showed available damping remained within requirements and propulsion and stress analysis also remained within requirements. Data are inconclusive as to whether the ET LO2 slosh baffle configuration alone caused bipod foam loss on STS-107/ET-93.

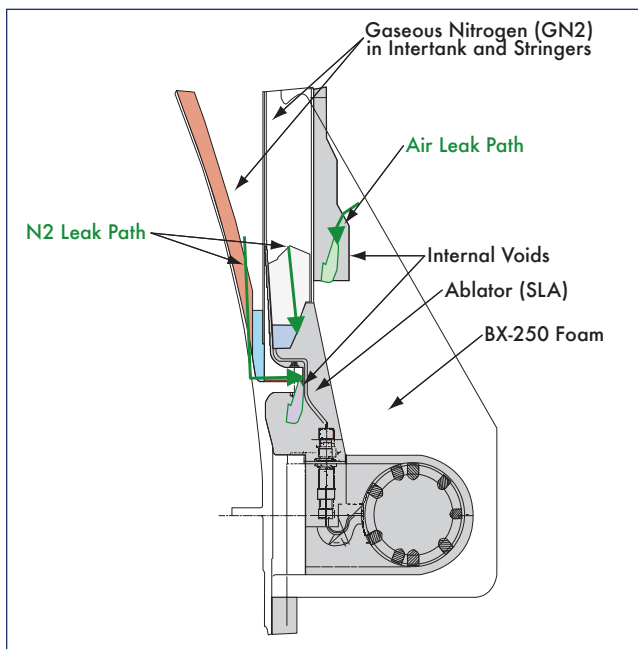
Figure 11-8. Schematic of bipod ramp - potential cryopumping.

Cryopumping could contribute to bipod foam loss, shown schematically in Figure 11-8. The mechanism that drives cryopumping is the transformation of a gas to a liquid at cryogenic temperatures. Gases may condense within a void or porous material at low temperatures. Air in cavities or porous material liquefies when in contact with structure below -297°F for oxygen or -320°F for nitrogen. Pressure is reduced locally due to the condensation. If a leak path exists, more air will be “pumped,” providing more gas to condense. When the structure warms, the consequence of cryopump-

ing is that the liquefied air returns to the gaseous state with a local pressure increase. If the leak path is large, gas escapes with no detrimental effect. However, if the leak path is small, cracks may form in the TPS to relieve pressure, or a rapid increase in pressure may result in a divot. In order for this to occur, the inlet source must be blocked off to avoid venting out the inlet. It should be noted that testing has been unable to demonstrate cryopumping in this application.

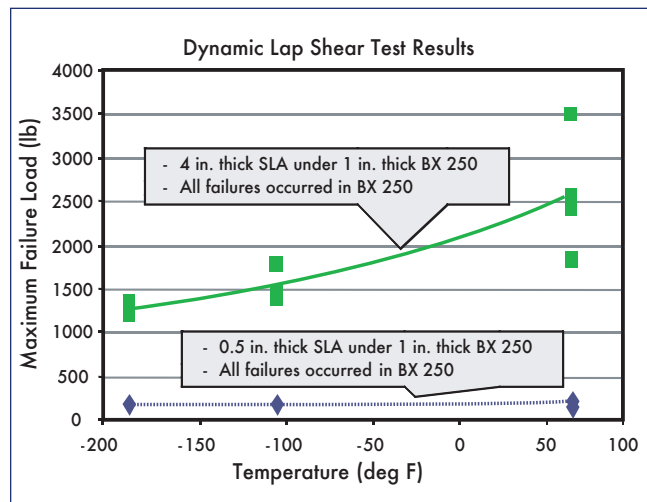
Figure 11-9. Critical test results in debris assessment.

Testing shows that the potential loss of BX-250 does not liberate hand packed SLA due to impulse loading for cryogenic applications; the BX-250 fails before the SLA. For shear, testing shows BX-250 fails before SLA at all test temperatures. For tension, testing shows BX-250 fails before SLA when SLA temperatures are less than or equal to -100°F (see Figure 11-9).

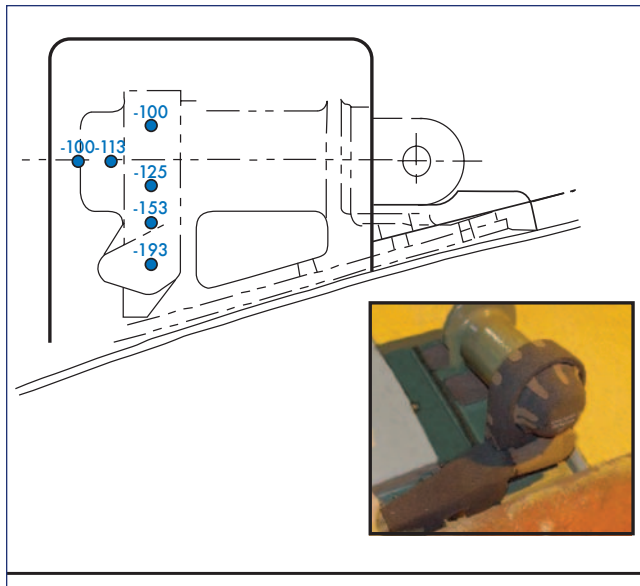
Figure 11-10. Max bipod SLA temperatures (80 seconds MET), °F.

The maximum SLA temperatures possible at 80 seconds were analyzed to determine maximum worst-case multi-event material loss. No cryopumping or cryo ingestion was assumed in order to calculate temperatures as high as possible. STS-107 ambient environments were used. Results showed the maximum SLA temperature possible at 80 seconds MET is less than or equal to -100°F , as shown in Figure 11-10. Tension testing shows BX-250 fails before SLA at temperatures less than or equal to -100°F .

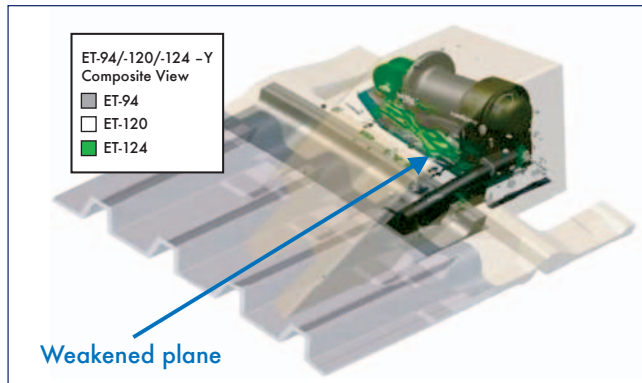
Figure 11-12. Weakened plane defect found.

The dissection of six bipod ramps indicated similar patterns for geometry-induced defects in all ramps. Roll-overs were observed at complex substrate elements, and the majority of observations were associated with spraying over complex details at the substrate. Sporadic voids were also observed. One internal delamination and one weak plane at the knit line were observed. Critical locations, or areas at-risk for producing debris, were identified near the edge of the machined foam surface for both voids and roll-overs (see Figure 11-11). Vacuum pressure is the primary driver for divot formation; however, wind shear also contributes to flight loads. A combination of multiple large voids, geometry-induced defects, and critical locations is needed to produce significant foam loss. For example, a large interconnected void at close proximity to the surface plus a “weakened plane” (see Figure 11-12) may produce foam loss.

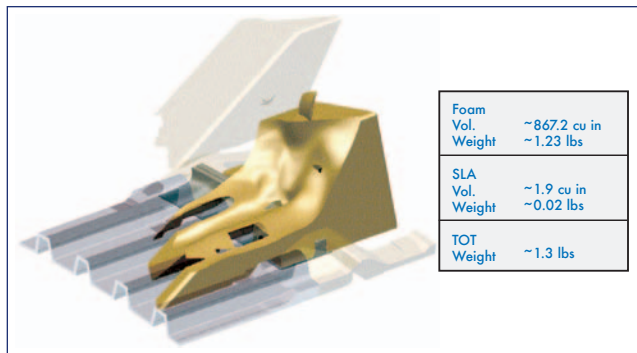
The ET Working Group conducted an analysis coupled with test data to estimate a multi-failure mode TPS bipod debris size and weight. The ET Working Group scenario includes seven simultaneous and interactive adverse events: A large rollover occurs at the inboard stringer interface immediately below the machined foam surface, side-to-side thermal crack/weak knit line, a large void near the topmost surface one inch below machined foam surface, warm SLA environment, and foam machined to minimum tolerances (not a failure). The specific results are shown in Figure 11-13.

Figure 11-13. Multi-failure mode bipod TPS debris estimated by the ET Working Group. Note that this size and weight were not used in the RCC impact testing as part of the STS-107 investigation.

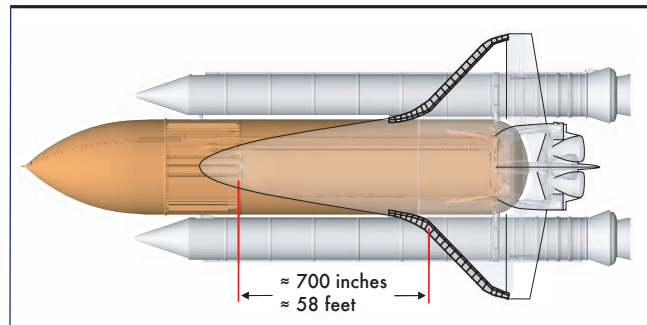
Figure 2-1. Distance from debris source to debris impact location.

Figure 2-1 shows that the impact location is approximately 58 feet downstream of the debris release point. Although the downstream distance is 58 feet the SSLV travels more than 370 feet during 0.16 second debris trajectory duration.

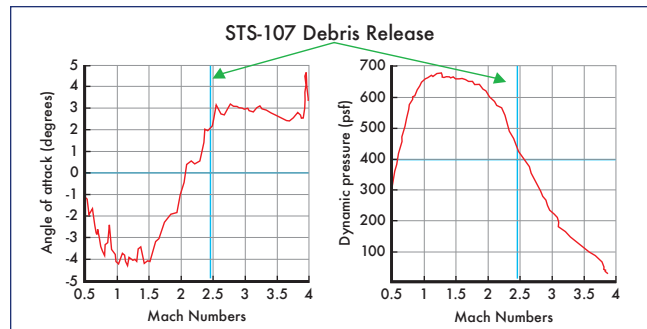
Figure 2-2. STS-107 ascent angle of attack and dynamic pressure history.

At Mach 2.46 the SSLV has transitioned from a negative angle of attack to a positive angle of attack. During the maximum dynamic pressure portion of the ascent profile the SSLV flies at a negative angle of attack to reduce the aerodynamic loads on the Orbiter. Additionally the vehicle has passed the maximum dynamic pressure or max \bar{q} , and the region of maximum aerodynamic loading on the vehicle. This data is shown in Figure 2-2.

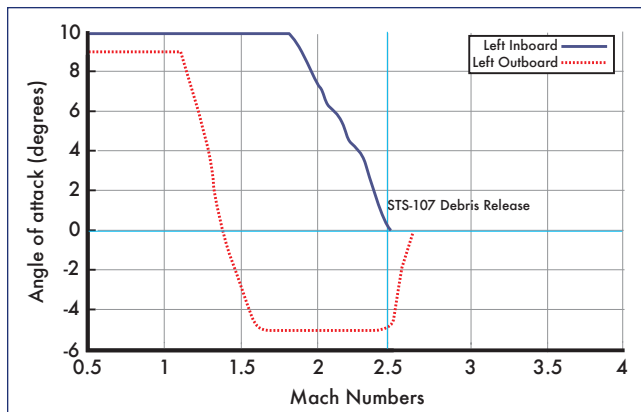
Figure 2-3. STS-107 ascent elevon schedule.

Figure 2-3 shows that the elevons were moving to their neutral or 0°/0° deflection position during the debris event.

Negative elevon deflections indicate that the elevons are rotated upward, away from the External Tank. The elevon deflection at this point in the ascent trajectory makes debris impacts on the outboard elevon lower surface unlikely.

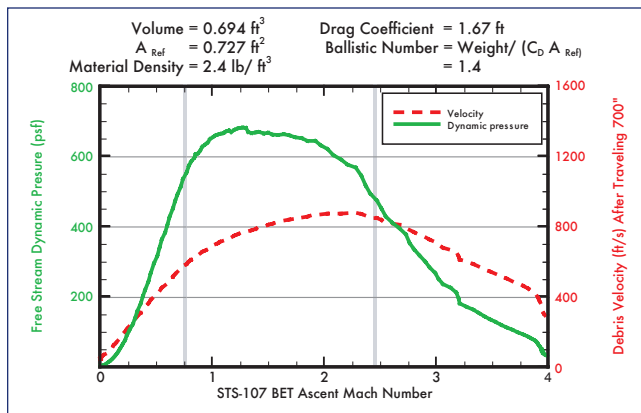
Figure 2-4. Impact velocity vs. Mach number (based on freestream conditions).

Figure 2-4 illustrates the importance of freestream density and velocity on the impact velocity. This figure is based on a constant drag coefficient and does not account for local variations in the flowfield.

Dynamic pressure produces the acceleration force applied to the debris and the freestream velocity determines the maximum relative velocity that the debris can attain. The maximum potential acceleration coincides with the maximum dynamic pressure or max q , which occurred at Mach number = 1.28, however this does not produce the worst case impact velocity. As shown in the previous figure, Mach 2.46 is near the worst case combination of dynamic pressure and freestream velocity in terms of impact velocity potential.

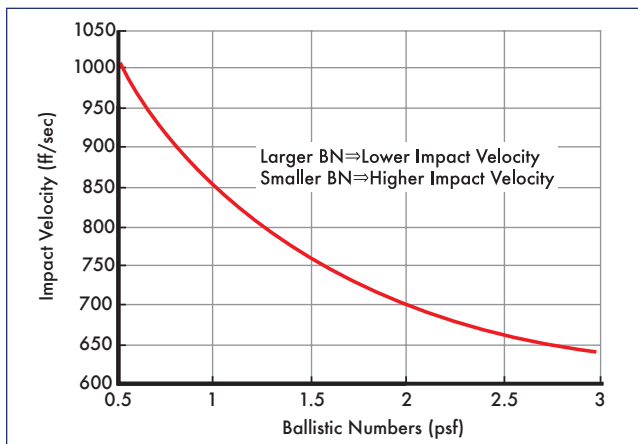
Figure 2-5. Impact velocity vs. ballistic number at STS-107 conditions.

aerodynamic acceleration is a function of BN. As the ballistic number decreases the drag force and resultant impact velocity increases and as the ballistic number increases the drag decreases and the resultant impact velocity decreases. The Figure 2-5 shows estimated impact velocity vs. ballistic number for a Mach 2.46 flowfield for debris from the bipod region impacting the wing leading edge on RCC panel 8.

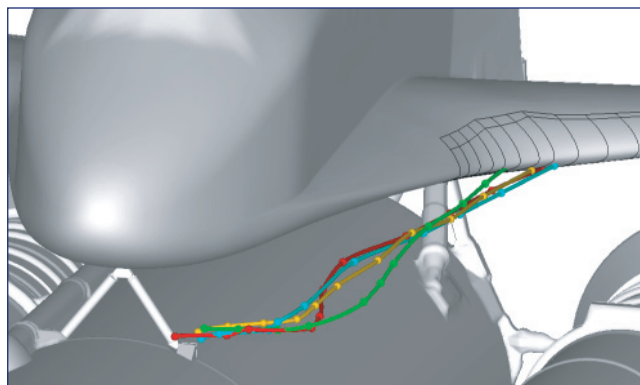
Figure 3-1. Sample set of 3-dimensional trajectories from various members of the Image Analysis Team.

One of the most important inputs from this group were 3-dimensional trajectories and view vectors extracted from the launch camera film and videos. Four of the trajectories are shown in Figure 3-1. These trajectories provided the reference information needed to narrow the estimated range of the weights and velocities for the debris released from the External Tank. This refinement was required due to the limited number of test articles available for impact testing and the critical nature of these impact tests to determine the foam damage potential.

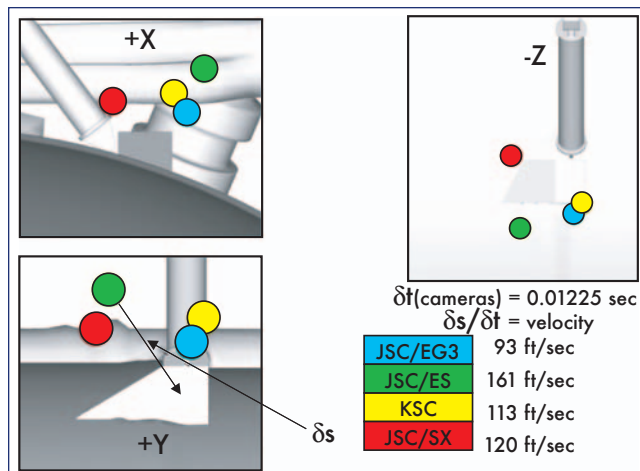
Figure 3-2. Initial trajectory points from Image Analysis Team.

Based on the initial positions of each of these trajectories and the camera frame rates an initial average velocity can be calculated for each of these trajectories. Figure 3-2 shows the initial positions of four of the 3-dimensional trajectories relative to the bipod ramp. These points are assumed to represent the debris locations 1/2 of a frame (12.25 milliseconds) after release.

Note that two of the initial trajectory points shown in the +Y view of Figure 3-2 are actually ahead of the ramp. This implies that the debris somehow moved forward, against the oncoming flow, initially and then traveled aft towards the Orbiter wing. This would require some force acting on the aft edge of the foam ramp that could overcome the aerodynamic forces acting on the ramp at the time of the debris release. Flaws in the bipod ramp shown in Reference 3-2 are in an area where this force could have been applied. However, there is no data on the STS-107 ramp to confirm the existence of similar defects in the STS-107 foam ramps.

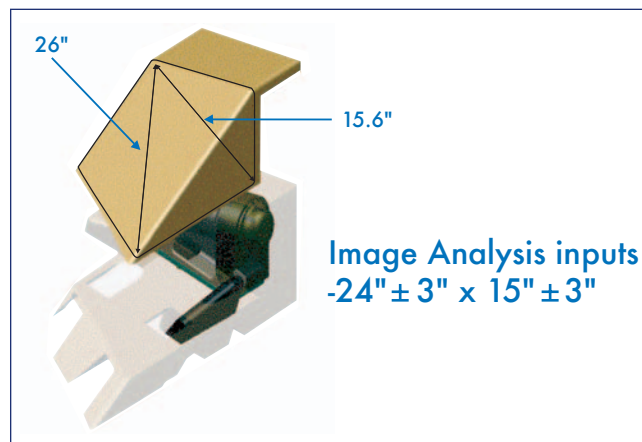
Figure 4-2. Initial maximum estimated foam loss.

An estimate was made of the maximum potential foam loss based on this ramp angle. The original estimated maximum foam loss was 855 in³. Later in the investigation this estimate was increased to 867 in³. The initial estimate assumed that the thin region aft of the ramp would break off during the debris separation. At a foam density of 2.4 lb/ft³ these volumes of foam would weigh approximately 1.2 pounds. These estimated volumes are shown in Figures 4-2 and 4-3.

The dark outline in Figure 4-2 represents the initial 855 in³ estimated worst case foam loss. Note that the diagonal dimensions are similar to those reported by the Image Analysis Team. The final estimate included a small amount of Super-Lightweight Ablator SLA.

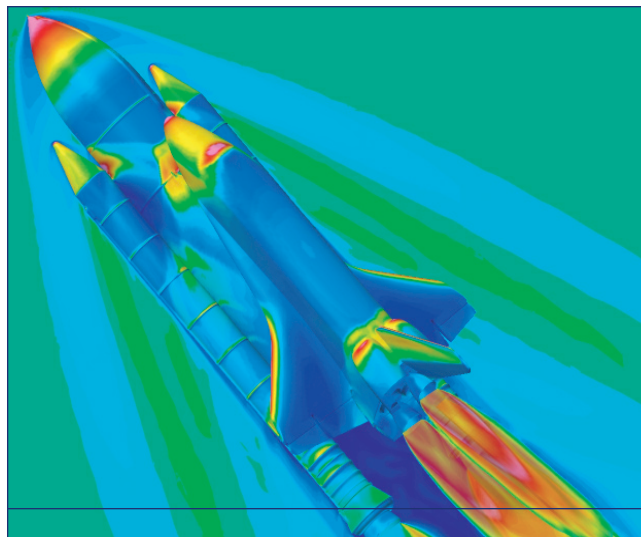
Figure 5-1. Pressure coefficient on the Space Shuttle surface and Mach number in the surrounding flowfield at the STS-107 debris release conditions.

The flowfield in the bipod ramp region, at the STS-107 debris release conditions, has a number of interesting features. Each of the SSLV elements generates a bow shock and the Orbiter and SRB shocks intersect just ahead of the bipod ramp. The left hand SRB shock effect on the local surface pressures is visible as a light blue area in Figure 5-1 on the ET between the SRB nose and the Orbiter nose. These shock-shock interactions with the boundary layer cause the boundary layer

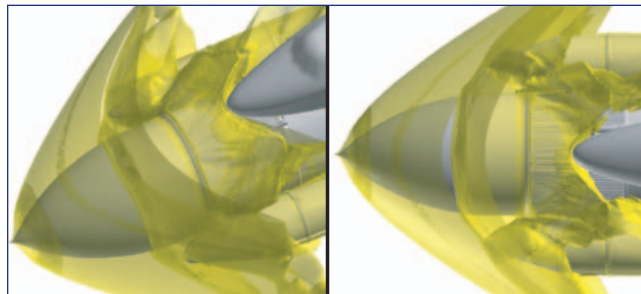
Figure 5-2. Mach number isosurfaces at Mach number = 2.46.

ahead of the bipod ramp to separate. Figure 5-2 shows Mach number isosurfaces, colored yellow, at the debris release conditions. These images show the bow shock ahead of the ET as well as the SRB shocks intersecting with the shock off of the Orbiter nose just ahead of the bipod ramps.

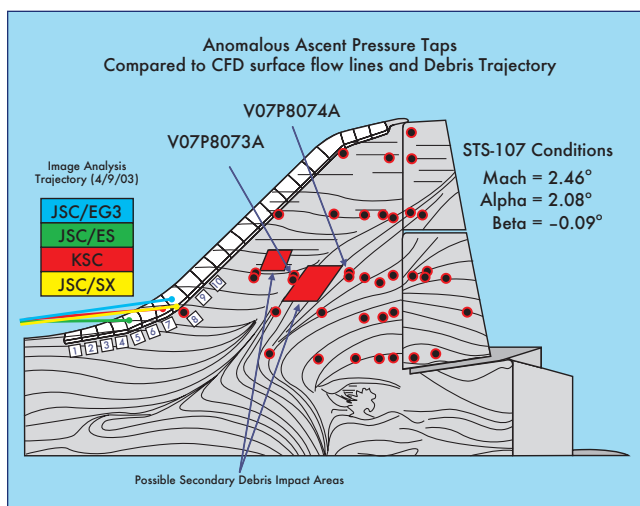
Figure 5-3. Surface flow lines and possible secondary impact locations.

Surface constrained flow lines, extracted from the static CFD solution, were used to estimate areas where secondary debris strikes may have been detected by the vehicle pressure sensors. Figure 5-3 shows flow lines on the Orbiter lower surface at the debris release freestream conditions the red regions indicate possible secondary impact locations that might have resulted in anomalous pressure measurements during the vehicle ascent. These locations were determined based on their positions relative to the anomalous pressure tap measurements, the local flow direction and further any damage should not affect any other down stream or adjacent pressure instruments which behaved nominally.

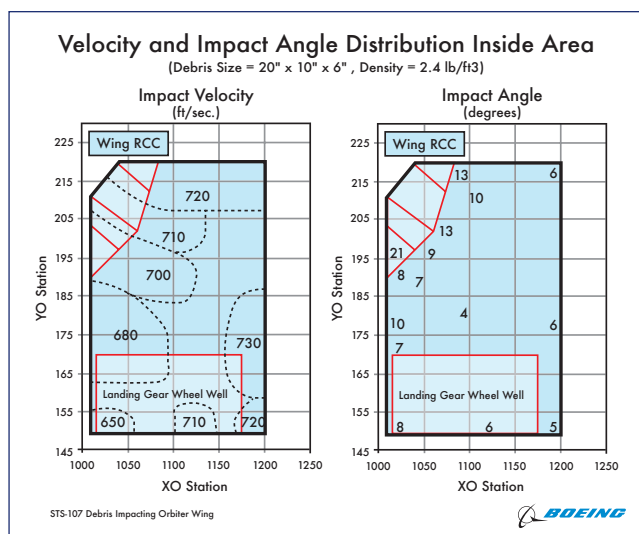
Figure 6-1. STS-107 debris impact results.

During the STS-107 three different foam debris sizes were analyzed. One of the debris sizes, a 20" x 10" x 6" volume, is within the final estimated range of foam volumes predicted by detailed ballistic number estimates in Section 7. The original predicted impact velocity on RCC Panel 8 was 710 ft/sec with an impact angle of up to 21° as shown in Figure 6-1. These analyses were performed using relatively coarse grid CFD solutions at a Mach number of 2.5 and at angles of attack of 1.5° and 3.0°. These values compare well with the Mach 2.46 and angle of attack of 2.08° values determined by the post STS-107 ascent reconstruction.

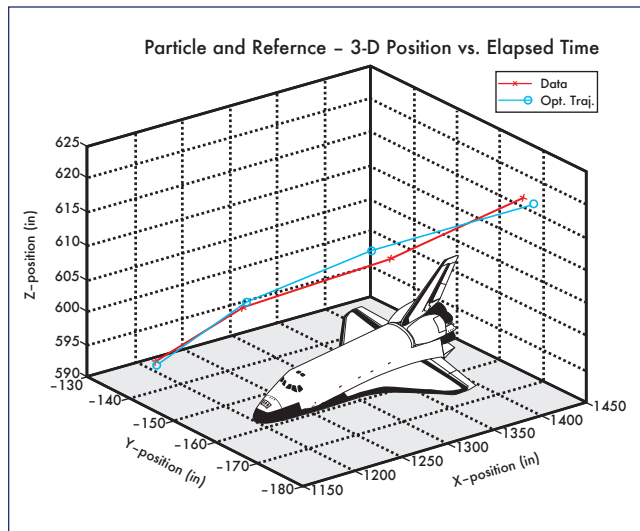
The KSC data set (see Table 7-1) for ranges (4-8, 4-9, 5-8, and 5-9) produced the most consistent BN values. Trajectory optimization using the KSC reference data set resulted in a BN ranging from 1.2317 – 1.4516 lb/ft² and an associated projected velocity range (at X=1800 inches) of 763 – 803 ft/s. These ranges represent approximately an 18% variation in BN and a 5% variation in predicted velocity at X = 1800 in. (near impact location). The minimum sum square error of all assessed data sets is 15.55 in² per interval in the index interval range 5-8. A 3-dimensional plot of the trajectory positions and the reference data set positions for this portion of the debris trajectory (Figure 7-3) reflects the low sum square

Figure 7-3. Three-dimensional view of foam debris trajectory as compared to KSC reference data for index range (5-8). Note: Shuttle diagram is for attitude reference only and is not to scale.

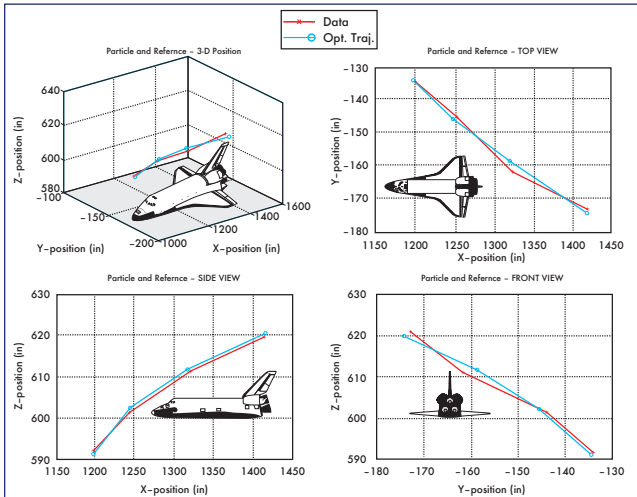
Figure 7-4. Composite view of foam debris trajectory as compared to KSC reference data for index range (5-8) including top, side and "front" views. Note: Shuttle diagram is for attitude reference only and is not to scale.

error. A composite view of the 3-D plus front, side, and top views of the trajectory comparison are shown in Figure 7-4.

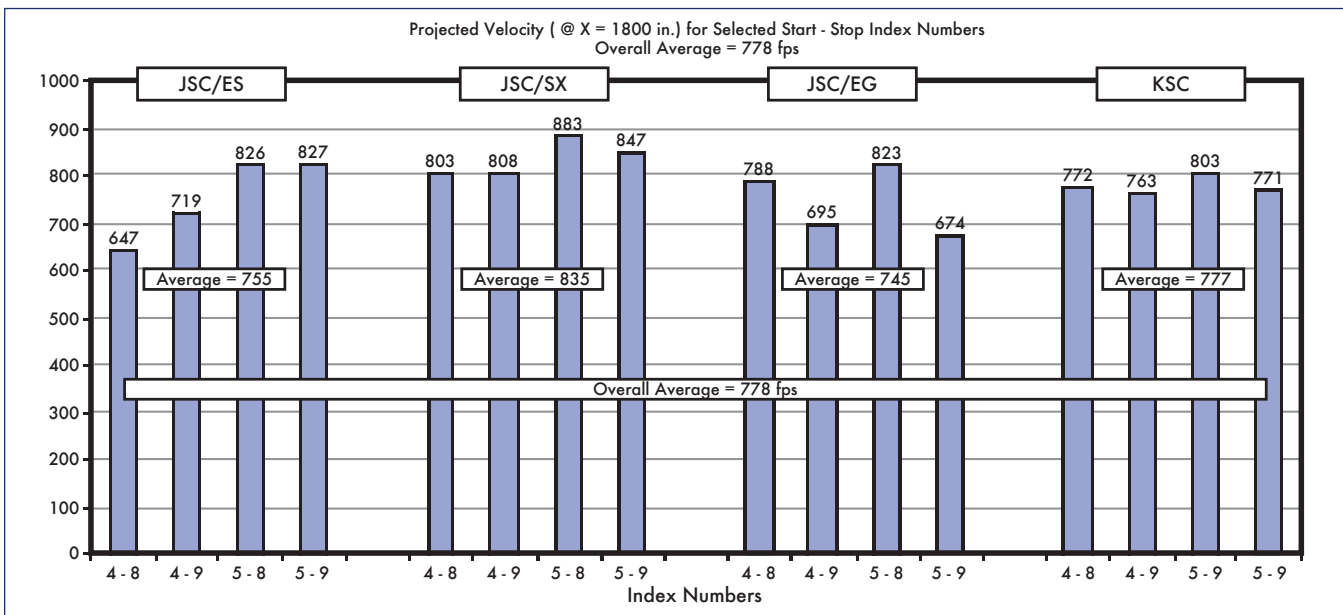
A plot of the projected velocities at X = 1800 inches (Figure 7-5) shows the consistent velocity results for the KSC based data. The JSC/SX velocities appear to be almost as consistent as the KSC data and are uniformly higher than the KSC data. The results for the JSC/ES and JSC/EG are a bit more "choppy". In contrast to the lower sum square error of the KSC data for index interval range 5-8, the JSC/EG carries a higher sum square position error and associated larger differences between the trajectory and the reference data set (see Figures 7-6 and 7-7).

Figure 7-5. Projected velocity of foam debris to position X = 1800 inches, for reference data sets JSC/ES, JSC/SX, JSC/EG, and KSC. The KSC data provides the most consistent projected velocity results.

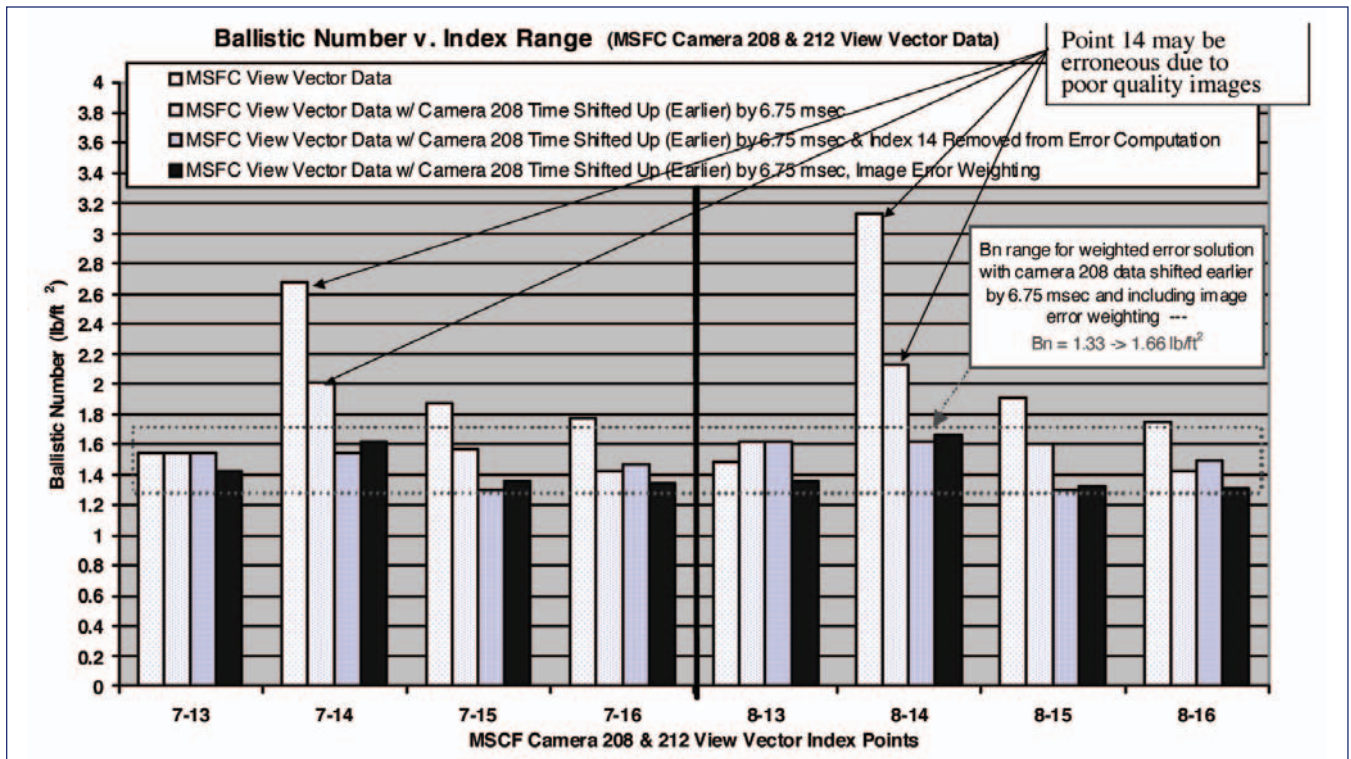
Figure 7-10. BN vs. index range for selected view vector data comparisons.

For the index intervals evaluated, the resulting BN ranged from 1.314 to 1.661 lb./ft² and the projected impact velocity of the foam debris at X-position of 1817.45 inches ranged from 742 to 814 fps.

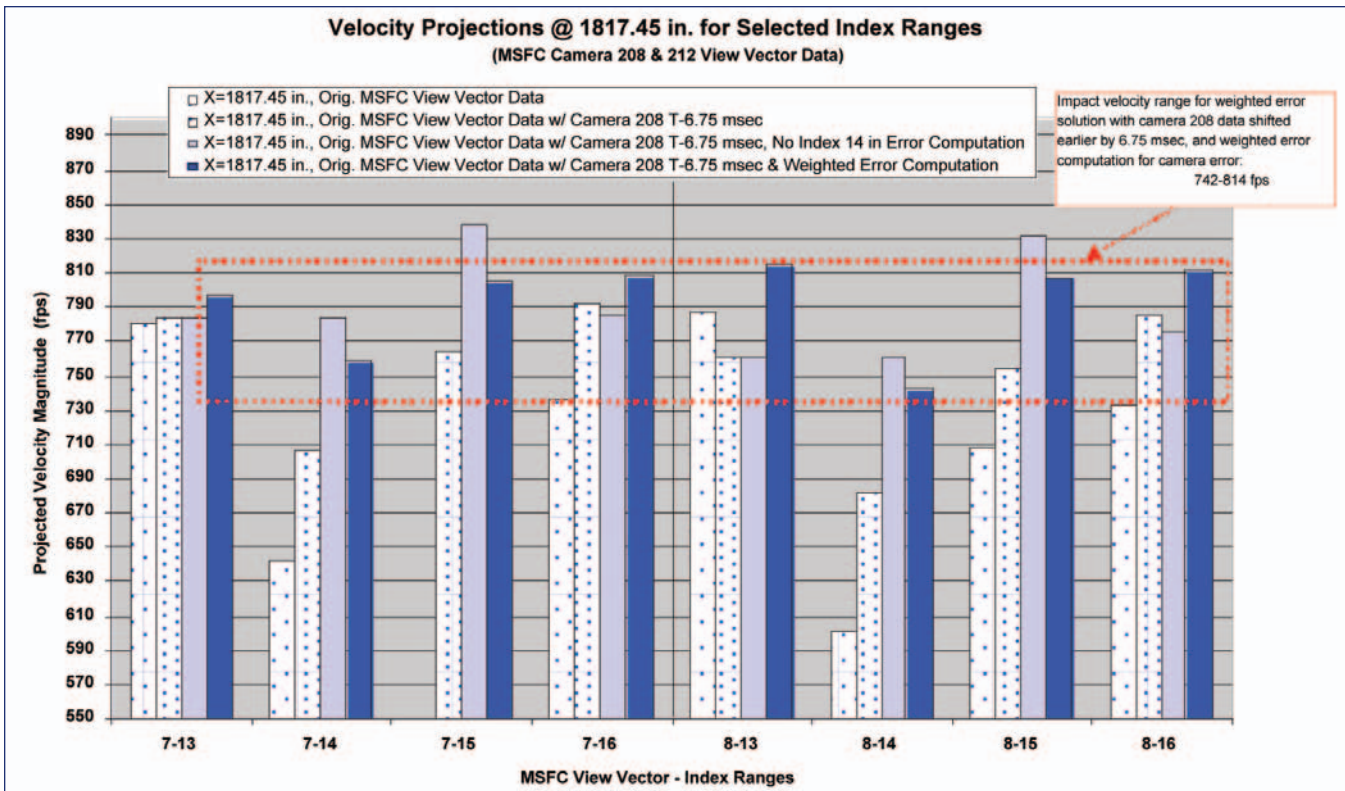
Figure 7-11. Projected impact velocity at X-position = 1817.45 inches vs. index range for selected view vector data comparisons.

The impact velocities for the selected-index-intervals trajectories shown in Figures 7-10 through 7-12 range from 729-815 fps, with the bulk of the velocity component in the ET coordinate frame x-direction (see Table 7-4). The trajectory heading ranges from about 6.5°-7.5° outboard at impact

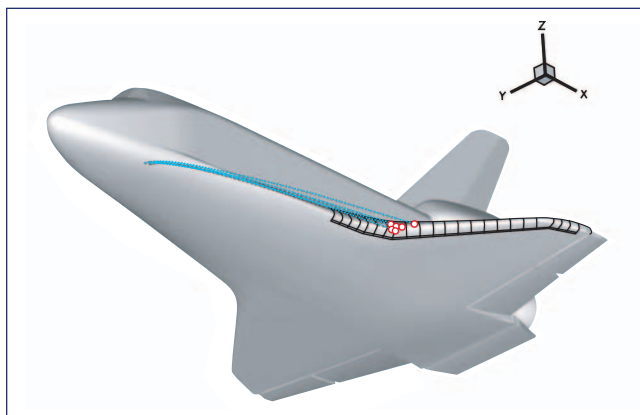
The foam debris trajectories for index ranges (7-13, 7-14, 7-15, 7-16, 8-13, 8-14, 8-15, and 8-16) are depicted in an oblique view of the Shuttle (Figure 7-13). These trajectories represent the optimal selection of the initial state and a constant BN to provide a minimum sum square error over the selected index interval. They begin at the initial state and are projected to impact the left Shuttle wing*. For all cases the debris impacts the Shuttle on Reinforced Carbon-Carbon (RCC) panels 7, 8, or 9.

Figure 7-13. Optimized foam debris trajectories for index intervals 7-13, 7-14, 7-15, 7-16, 8-13, 8-14, 8-15, and 8-16, projected to Shuttle impact. Graphic courtesy of Phil Stuart – JSC/EG3.

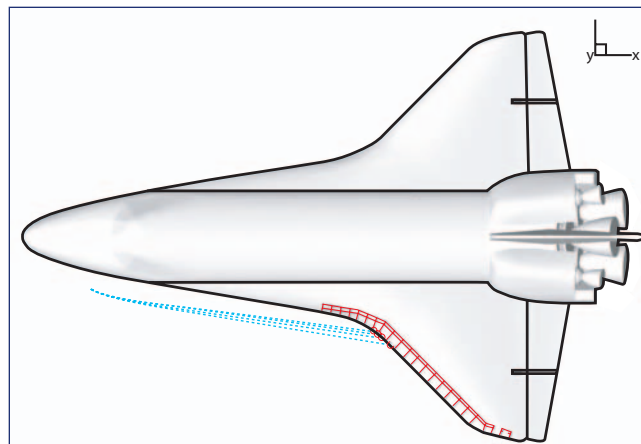
jectories shows that the impacts occurred with an outboard angle to the trajectory (see Figure 7-14).

Figure 7-14. Top view of optimized foam debris trajectories for index intervals 7-13, 7-14, 7-15, 7-16, 8-13, 8-14, 8-15, and 8-16, projected to Shuttle impact and showing outboard direction of trajectory at impact. Graphic courtesy of Phil Stuart – JSC/EG3.

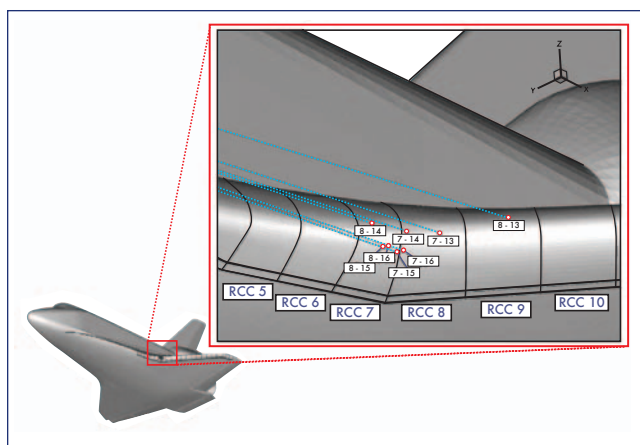
(as shown in Figure 7-15). The trajectory angle between the incoming debris trajectory and the Shuttle wing leading edge (impact angle) has a range of about 15.5°-31.8°. For all cases, the impacting debris trajectory lies within about 2.5° of the z-plane (angle x-y).

Figure 7-15. Close-up of optimized foam debris trajectories for index intervals 7-13, 7-14, 7-15, 7-16, 8-13, 8-14, 8-15, and 8-16, projected to Shuttle impact. Graphic courtesy of Phil Stuart - JSC/EG3.

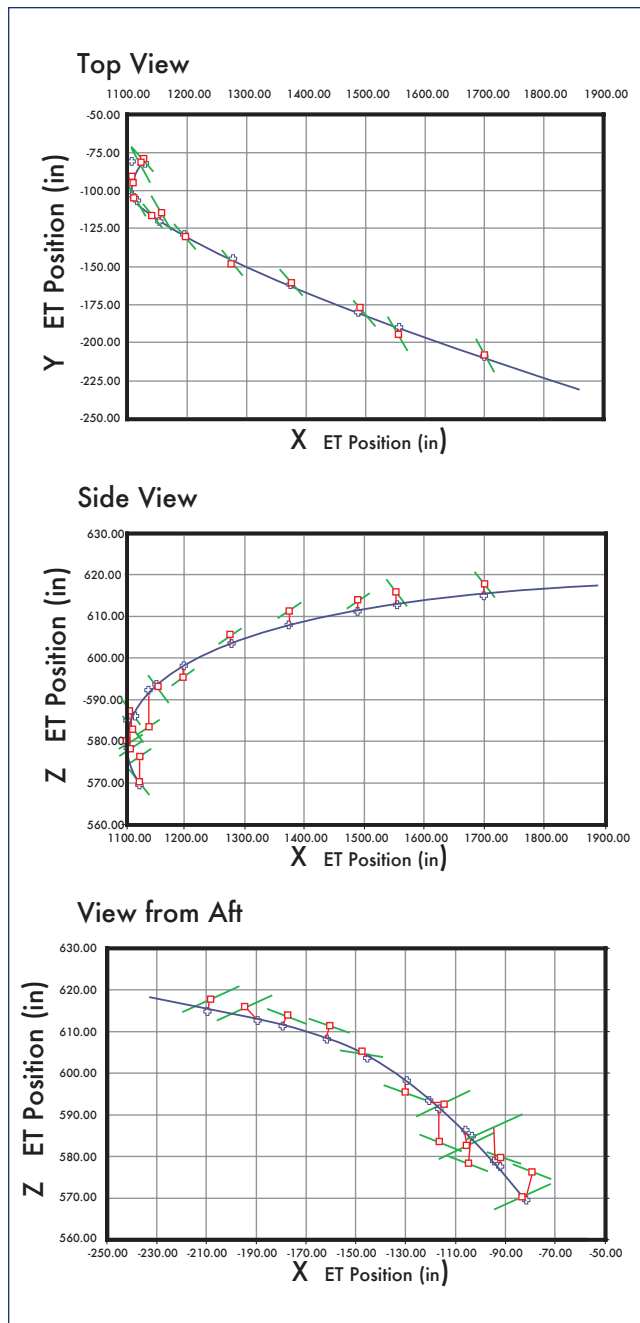
It is worth noting, however, that looking at Figure 7-19 ballistic-model trajectories do not seem to originate from an initial position and direction of motion consistent with departure from the bipod ramp location (pretty close, but not quite). Also, looking at Figure 7-18, while the ballistic model can fit the observational data pretty well, it doesn't seem to follow apparent trends in the Z direction. These discrepancies seem to suggest that lift is a significant factor in the trajectory shape.

Figure 7-18. Debris object trajectory solution with view vectors (ballistic model).

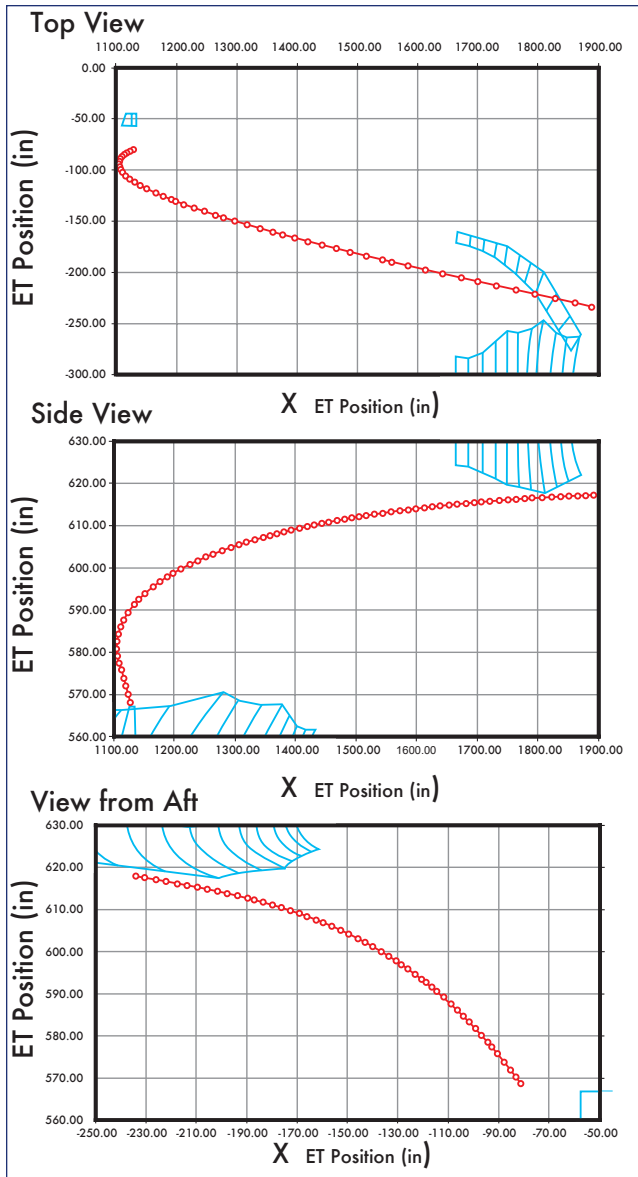
Figure 7-19. Debris object trajectory solution with rcc and bipod ramp outlines (ballistic model).

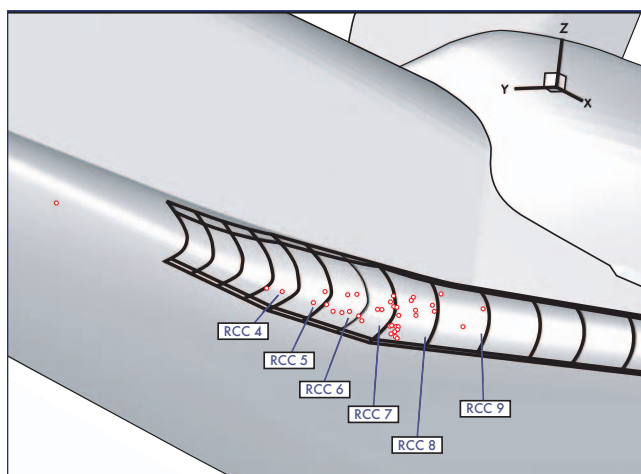
Figure 7-21. Interpolated impact points of all data sets.

cally the planes in these angles are +xy in the Space Shuttle up direction, +xz toward the starboard side, and +yz toward the Space Shuttle aft section. Note that data sets ES3-7 and SX3-7 did not impact the Space Shuttle. The velocity magnitudes at interpolated impact points ranged from 669 ft/sec to 853 ft/sec with incidence angles varying from 5 to 33 degrees. The impact point of each data set is represented visually in Figure 7-21.

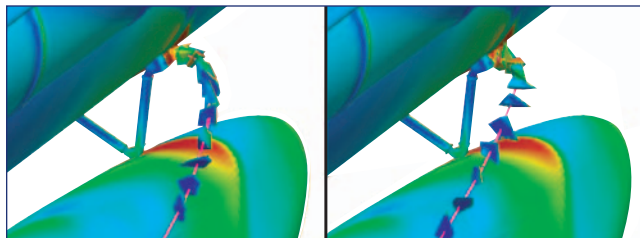
A trajectory that begins with a rotating forward flip (nose-down) is more likely than a backward flip (nose-up) to impact the Shuttle's lower wing leading-edge surface. A backward flip would generate significantly more lift before the

Figure 8-1. Backward vs. forward flip trajectories.

These images also illustrate the tumbling behavior of the debris after it separated from the launch vehicle. The homogeneous wedge shaped foam debris analyzed in these simulations is unstable and will tend to rotate rather than trim out in a stable attitude. To assume a stable attitude, with a correspondingly lower drag coefficient, would require a significantly different debris shape than the shape observed on the launch films or would require some additional mass embedded in the foam debris. No conclusive evidence supports this scenario.

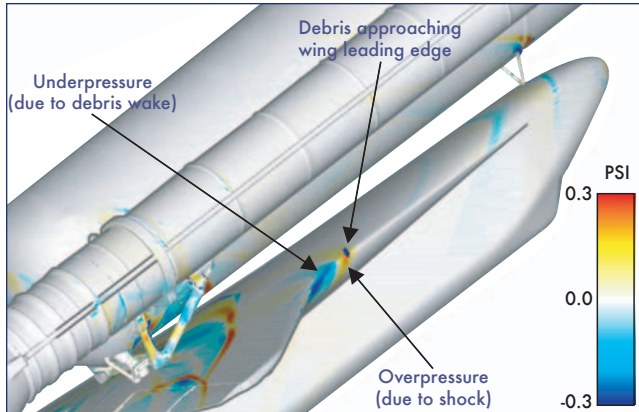
The effects of the debris on the surface pressures of the Shuttle were estimated by subtracting the steady state solution surface pressures from those computed during an unsteady trajectory computation. This analysis shows that the Orbiter leading edge pressure is lowered by approximately 0.4 psi just before the debris impact. This is shown in the following figure, which shows color contours of the difference in pressure on the surfaces.

Figure 8-6. Delta pressure on vehicle surface caused by debris.

Red and yellow indicate increased pressures and cyan and blue indicate lowered local pressure. White or gray regions show small or no change in pressure. The lowered local wing surface pressure is caused by the wake of the debris piece that precedes the debris as it travels past a fixed point on the Orbiter wing. This change in local pressure may help explain the anomalous accelerations measured on the left wing outboard elevon accelerometer recorded during ascent and may explain the unusual acceleration signature seen shortly after the debris impact on the leading edge of the wing.

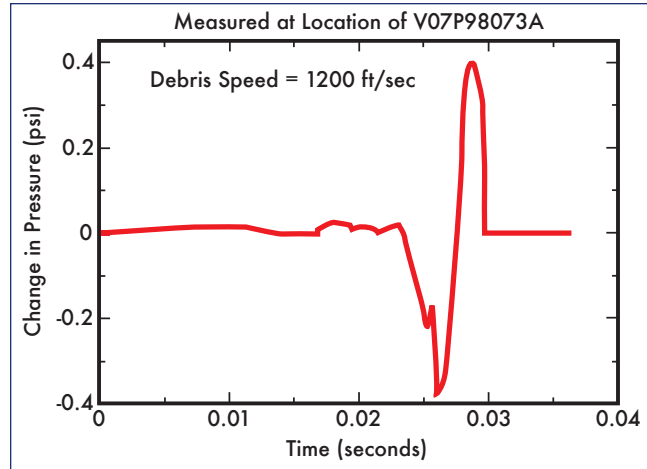
The following figure shows the change in pressure near one of the anomalous taps caused by the simulated debris shape passing near the Orbiter wing without an impacting the wing leading edge. For this debris velocity the pressure oscillation occurs over approximately 0.01 seconds and realistically would not have been sensed by the 10 Hz sample rate of the pressure taps. The zero value on the x-axis is simply a reference time prior to the debris's passage near the pressure tap.

Figure 8-7. Delta pressure near orbiter lower surface pressure tap.

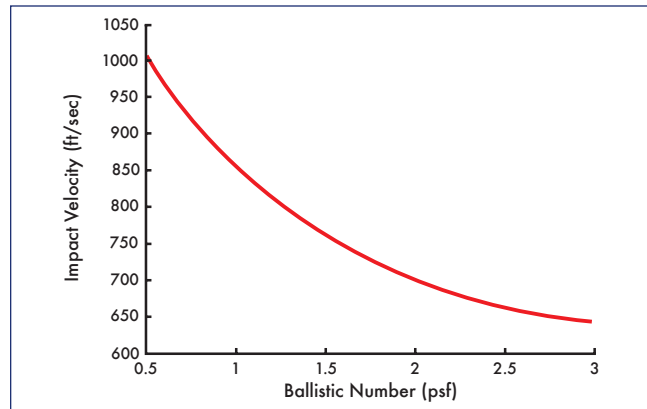
The debris mass estimates were based on the ballistic coefficient analysis results combined with the ADT program and unsteady CFD results for the 855 in³ foam volume estimate from the External Tank Project. ADT and the unsteady CFD results predicted that the 855 in³ foam would have a BN approximately equal to 1.0 with an impact velocity of 950 ft/sec.

figure 9-1. impact velocity at 1,800 inches vs. ballistic number.

Ballistic number analysis of the Image Analysis trajectories estimated the most likely range of $1.2 < BN < 1.4$. Due to the accelerated test schedule and lead times required to procure test article hardware a simple ratio of the predicted ballistic numbers to the baseline 855 in³ geometry was used to predict the as tested foam weights.
