COLUMBIA

ACCIDENT INVESTIGATION BOARD

REPORT VOLUME II
OCTOBER 2003

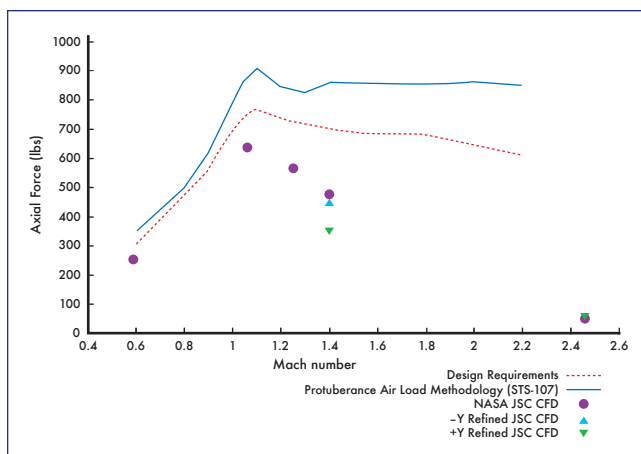
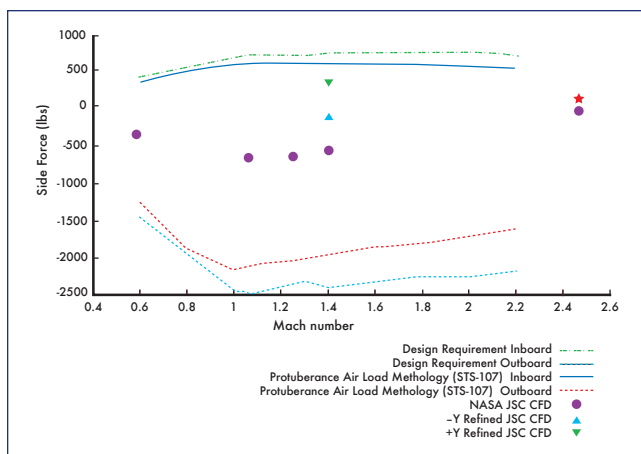
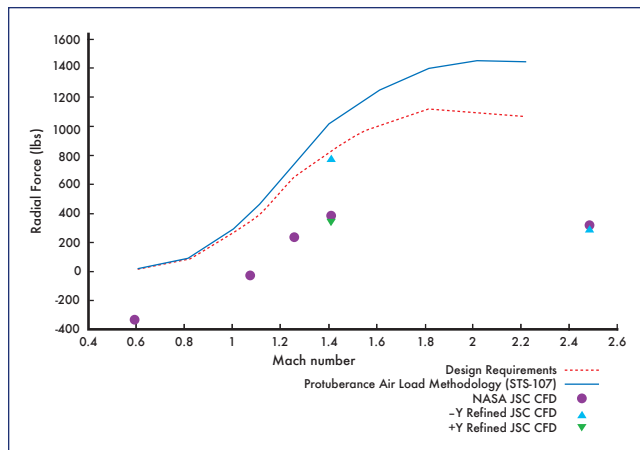
Figure 14-2. -Y Bipod ramp axial force vs. Mach number.

Figure 14-3. -Y bipod ramp side force vs. Mach number.

Figure 14-4. -Y Bipod ramp radial force vs. Mach number.

This analysis shows that the air loads were within the design envelope and implies that a ramp with no flaws would not fail due to air loads alone. Internal voids could contain gas at atmospheric pressure that would result in local failures when the delta pressure between the gas voids and the external pressure exceeds the strength of the foam insulation. Information from the ET Project indicates that internal flaws could significantly reduce the foam strength and that cryogenic temperatures would cause a further reduction in strength.

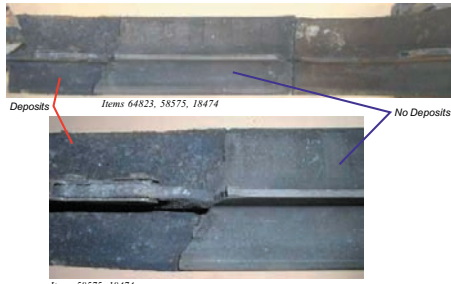
Deposits Items 64823, 58575, 18474

spar, with the aluminum access panel providing a secondary source. The highest concentration of deposits on the panels is the lower portion of right hand RCC panel 2, which coincides with a missing lower access panel 2. Fracture sequencing can be determined based on deposit levels. Panel 2 and its associated gap seal have a heavy concentration of metallic deposits on one side of a fracture while the mating fracture surface is completely free of deposits. This condition is found on the gap seal (64823, 58575, 18474) where the middle

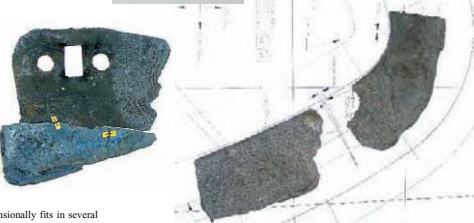
Items 17943, 35201

The erosion is on the upstream side of the ribs, indicating a downstream flow direction. The rib on each piece is eroded down to a knife edge. The lug holes, to accommodate clevis attach fittings for panel 8, are oversized by means of erosion. The bolts and split bushings were not recovered.

There are two pieces of left hand lower gap seal (35201, 17943) that still need location confirmation. Comparing wear, deposits, near fracture match and upstream erosion the pieces appear to be related. The pieces dimensionally fits in several locations, most eliminated due to recovered items. The remaining locations

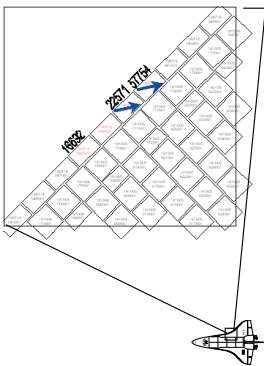
Figure 9.2. Reconstruction of recovered left hand lower LESS Carrier Panel 9 tiles.

Evidence of overheating and slumping was observed on three LI-2200 Lower Left Carrier Panel 9 tiles adjacent to left hand RCC panel 9. The item numbers of these are: 16692 (V070-199716-048), 22571 (V070-199716-052) and 57754 (V070-199716-054). Figure 9.2 shows the simulated configuration of the carrier panel tiles. Depressed/slumped and eroded regions were observed in two of the three tiles (Items 16692, 22571). For

Dark-colored deposits were observed on all three outer mold line (OML) tiles (Items 16692, 22571, 57754). The thickness of the deposits varied across the tile surfaces. In the case of 22571 and 57754, the deposits produced visually apparent flow-like patterns oriented in the aft/outboard direction (Figures 9.3 and 9.4). Visual evaluation showed evidence that in some locations on the tile sidewalls, the deposits had built up over adjacent soft goods. This was supported by the presence of entrapped ceramic fibers in the deposits.

One internal LI-900 tile originally located on Lower Left LESS Carrier Panel 9 was recovered. This tile (Item 50338, V070-194205-004) exhibited a heavily slumped and cratered appearance (Figure 9.2). An additional internal LI-900 tile was recovered from upper Left LESS Carrier Panel 8. This tile exhibited a greenish coloration and heavy slumping (Figure 9.5). The surface deposits on internal tiles 50336 and 50338 were not as thick as those

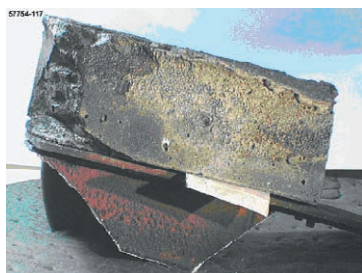
Figure 9.7. Tile Item 57754 bonded to section of carrier panel

The item 57754 remained bonded to a section of underlying carrier panel 9 (Figure 9.7). The items 22571, 16692, 50338

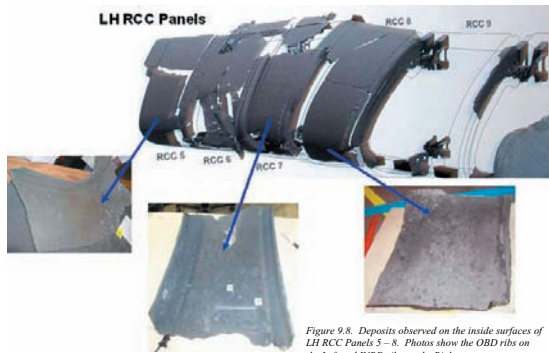
Figure 9.8. Deposits observed on the inside surfaces of LH RCC Panels 5 – 8. Photos show the OBD ribs on the Left and INBD ribs on the Right.

Deposits similar to those observed on the LESS carrier panel tiles were also observed on the inner surfaces of several LH RCC panels (Figure 9.8). The deposits resembled solidified metallic slag, and were strongly adhered to the internal surfaces of the panel segments. The quantity and thickness of the deposits also varied according to the RCC panel number.

Table 9.4 and Figure 9.8 show the relative severity of the left wing leading edge deposits approached a maximum at RCC Panel 8 and decreased on either side. Heavy deposits were also observed on the inner surfaces of the Outboard Ribs of Panels 4, 5, and 7, however very few deposits were observed on the inboard ribs of these panels.

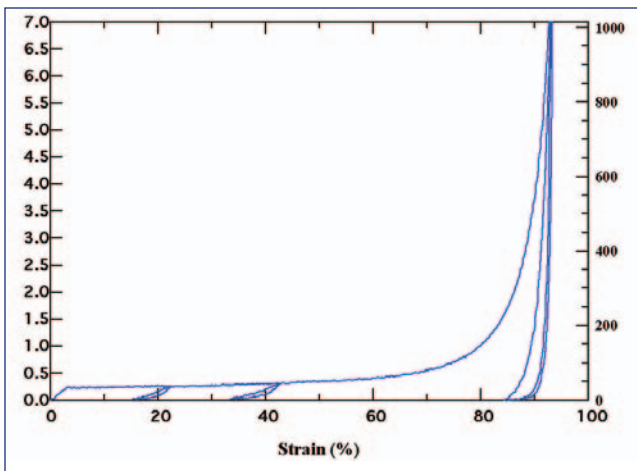
Figure 2. Test of second foam sample. Note the three unload/reloads.

Visual observation of the tests revealed two important facts about the foam during loading: first, there was virtually no lateral expansion; and second, when compressed the foam stayed intact and compressed (i.e., there was a permanent crush-up). The second observation on crush-up is confirmed in Figure 2 by the unloading curves that clearly indicate a permanent deformation.

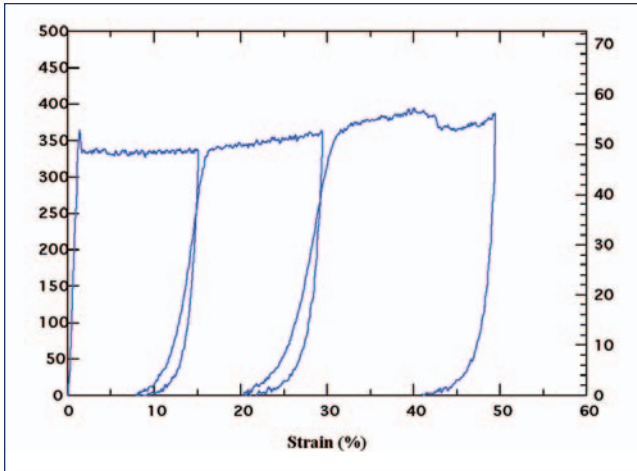
Figure 6. Stress-strain curve for shuttle thermal tile, including unload/reloads.

Upon loading, the initial crush-up point in the curve occurs at 345 kPa (50 psi). After this point, there is a slowly increasing stress as strains increase. A difference between the foam crush-up and the tile crush-up is that the tile breaks apart. Visual observation during the compression test indicated that failure begins when the stress-strain curve begins to dip in the 40% strain region. Fractures form in the tile material and the cube of tile subsequently disintegrates as loading progresses. To model this behavior, the elastic-plastic yield stress was set to 400 kPa (58 psi). The elastic-plastic yield is an important part of the crush-up behavior of the tile (see Figure 8, where the solid curve is without the yield stress while the dot-dash curve is with the yield stress in the formulation). Also, a failure model was invoked, namely that the material would fail at 50% equivalent plastic strain (this failure model was invoked by using constants $D2=0.5$, $D1=D3=D4=D5=0$ in the Johnson-Cook fracture model). The tensile failure stress was set at 360 kPa (52.2 psi). Also important in the computations that included both foam and tile was setting certain parameters in the CTH fracture input: $pvoid=pfrac=-50$ kPa and setting $nface1$ and $nface2$ equal to the material numbers of the foam and tile. Though the tensile behavior is not well modeled (a general problem for Eulerian codes), it is an important part of the model and does affect results. Fortunately, the most interest for these models is when the materials are under compression.

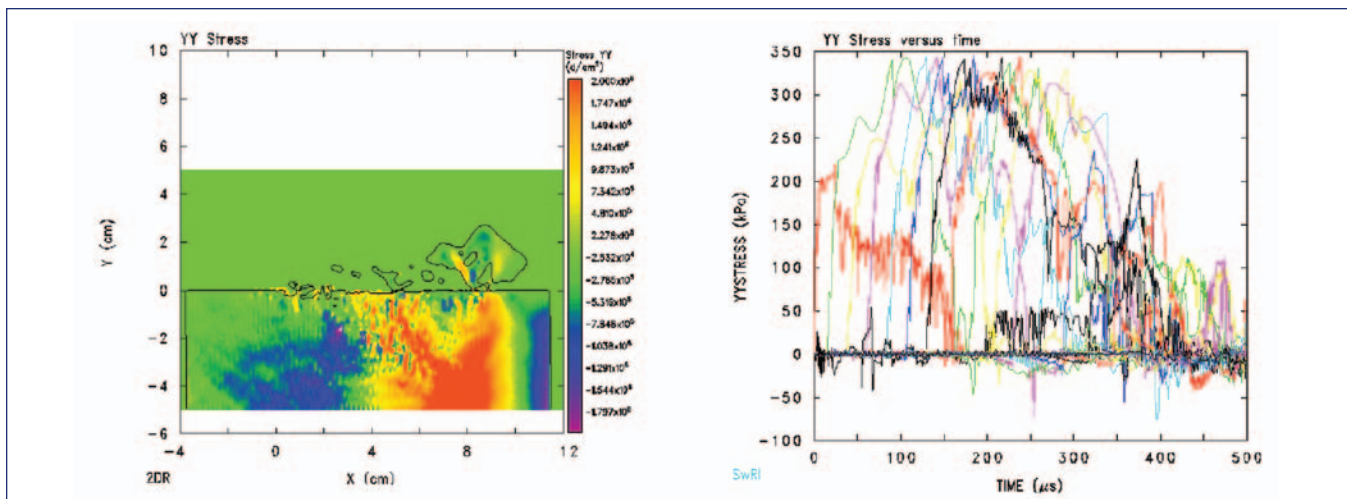
Figure 11. σ_{yy} (left) and normal stress (σ_{yy}) histories (right) for 1" cube of foam insulation impacting thermal tile at 700 ft/s at 15° impact angle; no damage occurs to the tile.

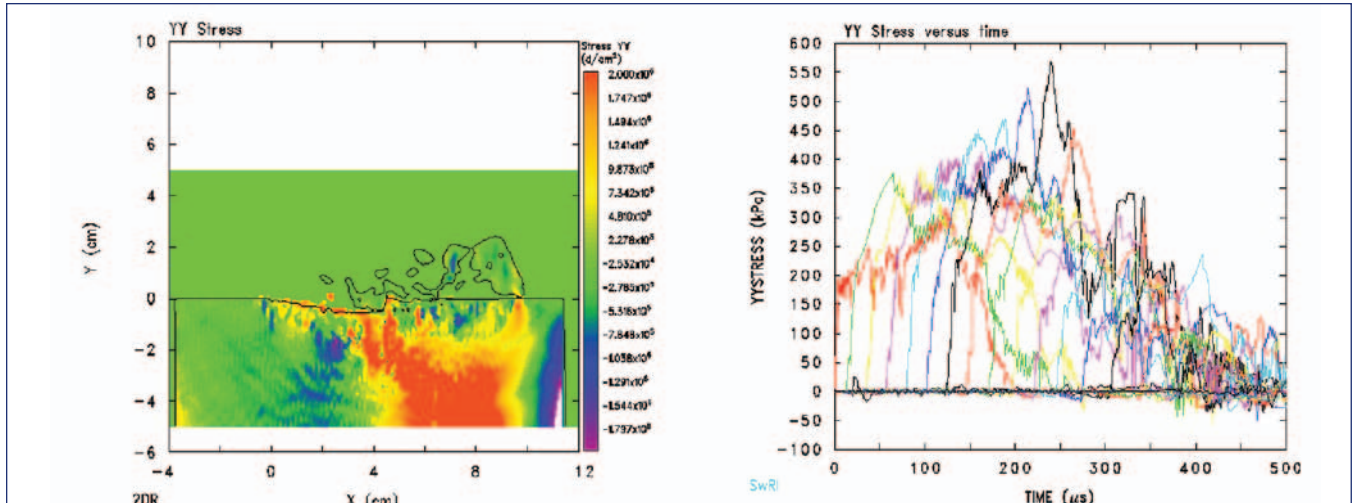
However, for an impact at the same velocity but a larger impact angle, damage does occur. Figure 12 shows the results for 1" cube of foam insulation impacting a thermal tile at 700 ft/s at a 23° impact angle. In this case there is damage: a crater is seen when the surface of the tile is examined and the normal stresses at the interface exceed 345 kPa by a significant amount and for a significant time duration.

Figure 12. σ_{yy} (left) and normal stress (σ_{yy}) histories (right) for 1" cube of foam insulation impacting thermal tile at 700 ft/s at 23° impact angle; damage occurs to the tile.

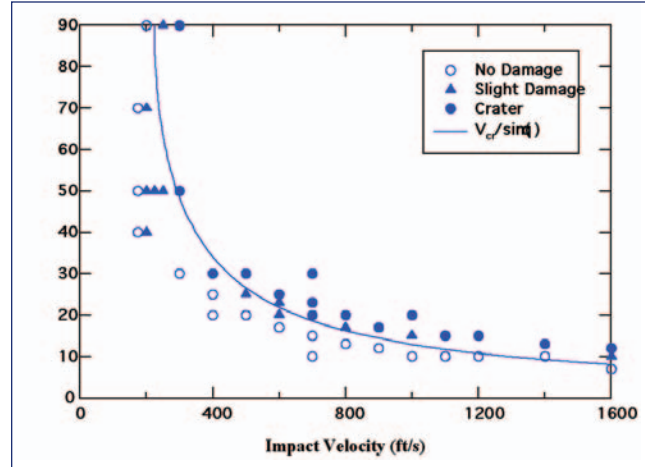
For the value of V_{crush} computed for the foam insulation impact into tile, this damage/no damage transition curve is plotted in Figure 14 along with the results from the computations. It is seen that there is excellent agreement.

Figure 14. Theoretical damage/no damage transition curve with computational results.

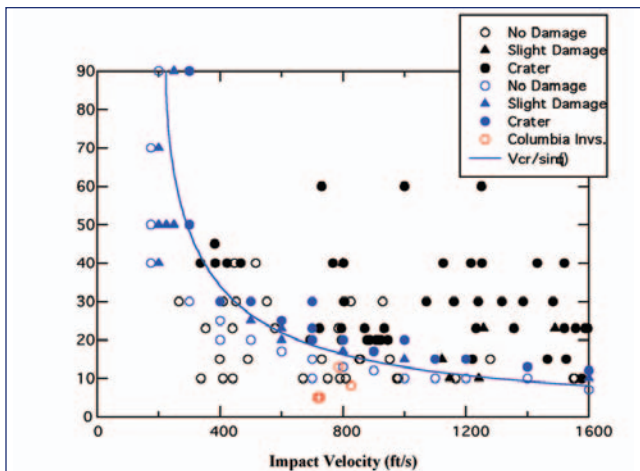
A strong case can be made that the foam insulation impacting thermal tiles is well understood. Good agreement has been shown between the large-scale numerical computations, the theoretical model, and experimental results. Thus, it is clear that loading from the foam arises from the component of the velocity normal to the surface being struck. If the resulting normal stress exceeds the crush-up stress of the tile, then the thermal tile crushes and a crater is formed. Otherwise, there is minimal or no damage to the tile. Figure 16 puts all three (CTH calculations, theoretical curve, experimental results) on one plot.

Figure 16. Theoretical damage/no damage transition curve with results of computations (blue) and all impacts into thermal tiles contained in [1,3] (black) and the Columbia investigation tests (red).

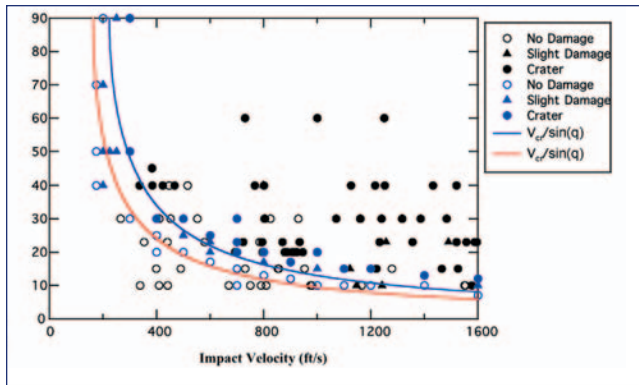
In this vein, two variables were considered. First, the question of what would be the effect of doubling the foam density is addressed. If the foam density is doubled from the value of 2.4 lb/ft³ (0.03844 g/cm³) to 4.8 lb/ft³ (0.07688 g/cm³), Eq. (8) gives that the new crush-up velocity is $V_{crush} = 49.7$ m/s (163 ft/s), or a reduction of 27%. When plotted on the previous graph, the result of such an increase in density is clear: it reduces the allowable angle for a given speed by about 25% for speeds above 400 ft/s (Figure 17).

Figure 17. Effect of doubling the foam insulation density on the damage/no damage transition curve (red).

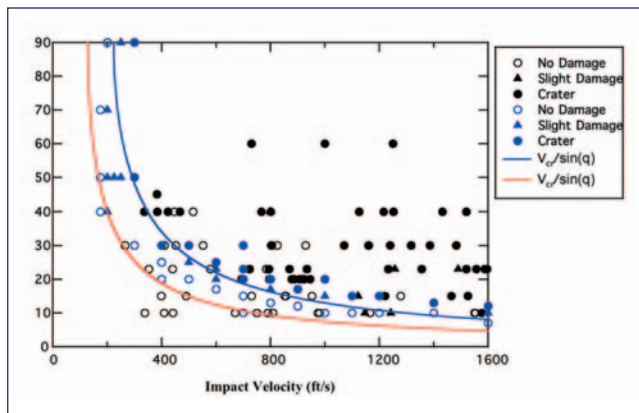
In a similar fashion, the question of what would occur if the thermal tile crush-up strength was reduced by 20%, from 345 kPa (50 psi) to 275 kPa (40 psi), was considered. Such a reduction has a much more severe effect on the damage/no damage transition curve: $V_{crush} = 39.2$ m/s (129 ft/s), and the allowable angle is reduced about 40% for a given impact ve-

locity for velocities above 400 ft/s. Thus, tile failure is more sensitive to tile crush-up strength than relatively large variations in foam density. The condition of the tile is therefore of more concern than variations in foam properties.

Figure 18. Effect of reducing tile strength 20% (red).

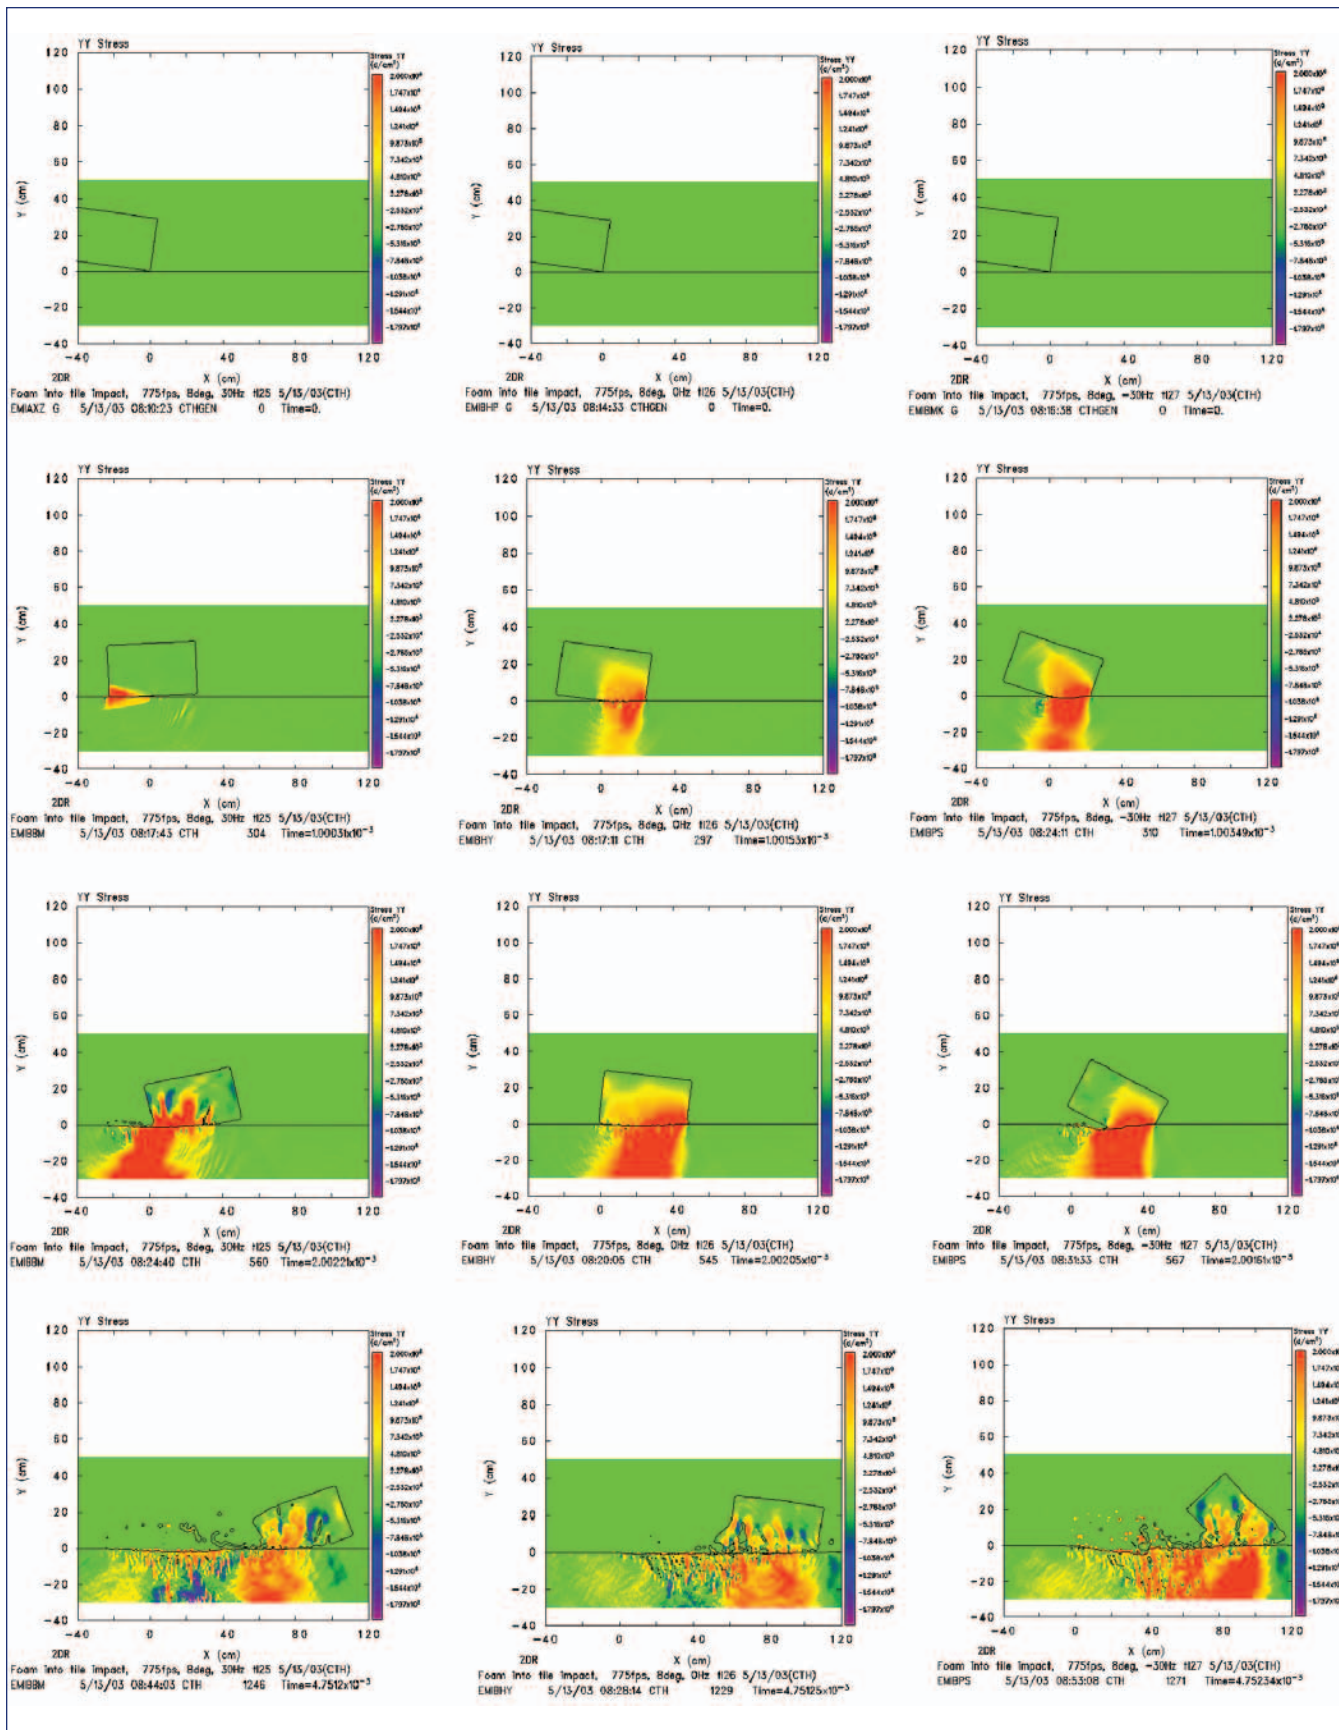
Computations were performed for the above impact geometry for a counterclockwise rotation, no rotation, and a clockwise rotation. Lacking a full model for a tiled surface, a single "large" tile was used to represent the thermal tile. Figure 19 shows the results of the CTH computations for the three cases. The figure shows the σ_{yy} stress. The images in the left column are for the impactor rotating counterclockwise, the center column is the non-rotating case, and the right column is the clockwise rotation. As time progresses (0, 1, 2 and 5 ms) it can be seen that the counterclockwise rotation prevents an impact on the front end of the impactor, and rather for this case the back end impacts first. For the counterclockwise case, little damage is done to the tile. As predicted, there is no crater formed for the non-rotating case. For the clockwise rotation case, however, the leading edge impacts with a normal velocity above the crush-up velocity and a crater is formed in the tile. Thus, for the clockwise case, rotation leads to damage of the thermal tile. Figure 20 shows the normal stresses at the tracer locations for the three cases; these normal stresses confirm the damage seen from the previous figure, namely that the stresses are below the 345 kPa (50 psi) tile crush stress for the counterclockwise and non-rotating cases and are well above the tile crush stress for the clockwise rotation case.

Figure 19. Comparison of rotation cases for 775 ft/s impact at 8° angle, 30 Hz counterclockwise in left column, no rotation in center column, 30 Hz clockwise rotation in right column. Times are 0, 1, 2 and 5 ms.

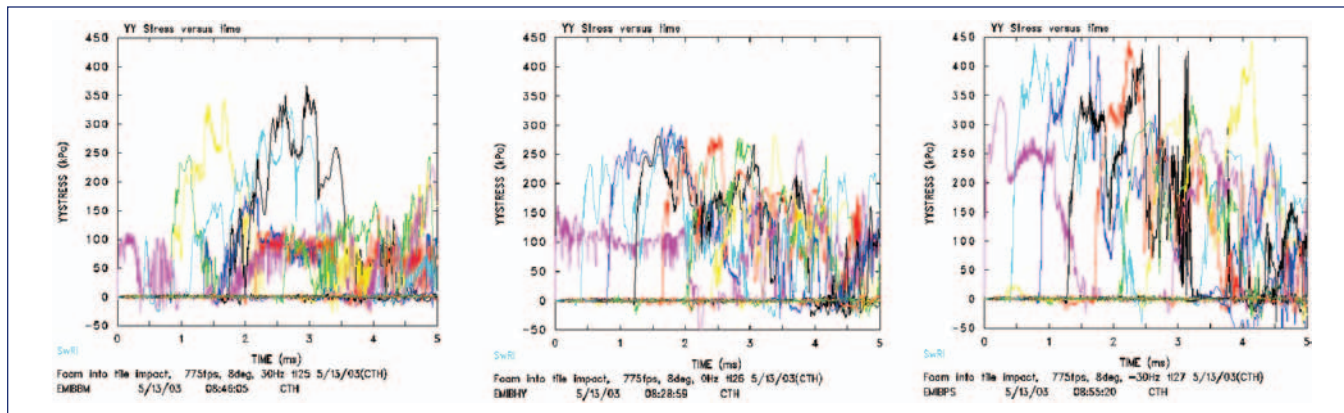
Figure 20. Normal stresses from rotation case comparison, left is 30 Hz counterclockwise, center is no rotation, right is 30 Hz clockwise. For the clockwise case, the stresses clearly exceed the 345 kPa (50 psi) crush-up stress of the tile, and damage is expected.

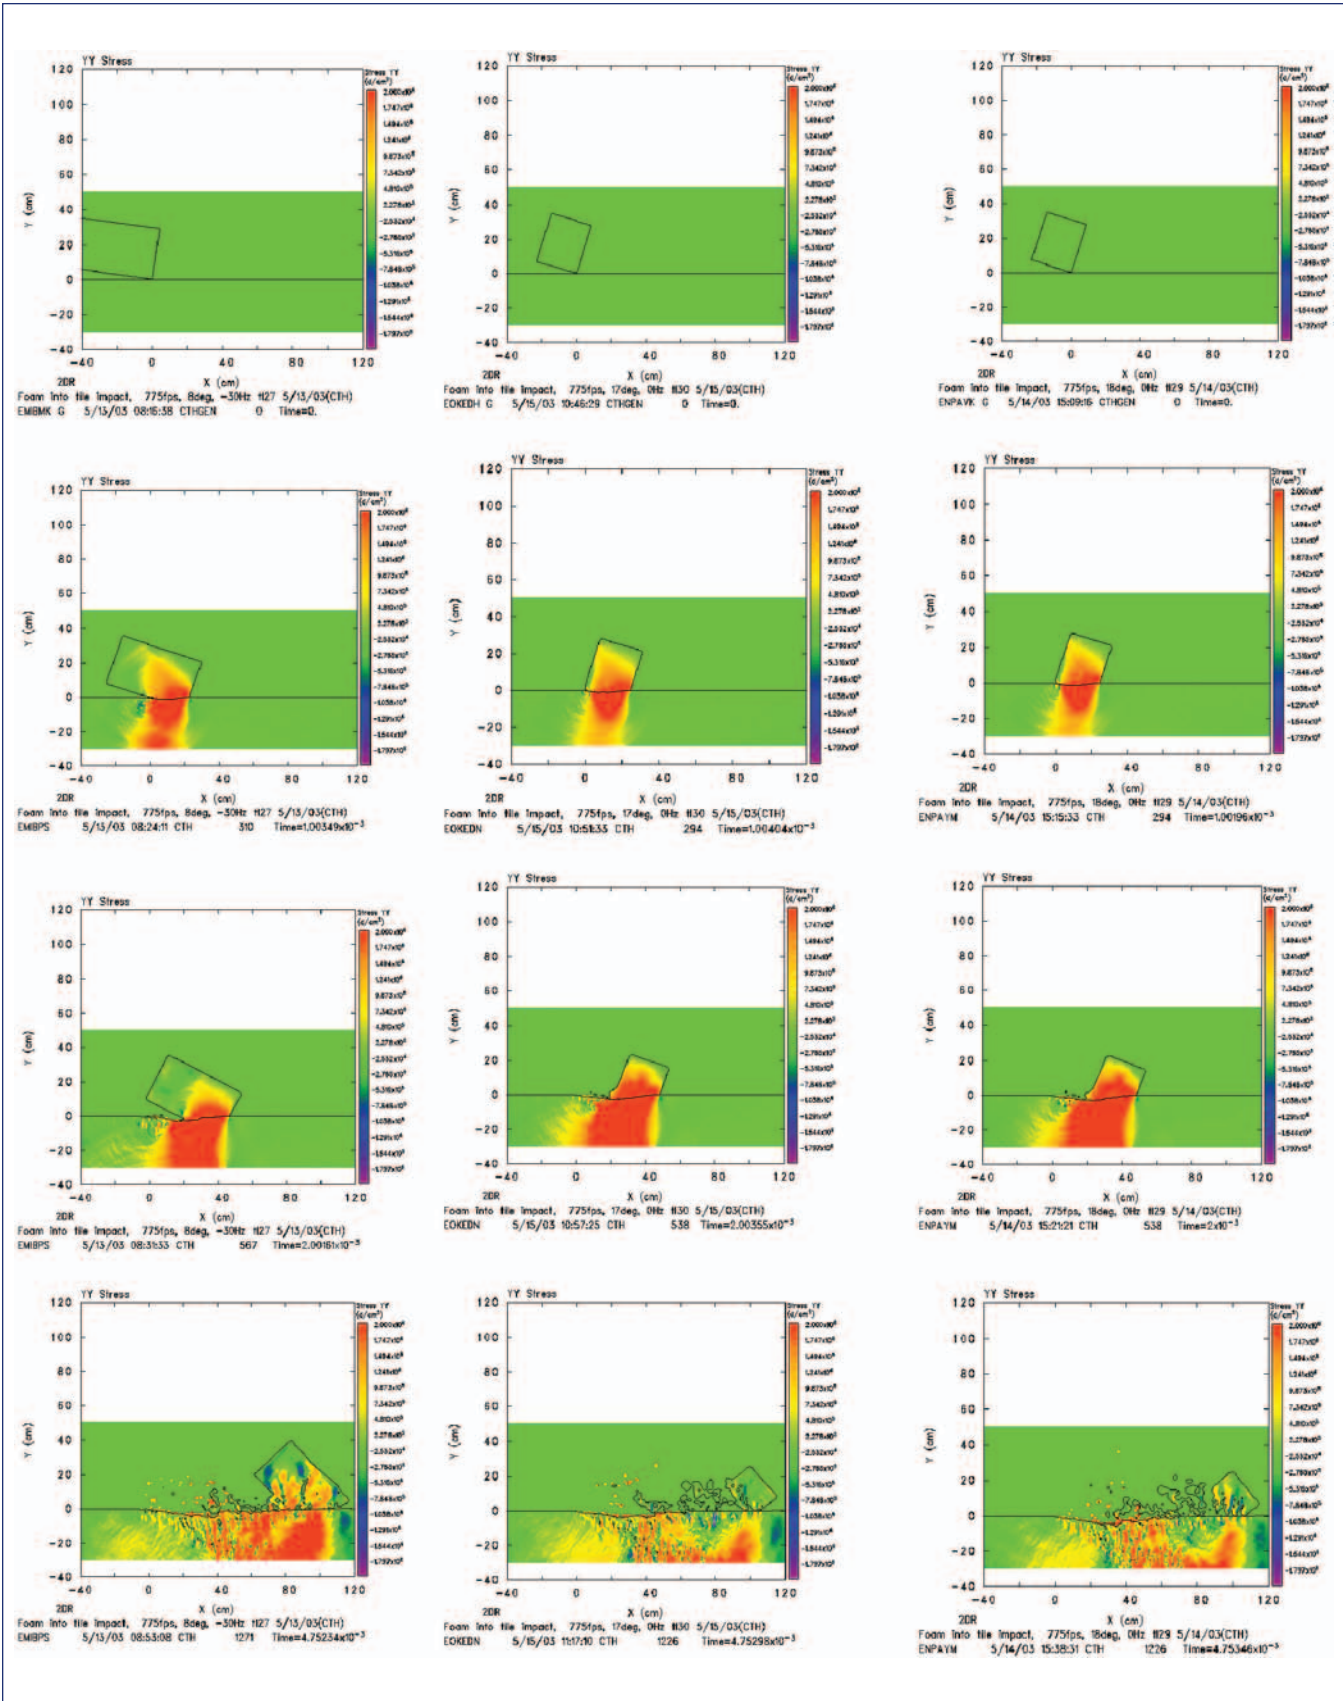
shows the σ_{yy} stress from three impact cases: 8° with 30 Hz clockwise rotation with the original sized impactor (left column), and 17° (center column) and 18° (right column) non-rotating impactors of half the length, or dimensions of 9.5” × 11.5” × 5.5” (though again the last dimension doesn’t enter in as the computation is 2D plane strain). It can be seen that all three impacts are producing similar stresses and craters in the tile. Figure 22 shows the normal stresses at the tracer locations. The tracers for the three cases are similar. Thus, to replicate the influence of 30 Hz clockwise rotation rate of the 8°-impact-angle impact one would use a non-rotating half-length projectile at a considerably higher impact angle of 17° or 18°. This equivalent impactor is determined based on how the tile crushes up and, in particular, that damage depends on the load delivered at the surface.

Figure 21. Nonrotating impactor to produce similar damage as 30 Hz clockwise rotating impactor. 30 Hz clockwise rotating impactor at 8° angle in left column, 17° degree nonrotating impactor in center column and 18° nonrotating impactor in right column. All impacts at 775 ft/s. Figures show σ_{yy} stress. Times are 0, 1, 2 and 5 ms.

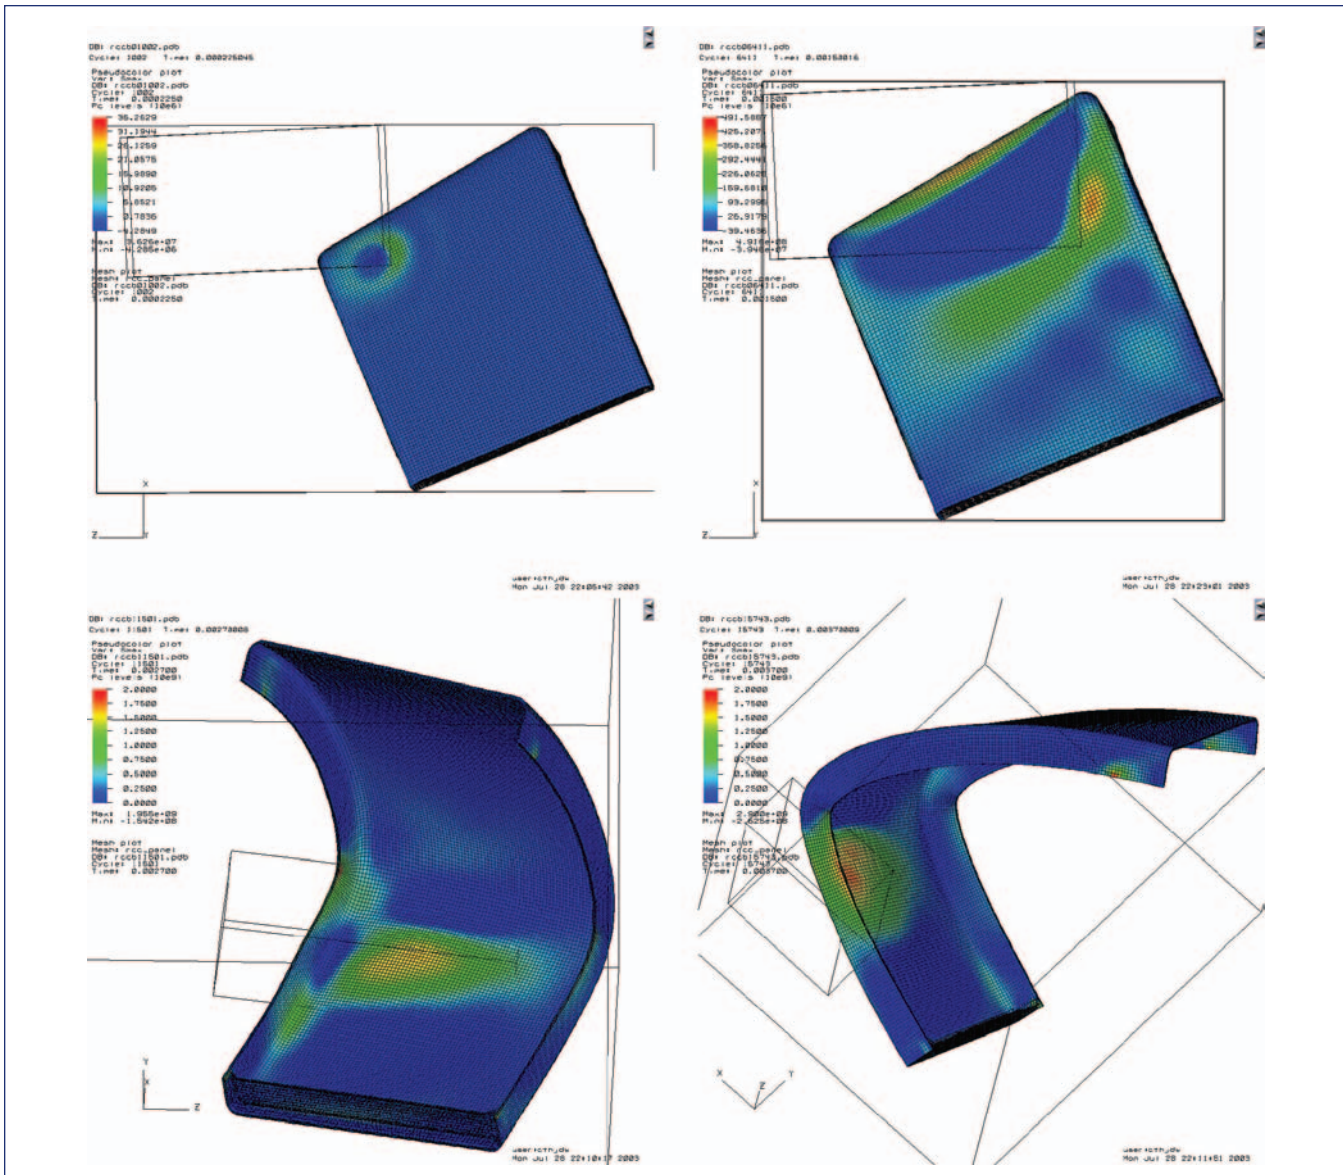
Figure 25. Four frames of the RCC Panel #6 test condition calculation ($\alpha=5.5^\circ$, $\beta=2.5^\circ$, 768 ft/s), at 0.225, 1.5, 2.7 and 3.7 ms. The 2.7 ms frame is where the peak rib stress is achieved near the greatest curvature of the rib; the 3.7 ms frame is where the outward flexing of the rib achieves the greatest stress.

In the test, the downwind rib broke, approximately 50 cm from the carrier panel. The crack ran, turning the corner slightly so that a small crack could be seen on the panel face.

The interpretation now focuses on the time in this loading history that the rib broke. It is likely that it happened later in the loading process, perhaps at 3.7 ms, since the crack does not propagate very far in the face of the panel. The lack of crack propagation in the face of the panel implies that the load to the panel was decreasing when the fracture occurred. This reasoning implies that the rib fails at a maximum principal stress in the vicinity of 29 ksi (200 MPa), perhaps after some loading time (some damage theories hold that a tensile stress state must exceed a given value for a given length of time before failure occurs). This reasoning also implies that the panel face can support a 27 ksi (185 MPa) maximum principal stress.

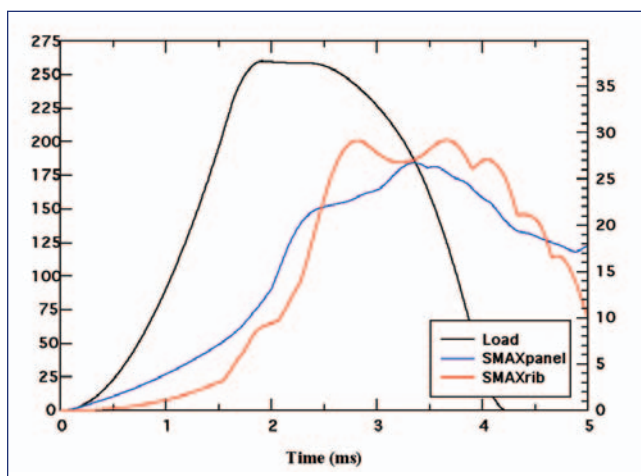
Figure 26 shows the maximum principal stress seen in both the panel and the rib as a function of time as well as the load as a function of time. The left hand scale is in metric units for both the load and stresses. The right hand scale is in English units and applies to the stresses. The undulating behavior seen in the maximum principal stress curves is due to the fact that these curves are the maximum of many curves, one for each computational cell. Thus, as one maximum principal stress curve decreases, another increases and overtakes the original maximum principal stress cell, thus becoming the maximum principle stress cell itself. It can be seen that both the maximum principal stress in the rib and in the panel face are still increasing when the load decreases, thus showing that inertia plays an important role in the impact event. Finally, Figure 27 shows the maximum displacement and the maximum velocity seen on the panel during the impact event. Table 8 summarizes the historical maximums.

Figure 26. Load and maximum principal stress for panel face and rib vs. time for RCC Panel #6 test condition computation ($\alpha=5.5^\circ$, $\beta=2.5^\circ$, 768 ft/s).

If one reasons that a higher failure stress is expected in the panel (since there are no boundaries) than in the rib (since the rib has an edge where presumably there are many fracture initiation sites), then no rigorous information can be obtained from Figure 26. (If it were assumed that the maximum failure stress is the same in the panel face and the rib, then it could be concluded that the minimum maximum principal stress the RCC material can support is 21.9 ksi (151 MPa), the value of the maximum principal stress when the two curves of Figure 26 cross at 2.47 ms). However, we know that at some time the rib broke, and that this point was after some load had accrued. Looking at the curves, at early time the maximum principal stress in the panel is significantly above the maximum principal stress in the rib. Thus, it is likely that the failure occurred at a later time, probably in the vicinity of the larger stress observed, 2.7-3.7 ms. The mechanics of the larger stresses are as follows. As the foam impact loads the panels, a large tensile stress is created near the largest curvature of the outer edge of the rib (see Figure 25 at 2.7 ms). The location of this large maximum principal stress is approximately 55 cm from the carrier panel. The maximum principal stress in the rib is at

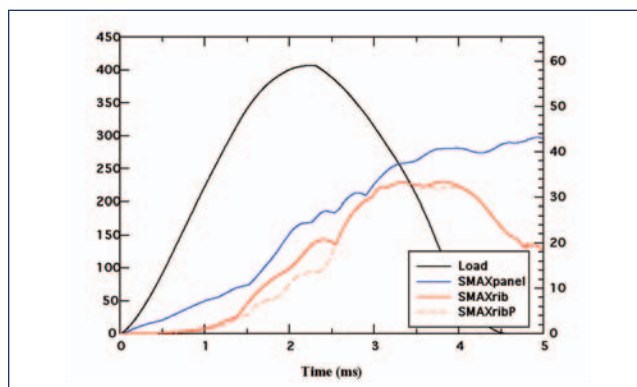
In the test, the panel face failed, and a large hole was produced. An additional conclusion from the test is that it is likely the failure occurred at 2.7 ms or later due to the fact that half the foam impactor survived the impact. In the fiberglass tests and the RCC Panel #6 test, the foam impactor completely disintegrated, apparently due to the foam catching on the 6-7 T-seal. In the RCC Panel #8 test, the foam impactor is lifting off the panel (ricocheting due to the arrival of rarefaction waves) just before the 8-9 T-seal, but when the panel breaks the foam catches on the hole edge that is formed. Thus, examining the time sequence of impact from the computation, it is conjectured that the failure probably occurred (assuming it started near the 8-9 T-seal or near the downwind rib) around 2.7 ms.

Figure 28 shows the maximum principal stress in the panel interior versus time, as well as the maximum stress observed in the thick portion of the rib (the dotted portion of the maximum principal stress for the rib includes only the thicker part of the rib). In this test, the thick portion of the rib did not fail, whereas the panel face did. At 2.7 ms, the maximum principal stress in the panel face was 30.0 ksi (207 MPa) and in the panel rib was 25.4 ksi (175 MPa). Based on the results of the RCC Panel #6 test, these seem to be reasonable stresses for the failure. Once a crack forms, it runs quickly leading

Figure 28. Load and maximum principal stress for panel face and rib vs. time for RCC Panel #8 test condition computation ($\alpha=5.5^\circ$, $\beta=5.0^\circ$, 777 ft/s).

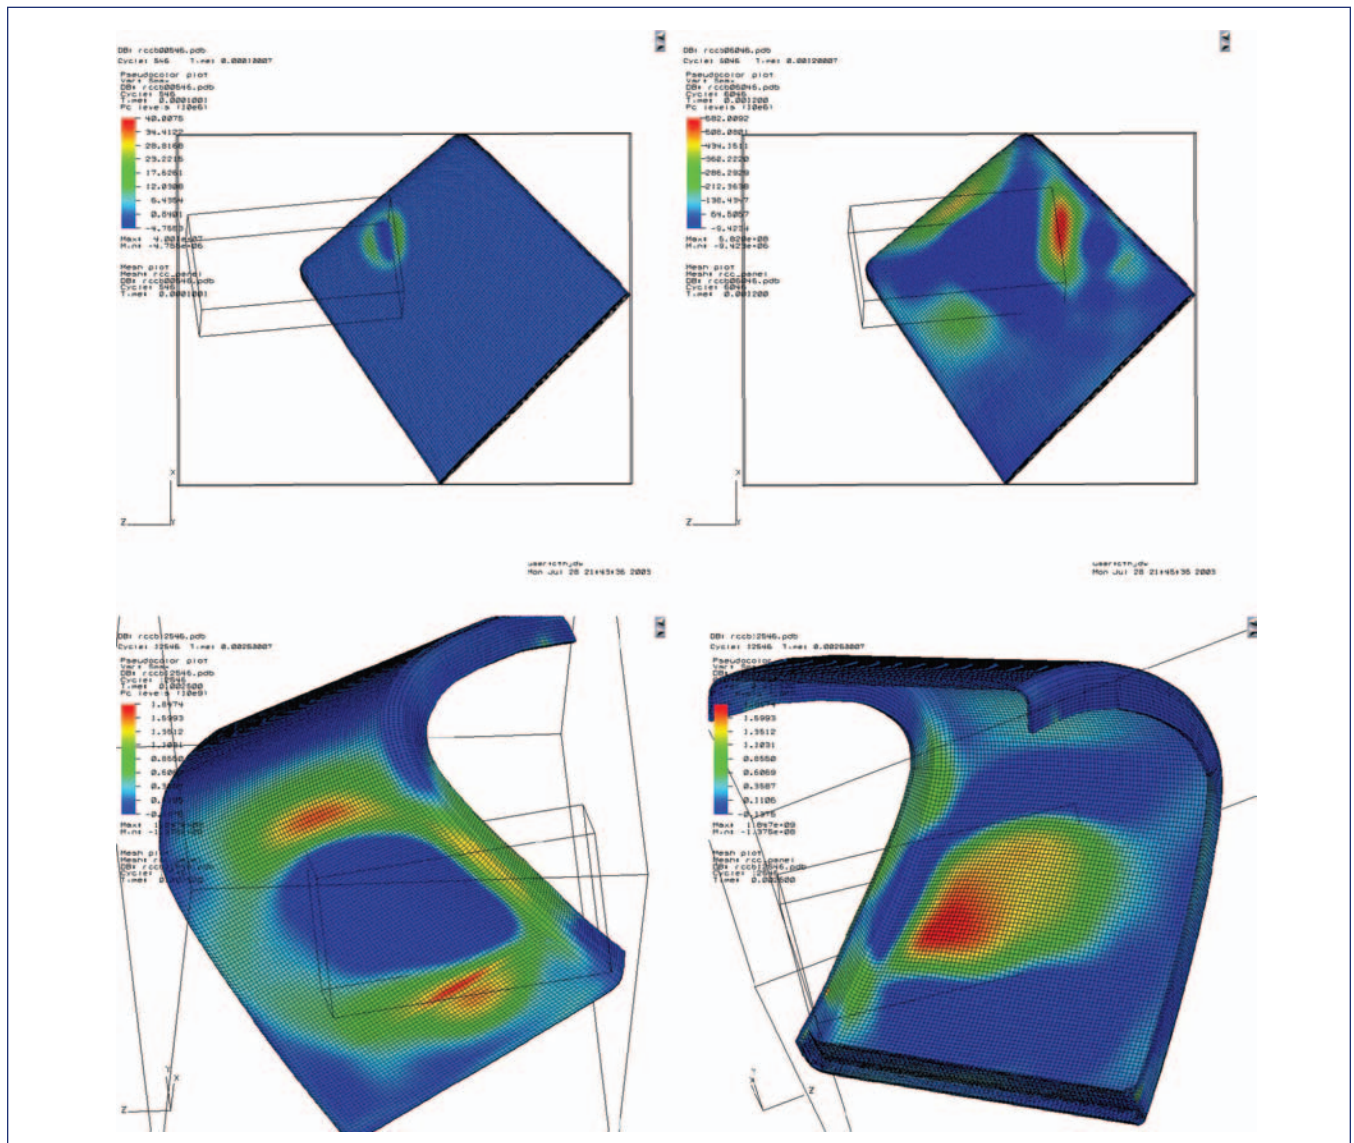
Figure 30. Four frames of the RCC Panel #8 test condition calculation ($\alpha=5.5^\circ$, $\beta=5.0^\circ$, 777 ft/s), at 0.1, 1.2, 2.5 (front face) and 2.5 (back face) ms (the last two frames are probably near the failure time of the panel).

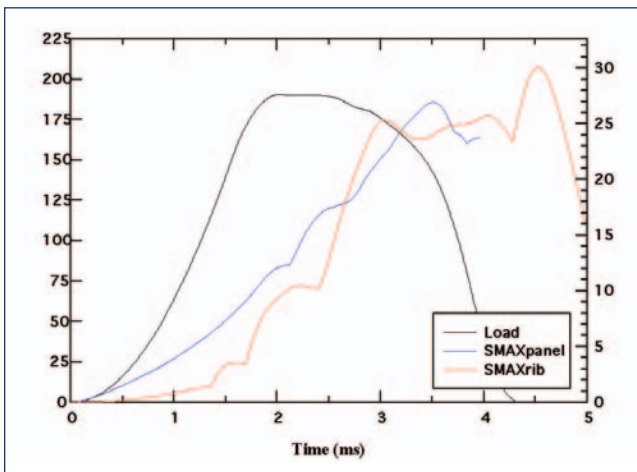
Figure 34. Load and maximum principal stress for panel face and rib vs. time for RCC Panel #6 hit location study maximum stress case ($\alpha=0^\circ$, $\beta=0^\circ$, 768 ft/s, 0.83" from 5-6 T-seal, 12.7" from carrier panel).

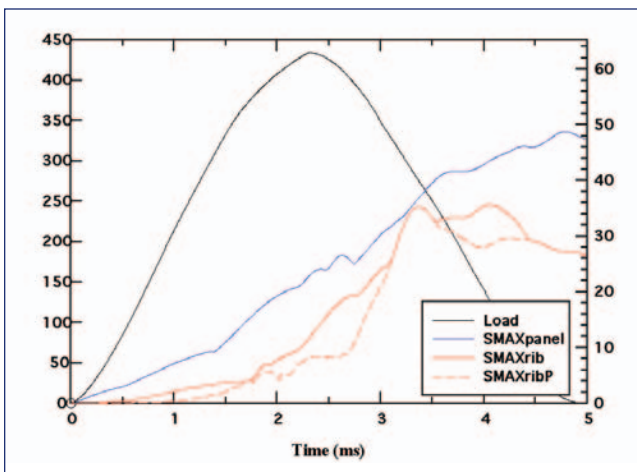
Similarly, two impact conditions for RCC Panel #8 were considered, referred to as "Option #3" and "Option #2" during the RCC Panel #8 test design. "Option #3" was chosen for the actual test that was performed. "Option #2" is essentially a 3" shift towards the 7-8 T-seal. Based on the results outlined above for Panel #6 it is expected that "Option #2" would have higher loads due to the larger loading footprint and larger stresses. Table 10 shows the results: as expected, shifting upwind does increase the load on the panel as well as the maximum principal stresses seen in the panel face and in the rib. Thus, the impact point chosen ("Option #3) was less severe than Option #2. In both cases fracture of the panel face would be expected. Figures 36-37 show the various results from the "Option #2" RCC Panel #8 calculation. Based on the stress histories, the panel face would be expected to fail.

Figure 36. Load and maximum principal stress for panel face and rib vs. time for RCC Panel #8 "Option #2" ($\alpha=5.5^\circ$, $\beta=5.0^\circ$, 777 ft/s).

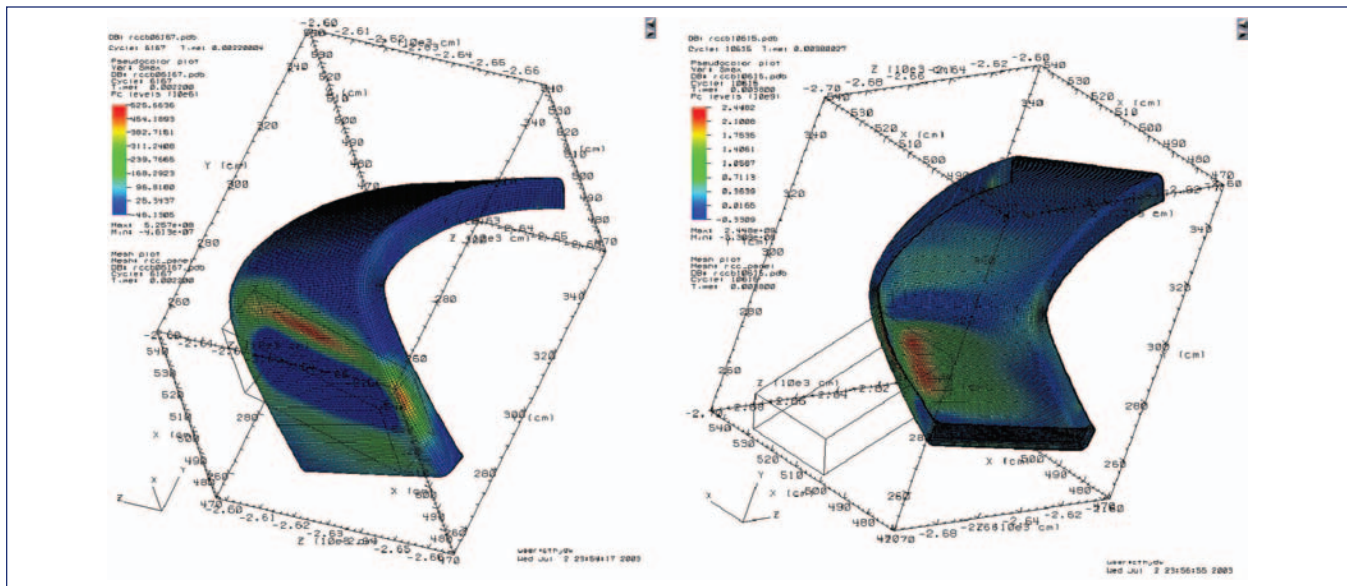
What would be the result of combining the lower impact location with the foam impactor rotation that led to the highest stresses (clockwise about the x-axis)? When these two states were combined, the resulting impact produced even larger loads and stresses as is seen in Table 12 (all save the lower right hand corner have appeared in previous tables). The increase in load over the baseline is 39% and the increase in the stress in the panel face is 36% and in the rib is 61%. Figure 42 shows two stills from the computation, and Figs. 43 and 44 show the various histories. Based on the stress history, it is expected that the panel face would fail.

Figure 42. 18 Hz clockwise rotation about x-axis with lower impact point, maximum principal stress at 2.2 (left) and 3.8 (right) ms.

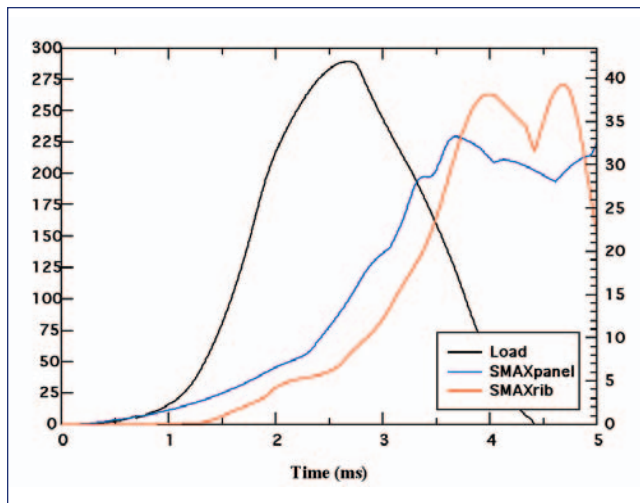
Figure 43. Load and maximum principal stress for panel face and rib vs. time for RCC Panel #6 lower impact point with clockwise rotation about x-axis case ($\alpha=0^\circ$, $\beta=0^\circ$, 768 ft/s, 18 Hz).

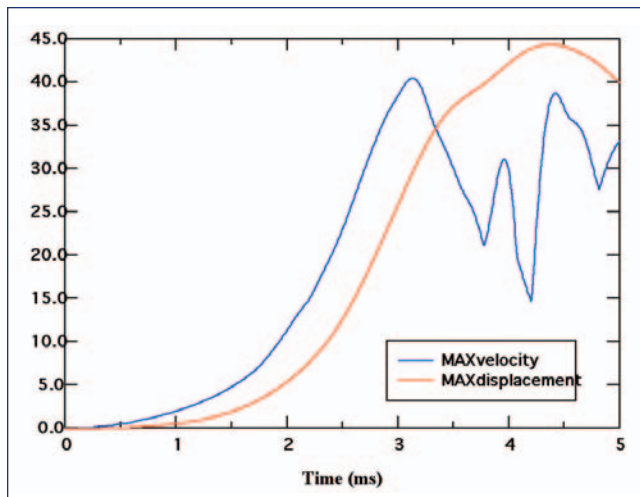
Figure 44. Maximum velocity and displacement vs. time for RCC Panel #6 lower impact point with clockwise rotation about x-axis case ($\alpha=0^\circ$, $\beta=0^\circ$, 768 ft/s, 18 Hz).

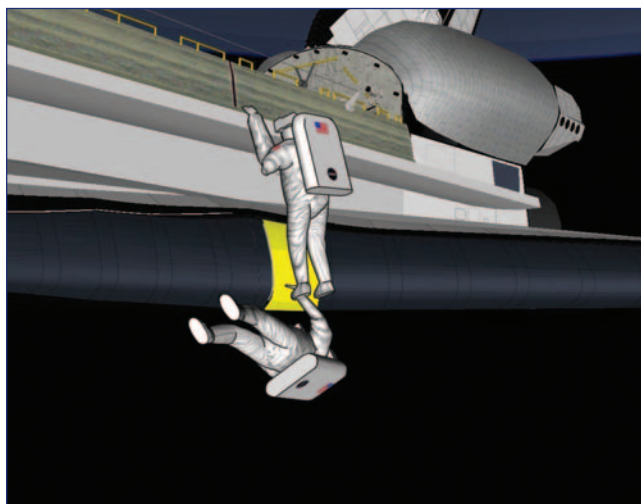
Two experienced EVA astronauts and two EVA flight controllers assessed this task in the Johnson Space Center virtual reality lab. The level of difficulty of the EVA inspection procedure is moderate. The risk of injury to crew is low and of further damage to the site is low to moderate. The expectation of mission success (providing conclusive information regarding damage severity) is judged to be high.

Figure 5. EV-1 position between payload bay door and wing leading edge.

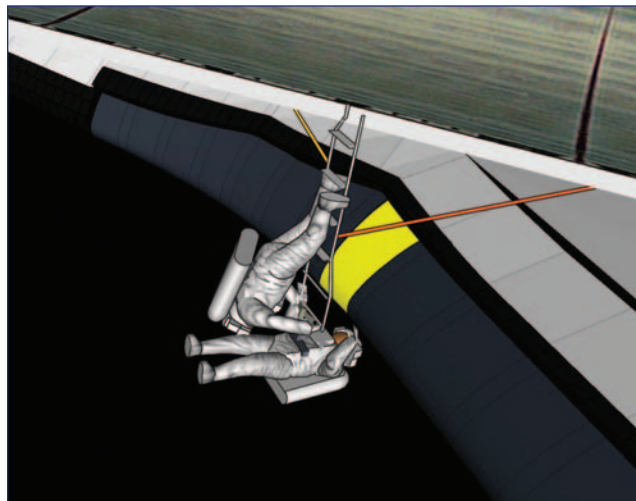
The assessment of the level of difficulty of the repair operation is high. The level of risk to the crew is moderate and the risk of doing additional damage to the Orbiter is high (i.e. enlarging the wing leading edge breach). The overall assessment of the expectation of task success is moderate to low, depending on damage site characteristics and the required repair technique.

Figure 11. Repair EVA.
