COLUMBIA

ACCIDENT INVESTIGATION BOARD

REPORT VOLUME II
OCTOBER 2003

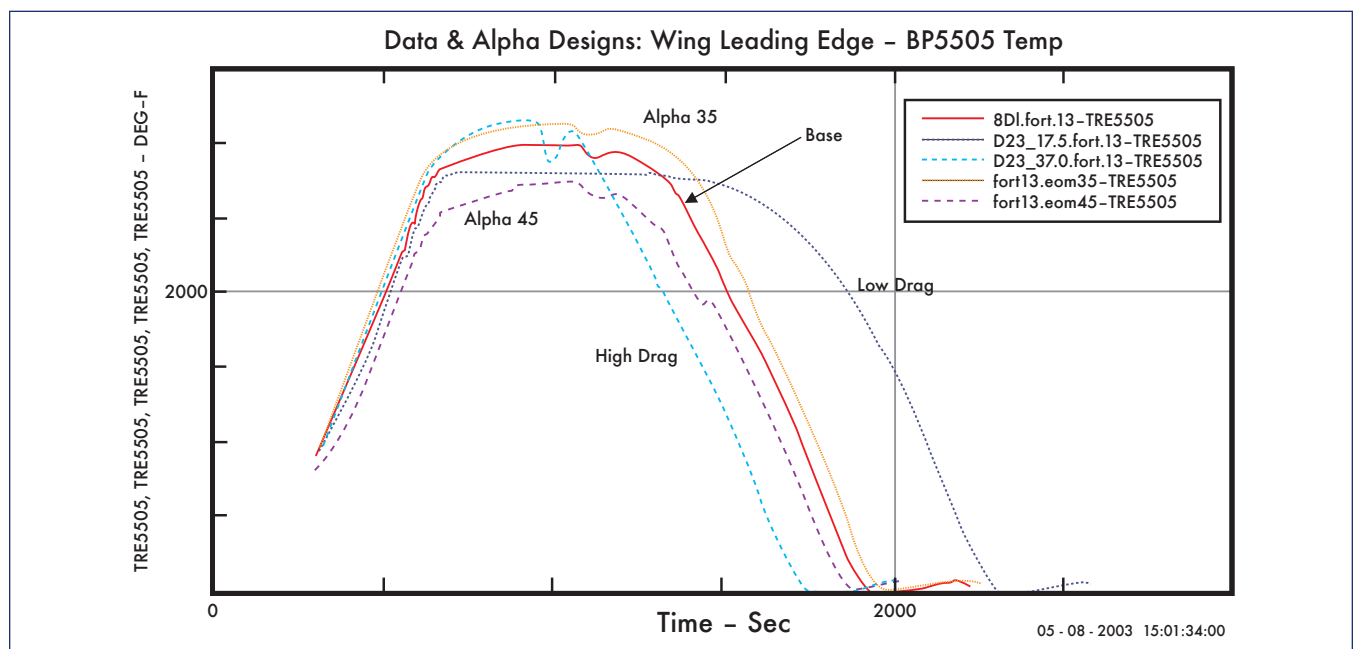
Figure 12. Relative Wing Leading Edge Temperature (No Boundary layer trip).

which assumed a flat plate of metal behind a flat plate of ice, behind a layer of AFRSI. The results while inconclusive, do not indicate this option was likely to succeed. However, the team believes it is sufficient to say that this would have been the best option to try, given the limited time and materials.

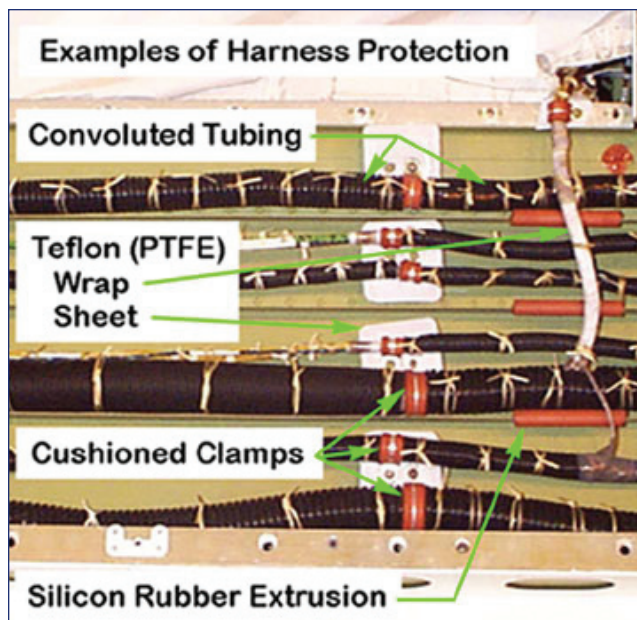
Wiring nonconformances can be corrected several ways: re-routing, reclamping, or installation of additional insulation (convoluted tubing, insulating tape, insulating sheets, heat shrink sleeving, abrasion pads, and so forth). (See Figure 1.1.2) Additionally, testing of Orbiter wiring under normal operating loads has shown arc tracking in bundles usually stops due to wire separation (as opposed to circuit protection devices tripping). Further testing under conditions approximating the Shuttle wiring environment also showed that, after separation, arc tracking did not progress beyond six inches. Based on these results, Boeing recommended NASA separate all critical paths from larger wire bundles and individually protect them. This protection should extend a minimum of six inches beyond the confluence of critical paths.³ This is being implemented during OMMs.

Figure 1.1.2. Examples of Harness Protection.

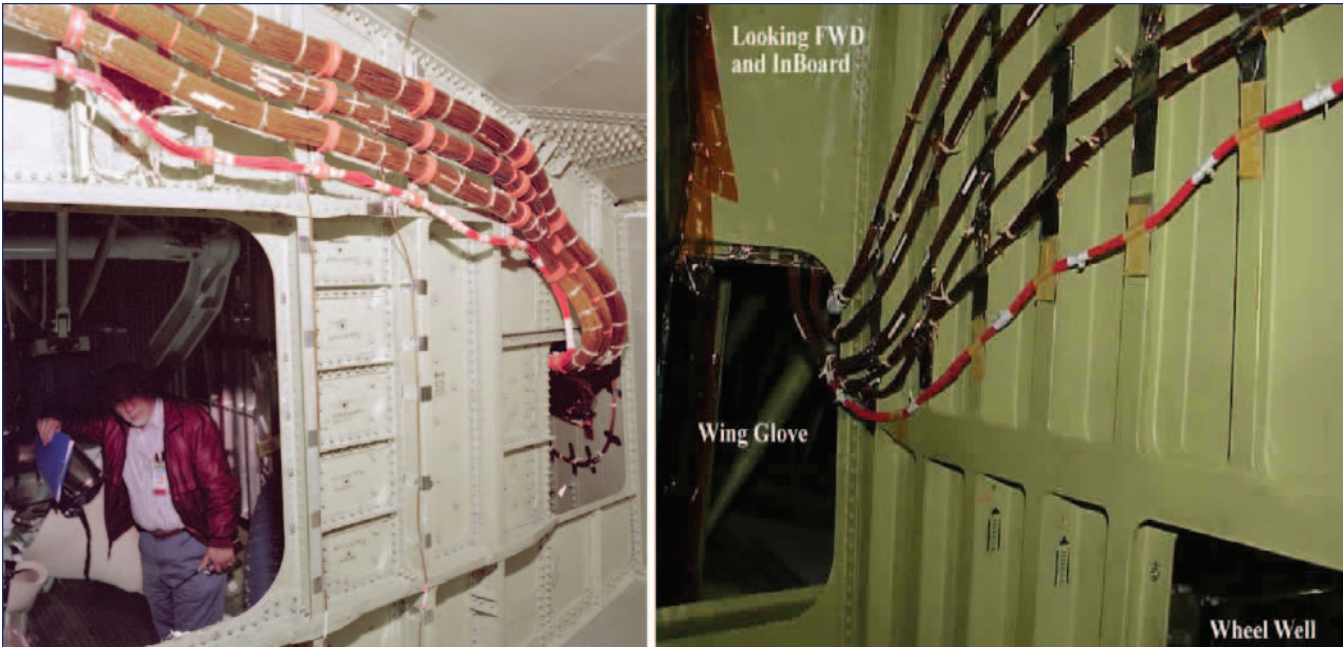
There were wiring variations between the first Orbiter (OV-102) and subsequent vehicles. The wiring routed through the wing cavities outboard of the main landing gear wheel well wall of OV-102 were gathered in four bundles, while the wiring in other Orbiters was secured in seven bundles. (See Figure 1.1.3) This variation resulted from design changes to the wire bundle securing method. Clamps were used on OV-102, and metalized tape (MBO 135-050) straps were used on the remaining vehicles. Although effective, metalized tape is incapable of securing a bundle containing a large quantity of wires as configured in OV-102, hence the increased number of smaller bundles in subsequent Orbiters. Nearly 90 percent of wires routed through OV-102’s left wing forward of the main landing gear belonged either to systems gathering thermal, strain load, acoustic and other data for the Orbiter Experiment (OEX) instrumentation package (similar to the Modular Auxiliary Data System – MADS – on other Orbiters) or to disconnected systems. OEX data was recorded on magnetic tape that was downloaded after landing and not relayed via telemetry. The typical wire harness routing passes within 8-10 inches of the forward wing spar at the forward corner pass-through, immediately aft of the Reinforced Carbon-Carbon (RCC) panel 6. All temperature sensors in the main landing gear well were located within a four-foot radius with the main landing gear retracted. Fifty percent of all electrical drawings for the Orbiter fleet were unique to OV-102, due to first-production unit anomalies/changes, and additional wiring for the Developmental Flight Instrumentation (DFI, later OEX).

Figure 1.1.3. Wire Bundle Comparison.

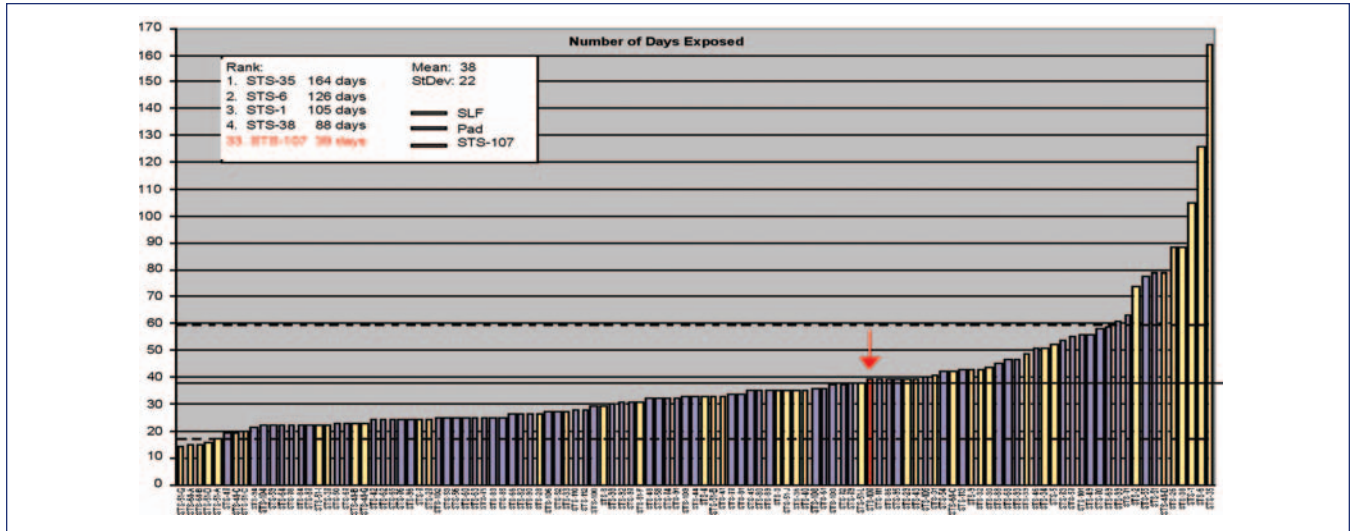
The 164-day exposure for STS-35 occurred over eight months and four launch attempts, from April to December 1990, and illustrates the complexities associated with launching Shuttles. OV-102's initial rollout was on April 22; a Freon system repair added 14 days, but the launch was scrubbed on May 30 due to a Main Propulsion System (MPS) liquid hydrogen (LH2) leak. After troubleshooting and maintenance preparations, OV-102 was rolled back to the VAB on June 12. It was rolled out a second time on August 9, but required a 6-day stand down for telemetry repair. Its September 1 launch was scrubbed on 5 September due to another hydrogen leak. Following maintenance at the pad, the next launch attempt was scrubbed on September 18, due to another MPS LH2 leak. After further troubleshooting and maintenance preps, it was rolled back on October 9. Rollout next occurred on October 14, followed by special LH2 tanking tests for two additional days; however, Auxiliary Power Unit water valve problems and follow-on maintenance and servicing took another 16 days. OV-102 finally launched successfully on December 2. It should be noted that STS-35 is an outlier when compared with all other Shuttle launches. Figure 1.3.2 shows a comparison of exposure time by mission.

Figure 1.3.2. Exposure by Mission: red arrow depicts STS-107, STS-35 is at far right.

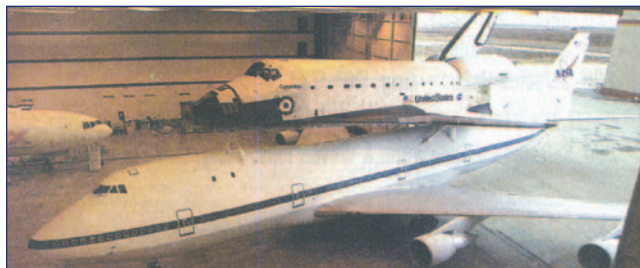
Figure 1.3.4. An Orbiter and SCA partially inside a hangar in Palmdale.

vertical clearance limits, the tails of both craft remained exposed (See Figure 1.3.4). After arrival at KSC, 112 pounds/14 gallons of water were removed. The same February 2001 rainstorm at Palmdale also affected OV-104, which had recently landed (February 20/STS-98) and was being prepared for its ferry flight to KSC. OV-104’s “aft fuselage under bay 6 [was] full of standing water” and water was “five inches deep along [the] back of 1307 bulkhead;” 1,600 pounds (200 gallons) were removed after its arrival at KSC.

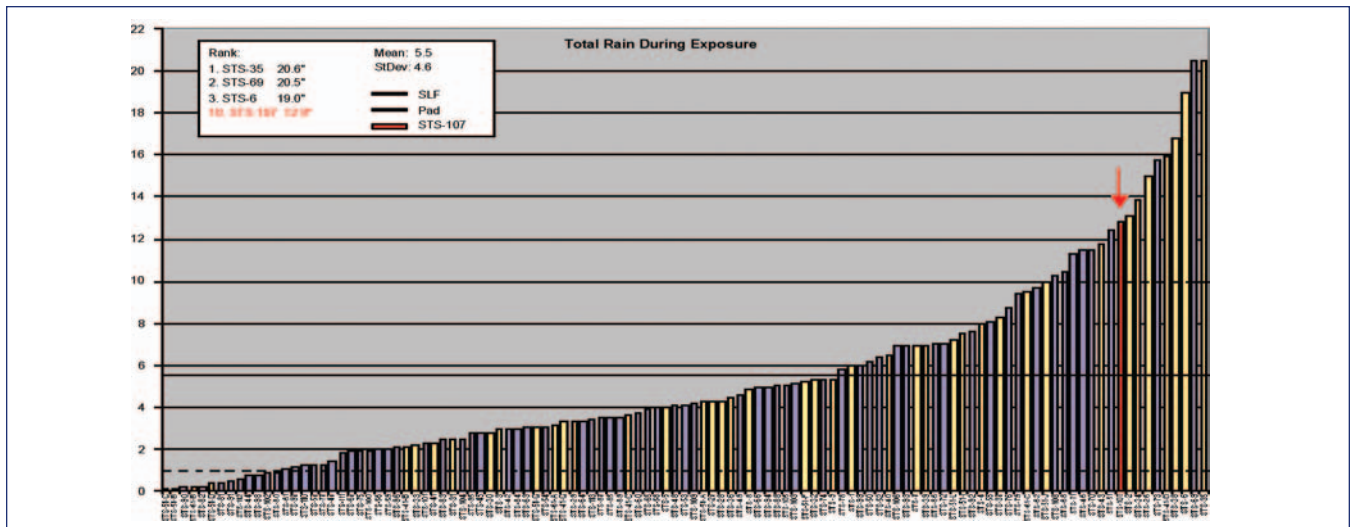
Environmental exposure constraints are clearly outlined in RTOMI S0018.100, Adverse Environmental and Lightning Monitoring at LC39. This publication includes guidance on actions to minimize exposure to rain, hail, winds, freezing temperatures, or tornados. In spite of this existing guidance, circumstances such as those related above, both on the launch pad and during ferry operations, contribute to more exposure than is desirable. Figure 1.3.5 shows rain exposure data by launch, with STS-35 again being the worst case.

Figure 1.3.5. Total rain exposure by launch (arrow denotes STS-107; STS-35 at far right).

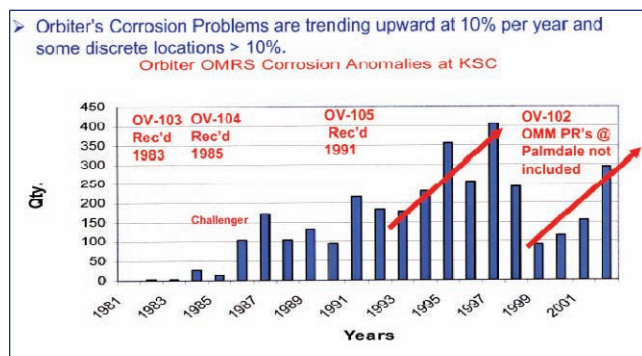
Figure 1.3.6. Increasing orbiter corrosion trends.

The environment at KSC is about as challenging, from a corrosion perspective, as exists. The necessity to control exposure is reflected in the amount of work needed to keep the Orbiters in a mission-ready condition. Corrosion, in general, is trending upward for the Orbiter fleet by 10 percent annually, and there is a marked increase in corrosion in areas such as the body flap cove (one of the lowest points when the Orbiter is in a vertical orientation). Figures 1.3.6 and 1.3.7 show these corrosion increases, one classic symptom of aging aircraft.

While corrosion is symptomatic of normal aging, in the Orbiter's case, its location at the aft (lowest point in its launch configuration) shows the effect of launch pad exposure. The body flap cove and surrounding area, as well as associated hardware, are showing significant growth in man-hour consumption to grind out corrosion pits. Components, such as the body flap actuator, illustrate the increasing challenge posed by corrosion and the impact on logistics and spare parts availability. Over the last several years, body flap actuators have been removed for corrosion. During repair, internal corrosion has also been discovered, with some piece parts being beyond repair. Manufacturing new piece parts entails extensive lead times, in some cases years. Status of body flap actuators at the end of April 2003 was seven in inventory, with four installed; two had been removed and were in the repair cycle, along with the only spare; the first serviceable spare was projected to be available in June 2003.

Corrosion is a problem in both military and commercial aviation. Due to the Shuttle's critical mission and limited design life (originally projected to be between 10 and 20 years), as well as its now projected use for as much as another 20 years, strict adherence to existing guidance must be reemphasized on an ongoing basis. Furthermore, every opportunity to avoid/minimize/reduce exposure must be taken. Ground Operations should review launches where exposure was more than one standard deviation above or below the mean (Figure 1.3.5.) for lessons that may be applied to reduce exposure. Finally, as some amount of exposure is unavoidable, the Space Shuttle Program must have an intensive corrosion program of inspection, treatment, and prevention. Such a program will factor into the fledgling Service Life Extension Program.

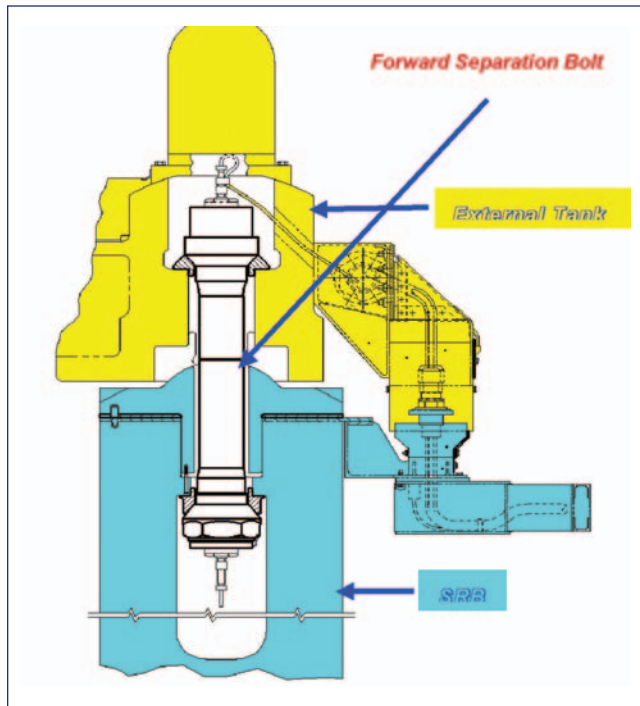
Figure 1.5.1. Diagram of a bolt catcher.

The External Tank (ET) is attached to the SRB Forward Skirt with one pyrotechnic separation bolt. At SRB separation, this bolt is pyrotechnically separated into two halves. On the ET side of the interface, a "bolt catcher" (see Figure 1.5.1) is mounted to catch the upper half of the fired separation bolt following NASA Standard Initiator (NSI) firing. The bolt catcher consists of a domed aluminum cover containing an aluminum honeycomb matrix to deform and absorb the bolt's energy as it is "caught." The bolt catcher is designed to prevent liberated objects from hitting the Orbiter after firing.

The configuration of the current bolt catcher flight hardware differs significantly from the original qualification test configuration.⁶ First, the attachment of the bolt catcher used in the original test fixture was qualified using through-bolts into a metal that was dissimilar to the ET/SRB attach point. The mounting method used for flight hardware (including STS-107) is bolts threaded into inserts. Second, original catcher testing did not have the SLA applied. Third, the original design load expected during bolt separation was determined to be 29,800 pounds in the 1979 timeframe. During initial tests the bolt catcher failed at the weld. The reason for this failure was determined to be overly rigid honeycomb, which led to the redesign of the honeycomb to reduce its static pressure capability from 1400 to 1000 psi. Finally, during the original test, temperature and pressure data were not recorded for the bolt firing. Instead of conducting additional tests, the flight design configuration was accepted by analysis (of extrapolated test data and the redesign specifications) and similarity. Consequently, predictive failure analysis, in the absence of post-flight evidence for examination (the bolt catcher and upper half of the separation bolt remain with the external tank and are therefore lost on reentry), must also be

based on analysis of limited data from testing 24 years ago or a new round of testing in order to remove the bolt catcher from investigative consideration. The current bolt catcher design was certified on the basis of analysis and similarity after limited testing. A new round of testing is underway to support the investigation.

In the absence of physical evidence and adequate test data to measure bolt catcher performance against, it must be assumed that the bolt catcher could have played a role in damaging the left wing LESS of *Columbia*. Specifically, the dome could have catastrophically failed at the weld, SLA coating could have come off (in adequately large quantity to damage the shuttle), or a bolt/insert could have failed to hold. Review of radar imaging data reveals objects were liberated from the STS-107 stack at the time of SRB separation (approximately 126 seconds).⁷ Much of this debris is from known sources aft of the Orbiter, and do not present a threat to the vehicle. However, the radar data has been inconclusive, to date, as to whether the bolt catcher could have been a part of the separation debris. Several other methods will be used to investigate the bolt catcher's potential as a source of damage to the LESS Thermal Protection System on *Columbia*. First, review of existing, but limited, data from STS-107. Second, a new set of tests of the as-flown configuration is being performed to better characterize the bolt catcher performance parameters.

Remove all remaining Summa and Harris catchers from service until testing is complete (including x-ray evaluation of all welds). Attempt to determine the Factor Of Safety on the Summa bolt catcher and the likelihood that STS-107 experienced an in flight failure of the Summa bolt catchers. Complete design upgrades to the SRB Bolt Catcher and perform qualification testing to certify the new configuration for flight use.

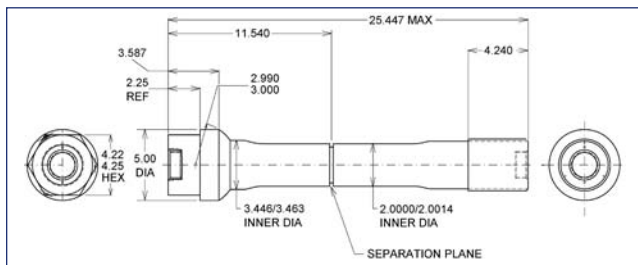
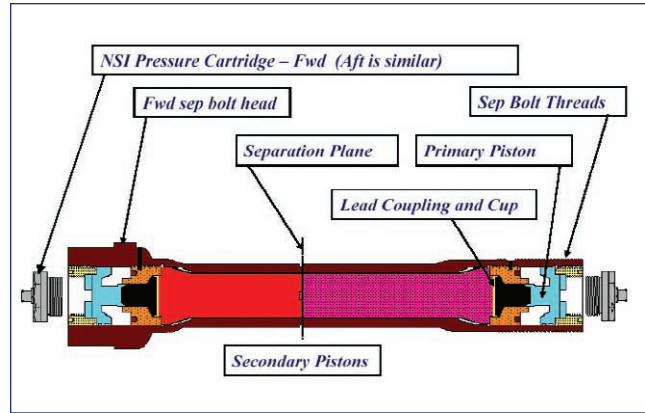
USA replaced Hi-Shear as the prime contractor for separation bolts in May 2000. Certification of new bolts may have

been done without adequate NDI (magnetic particle) of the internal bore. (See Figures 1.6.1 and 1.6.2.)

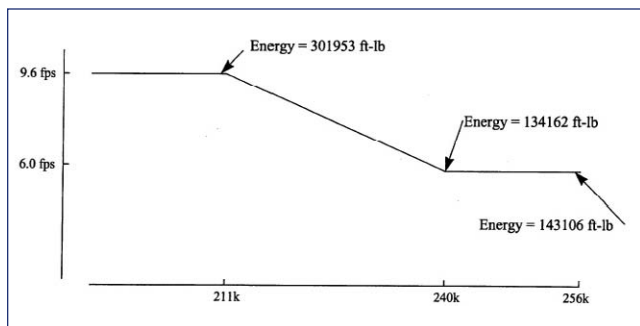
Figure 1.8.1. Energy Levels Based on Sink Rate/Landing Weight.

Based on a 6.7 fps sink rate and 11 knot crosswind, reconstructed gear loads were determined to be less than half of design limit load. Figure 1.8.1 shows how energy levels decrease with lower sink rates and landing weights and explains how design criteria can be exceeded without exceeding structural capability. This was verified using MADS accelerometer and strain gage data.

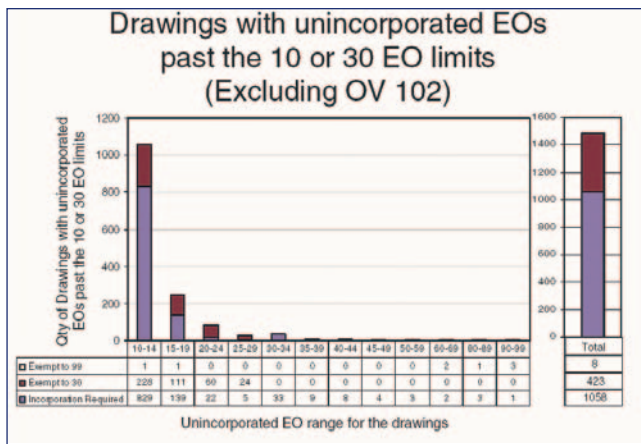
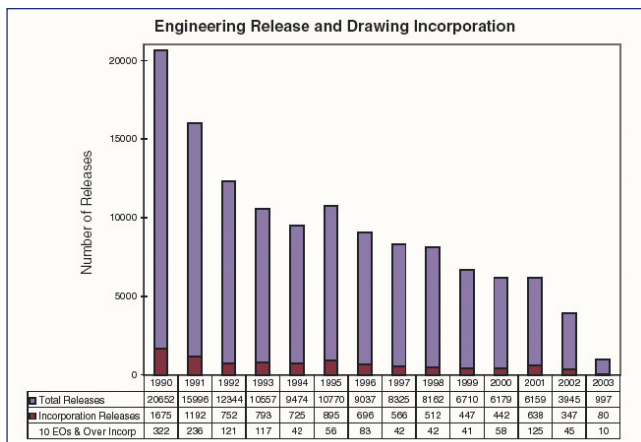
"Previously, the Panel has been concerned with the large number of Orbiter drawings that are out of date. Many EO changes have not been incorporated into the drawings. Although they are noted on the drawings, engineers must refer to additional paperwork to understand the state of the hardware systems. Over 1600 drawings have more than 10 unincorporated EOs. The Orbiter program will update and incorporate all EOs on 59 of the most frequently used drawings by the end of 2003. Also during the year, an effort to address the 589 drawings referenced most frequently after those 59 will begin. Orbiter program management has committed to maintaining the upgraded drawings at no more than 10 unincorporated EOs. The Orbiter Project is now

reviewing the possibility of identifying the safety-critical drawings that should always be kept current. Recommendation 02-8: Identify drawings that are critical to flight safety, update them to include all EOs, and keep them current.”¹¹ (See Figures 2.1.1 and 2.1.2.)

Figures 2.1.1 and 2.1.2 show the status of the Shuttle Program's technical data in two graphics. The first shows the number of drawings that have greater than 10 unincorporated EOs each. The total figure, as mentioned above is 1,058. However, the significance of this number is further emphasized in the columns that have larger numbers of unincorporated changes but are supposed to be limited to no more than 10 unincorporated changes. Specifically, 90 have more than 20 EOs and 21 have over 40 unincorporated changes. The second graphic shows the number of total releases (new or updated technical drawings or specifications) by year. Over the last 10 years there has been a steady decrease in the number of new releases but incorporations have remained at a significantly lower level and at a relatively slow pace. In 2001 NASA accelerated this pace and has continued at this rate since then.

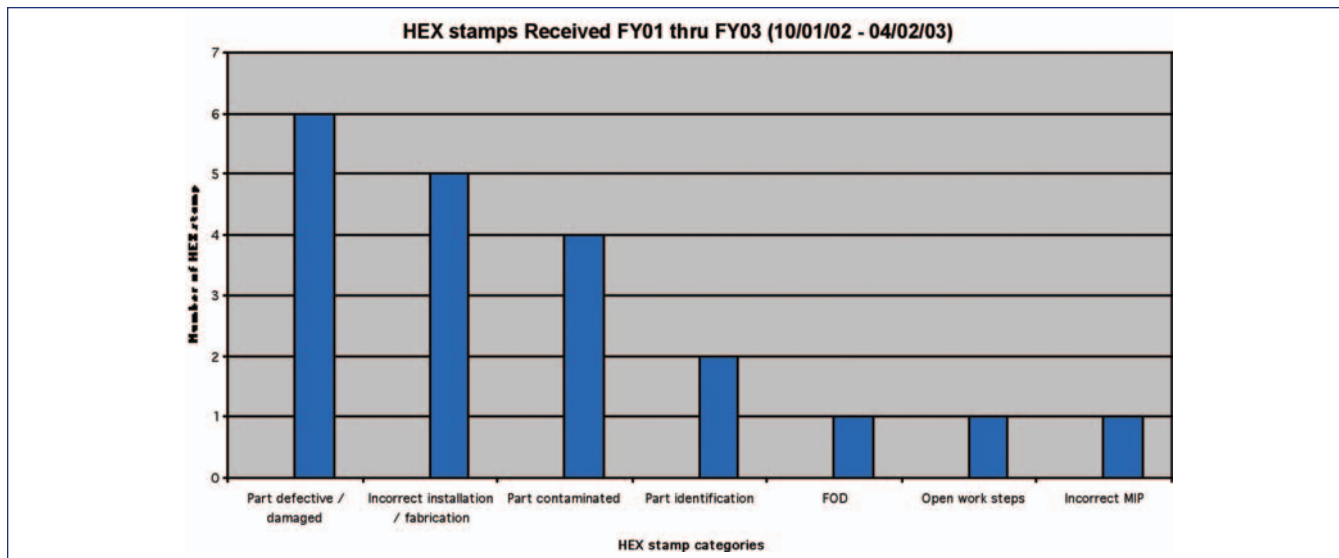
Figure 2.2.1. HEX stamps received between October 1, 2002 and April 2, 2003.

Feedback to members of the Board reflected that NASA QA inspectors feel they do not have authority (or are discouraged from doing so) to reject USA work. Consequently, NASA S&MA does not track reject rates (hexagonal-shaped stamps applied to WADs by S&MA inspectors) for occurrences in which a NASA QA inspector might reject a job closed out by a USA quality inspector. They also assert that inspectors are only authorized to use their Hex stamp to notify the contractor to “stop work.” Use of the Hex stamp is apparently rare, presumably due in part to overall inspector reluctance or potentially NASA’s lack of metrics to track hex stamp issuance. The following data was retrieved for use in this report. Total inspections conducted from FY2001 through

March 2003 that would have been subject to potential hex stamp use were 141,247. During that same period only 20 hex stamps were issued for various operations. (See Figure 2.2.1) HEX stamps received in FY2001, FY2002, and current FY2003 have been reviewed and the conclusion drawn is that the number of HEX stamps received compared to the number of inspection opportunities and hardware items completed/shipped provided too few data points for extensive analysis. According to several sources, this practice has been curtailed due to previous practices of using the stamps as a “hammer” against the contractor. The more common practice is for the inspector to refuse to buy the discrepant job, and offer to come back later once corrective action is taken. Such instances are not tracked by any measurement.

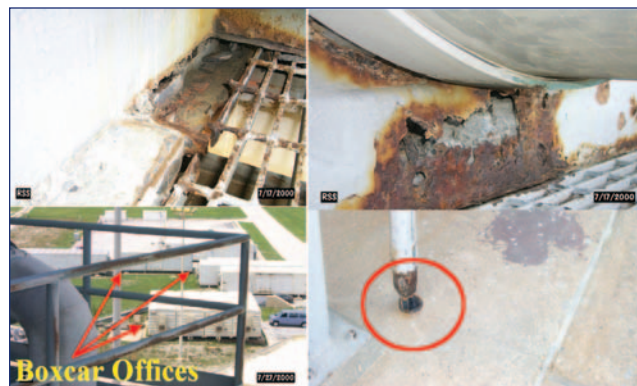
Figure 3.2.1. Launch Pad Corrosion and Boxcar Facilities.

Example 1: KSC launch pads 39A and 39B are continual challenges to maintain in launch ready condition due to corrosion and the forces associated with launches. The original

structure, which serves as the core of the Fixed Service Structure (FSS), was designed and built in the Apollo era and incorporates older designs which trap fluids, including corrosives, even after post-launch wash downs, as well as precipitation. To their credit, ground systems support personnel and engineers recognized these design problems a long time ago, and newer modifications/replacements, such as the Rotating Service Structure (RSS), are better designed, without fluid traps. As the pads have aged and modifications/upgrades have been incorporated, many of the older systems have been abandoned in place; there is evidence of old clamps, conduits, mounting brackets, and other hardware that continue to corrode. This can be problematic, as continued degradation of these abandoned systems can contribute to loose debris during launch, posing a hazard to the shuttle. Again, to the ground support systems management's credit, they have recognized this and have lobbied for/received funding to remove formerly abandoned-in-place hardware; while much has been done, much remains and efforts are continuing. On each pad's RSS, the Payload Changeout Room's walls of foam core sandwich construction are deteriorating due to acoustic loads during launch. While repairs have been accomplished using a multitude of through-bolts, these are at best temporary and add needless weight to the movable structure. A more permanent repair will require serious consideration of an alternative design to ensure durability. There is also extensive concrete deterioration at the pad base and blast deflector areas; these are repaired from launch to launch. KSC has 83 railroad boxcars at pads 39A and 39B. These were procured for their durability and are used as offices and work centers for support personnel. Unfortunately, they are extensively corroded and ceiling leaks/buckled floors can be seen in various locations. To KSC's credit, they are correcting this situation with the construction of new facilities at each launch pad that will completely replace the boxcars; move-in is scheduled for FY2003.

Past upgrades of wiring in the Pad Terminal Control Room are another example of attention to the sustainment of a launch critical system, with a progressive approach incorporating modernization as demanded by system requirements. One specific area requiring attention is the theory (suggested in the early- to mid-1990s) that the lack of top-coating over inorganic zinc primer on launch pad areas was leading to zinc leaching through rainwater runoff onto Orbiter wing

leading edges; this, in turn, was causing the formation of pinholes in the RCC panels and possibly decreasing the service life of these critical Orbiter components. Launch pad rain sampling in 1994 confirmed zinc oxide contamination. Despite improved corrosion control management and execution since then, follow-on rain sampling in July 2003 showed that zinc oxide contamination persists and illustrates how infrastructure maintenance can have a direct impact, not just on immediate Shuttle operations, but also on service life. NASA Standard 5008, “Protective Coating of Carbon Steel, Stainless Steel, and Aluminum on Launch Structures, Facilities, and Ground Support Equipment” “requires a top-coating on all new and repaired surfaces, with the exception of Mobile Launch Platform (MLP) 0-level deck surfaces and lower levels of the FSS (95- and 75-foot levels), as these are in the direct blast impingement area during liftoff. Despite these requirements, launch pad corrosion control measures need to be examined with the objective of further reducing or completely eliminating zinc fallout.

ters for its ground support equipment, much of which is left outdoors. They should also perform trending and analysis of infrastructure/ equipment support costs factored over unit of output wherever possible, rather than simply tracking costs, as rate comparisons will facilitate tradeoff/investment decisions. Finally, KSC should examine current launch pad maintenance practices and make every effort to reduce or, better yet, eliminate zinc fallout.

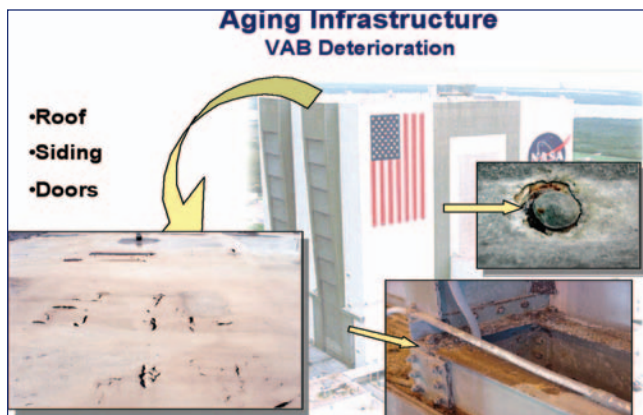
Figure 3.2.2. Vehicle Assembly Building.

Example 2: The Vehicle Assembly Building (VAB) is the only facility of its kind in the world and a critical element of the Space Shuttle Program. It is where the Orbiter, External Tank, and Solid Rocket Boosters are mated and demated. It was constructed in the 1960s for Saturn V buildup. Like the launch pads, it serves as an example of both the problems faced by the SSP and NASA in maintaining aging infrastructure, as well as ongoing efforts to meet these challenges. The 5-acres of roof from its original 1964 construction are comprised of 6 inches of foam and vinyl layers added over the concrete slab through the years. Regular repairs are accomplished on the roof’s outer surface using sealant and asphalt paper. Roof leaks over the years have led to deterioration (spalling) of the concrete ceiling on the interior of the roof slab, with concrete fragments occasionally falling loose from a height of over 500 feet. This FOD hazard has been mitigated by the installation of a subdeck five feet below the ceiling to catch debris and safety nets at lower levels. A comprehensive repair effort has been funded for FY2004 to remove all roof outer layers down to the original slab and recover with sloped roofing boards and a synthetic membrane, as well as repairs to the interior concrete ceiling. Significant portions of the VAB’s 1.1 million square feet of siding also require repair due to corrosion; this is especially critical due exposure of this vast surface area to hurricane-force

winds; repairs are scheduled for FY2006. Several of the VAB’s massive multi-panel doors require extensive corrosion repair. The structure’s overhead bridge cranes are a mix of 1960s and 1990s vintage equipment, but are effectively sustained through regular maintenance due to their critical role in mating/demating operations.

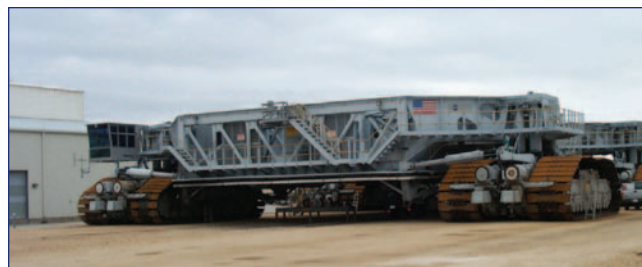
Figure 3.2.3. Crawler Transporter (CT).

Example 3: Two of the Shuttle Program’s most critical pieces of equipment, the Crawler/Transporter (CT) systems, pose a significant technical sustainment challenge. (See Figure 3.2.3) These unique vehicles are necessary to move the stacked Space Shuttle to and from the launch pads. During hurricane season – roughly half of the year starting in early summer – both must be up and running in the event Shuttles must be moved from the pad back to the VAB for “safe haven.” This precludes extensive maintenance during this entire period. Built in 1965, the CTs each average over 1,700 miles. They have received incremental capability upgrades over the years, including a laser docking system, computerized control stations, and replacement control cabs. The massive hydraulic actuators used to jack, level, and carry the Mobile Launch Platform (MLP) and Shuttle Stack were recently refurbished for the first time. Obsolescence of purpose-built components poses a major challenge, and will continue to need correction through upgrades. Corrosion is a significant problem due to no sheltered storage, and maintenance is frequently suspended due to severe weather. As support costs rise due to aging and obsolescence, it was noted that managers track resources expended (costs of modifications/parts/labor) over time, but do not do so per unit of output (miles driven or operating hours). While costs over time will always increase, a more valuable metric is cost per unit of output, as this can be used for analysis and trending and can help in more clearly comparing the cost/benefit tradeoffs of inaction, modification, or replacement.

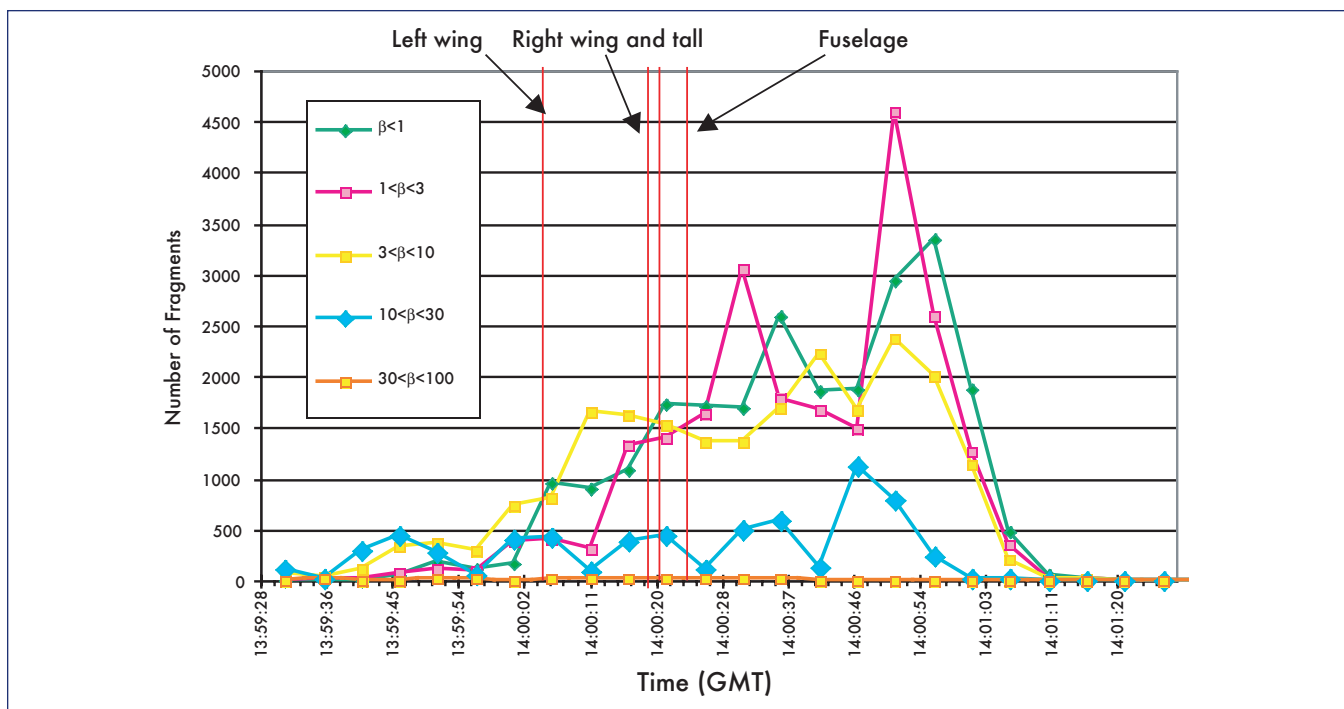
Figure 2-14. Estimated Breakup Model as a Function of Time by Ballistic Coefficient Category.

The breakup model developed to account for the total weight of the recovered debris is plotted in Figure 2-14. The fraction of the highest ballistic coefficient group $30 < \beta < 100$ lbs/ft² is much less prominent when compared to the impact range distribution shown in Figure 2-9 because the fragments without dimensions were not assigned to large weight debris groups in order to meet the overall weight constraint. Because the breakup model would vary if the reference trajectory is varied, it does not reflect the actual time when a fragment separated from the orbiter. It does, however, illustrate the progressive nature of the breakup process, and matches the available data as presented in Section 3.

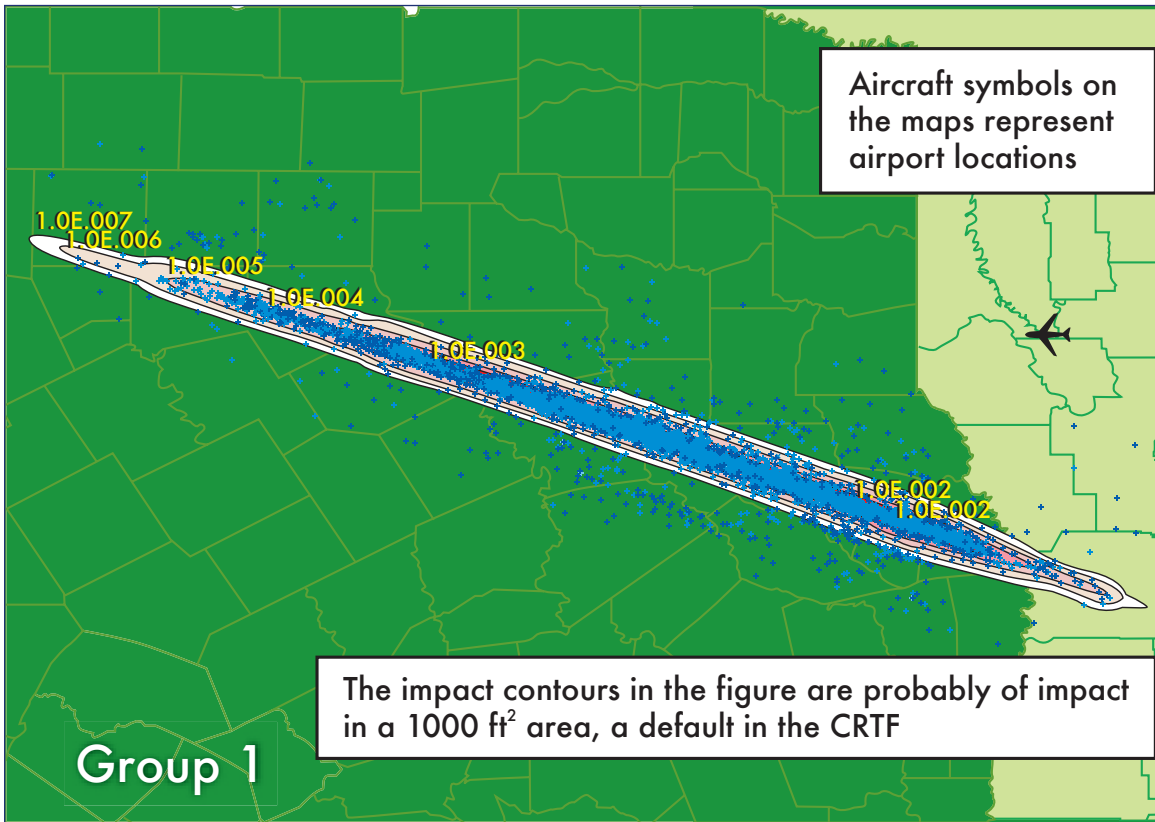
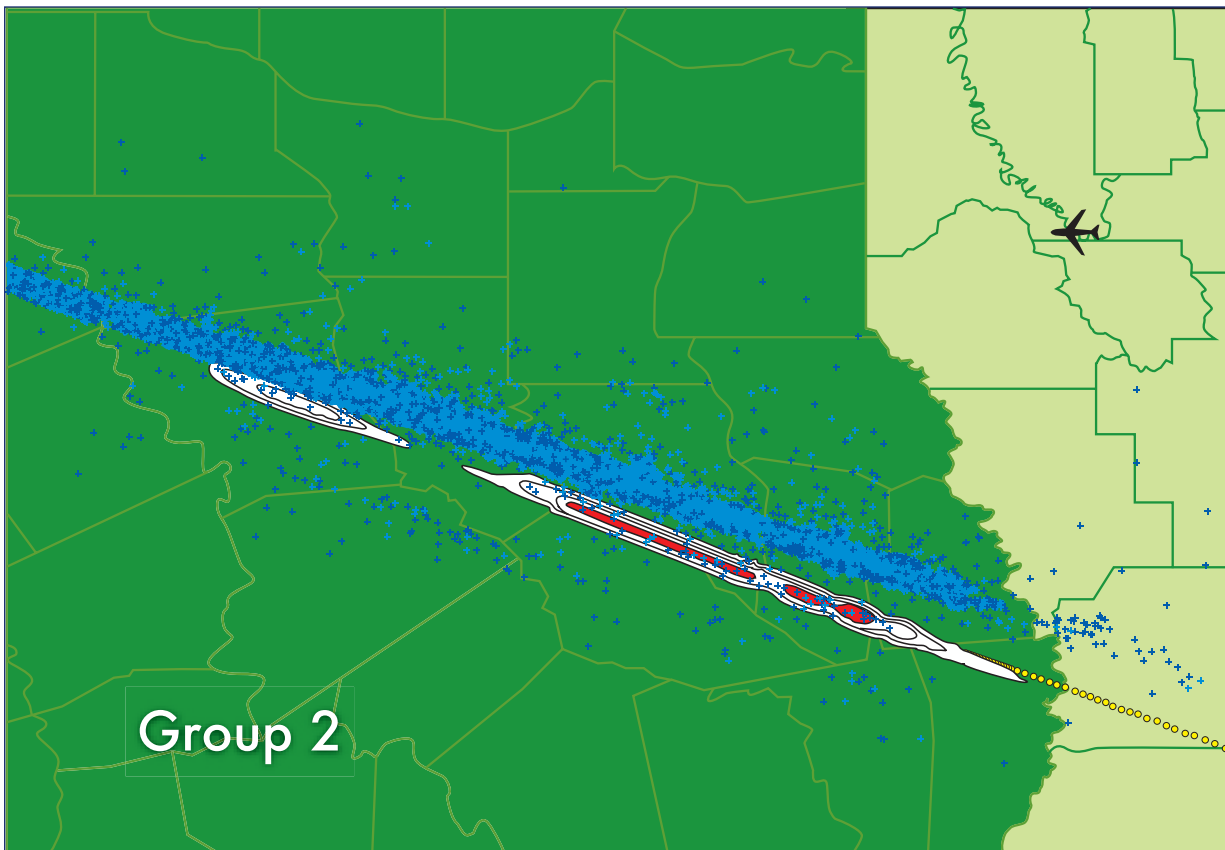
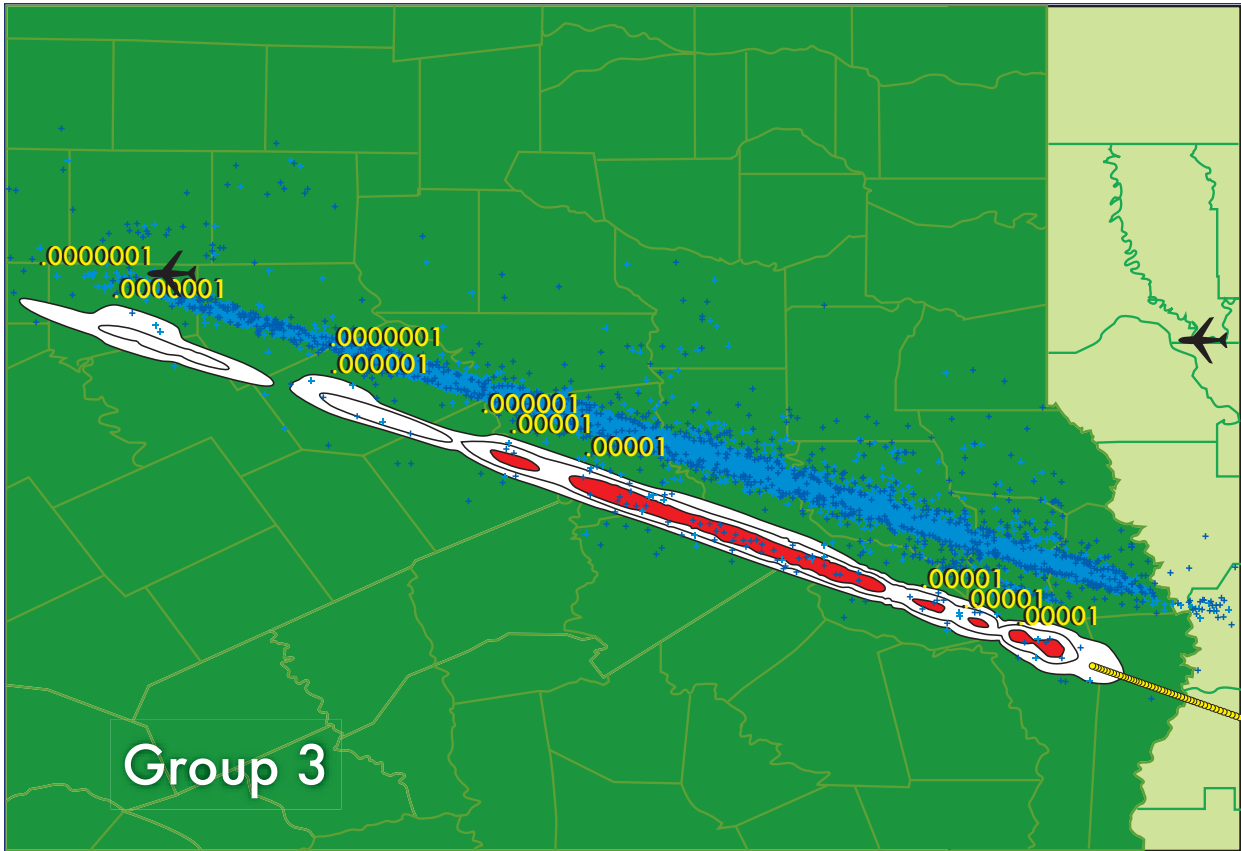
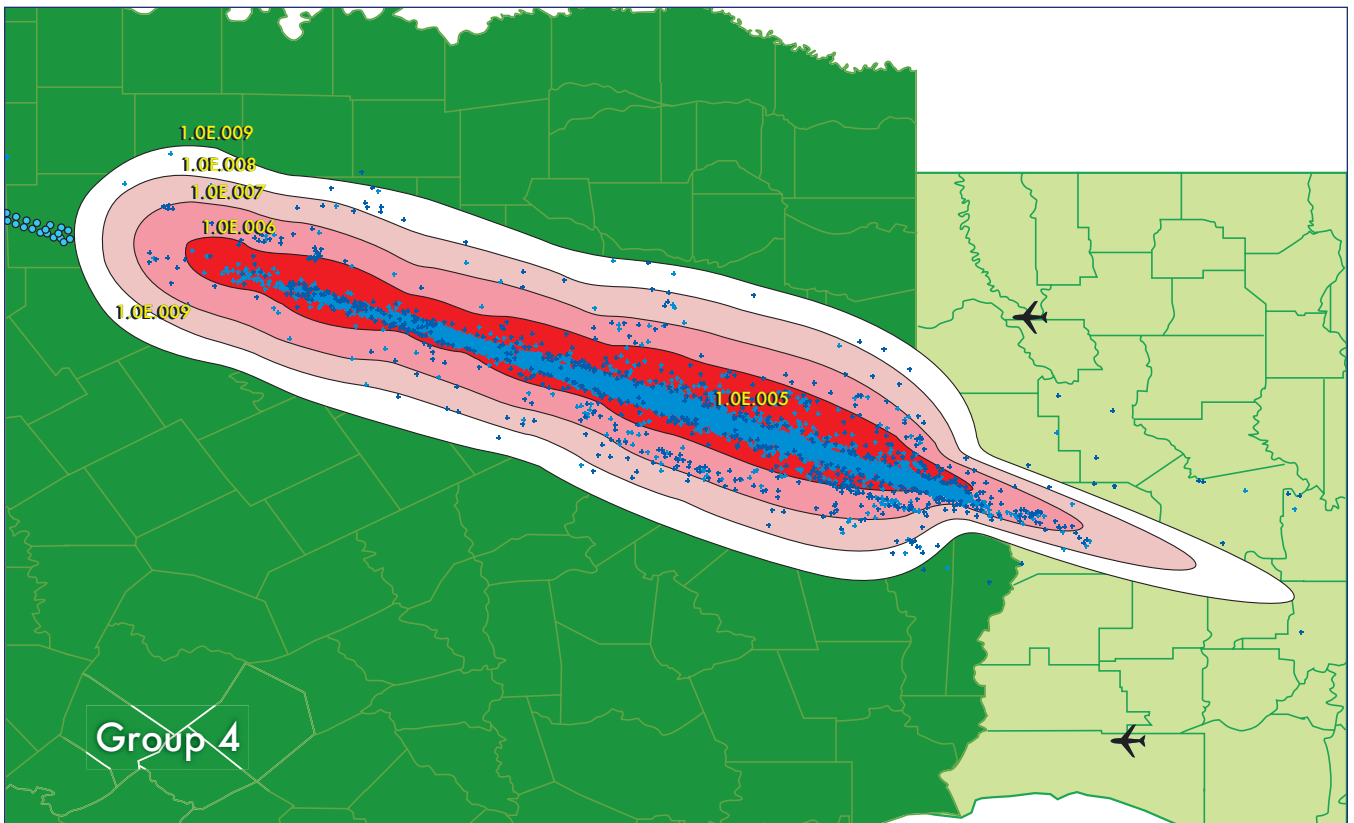
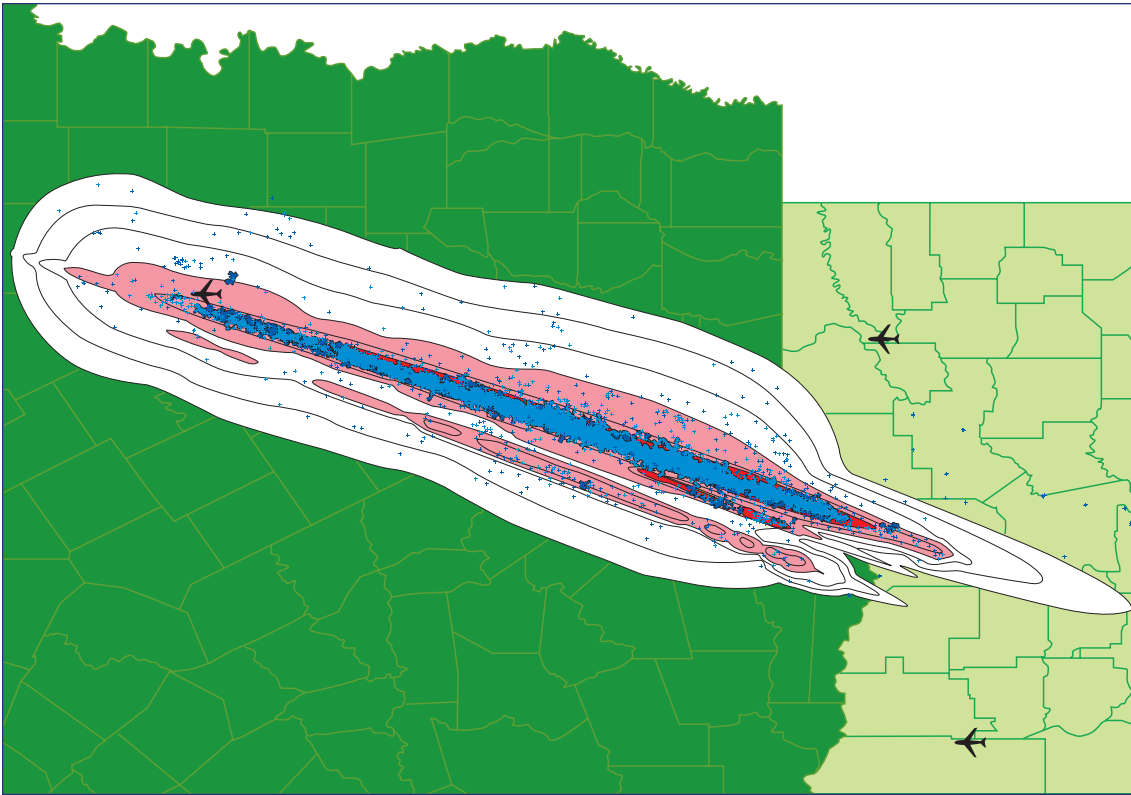
Wind data for Feb 1, 2003 was obtained from both the Dallas/Fort Worth and the Shreveport airports. A monthly averaged model was used for atmospheric temperature and density, and for upper atmospheric winds. Probability of impact, P_i , per 1000 square feet for each of the debris group was contoured and is presented in Figures 3-2, 3-3, 3-4 and 3-5 for four debris groups. The combined contours are plotted in Figure 3-6. Figure 3-7 provides a three-dimensional view of the reference trajectories and combined P_i contours. Figures 3-8 and 3-9 compare the dispersion of the gathered debris and the model results in both the downrange and cross-range directions. The standard deviation used for the lift-to-drag ratio was 0.04 for all debris groups. This value produced the best fit to the cross-range dispersion of the debris in Group 1. The standard deviation of velocity impulse in Groups 1 to 3 was assumed to be zero and in Group 4 was assumed to be 333 ft/sec respectively.

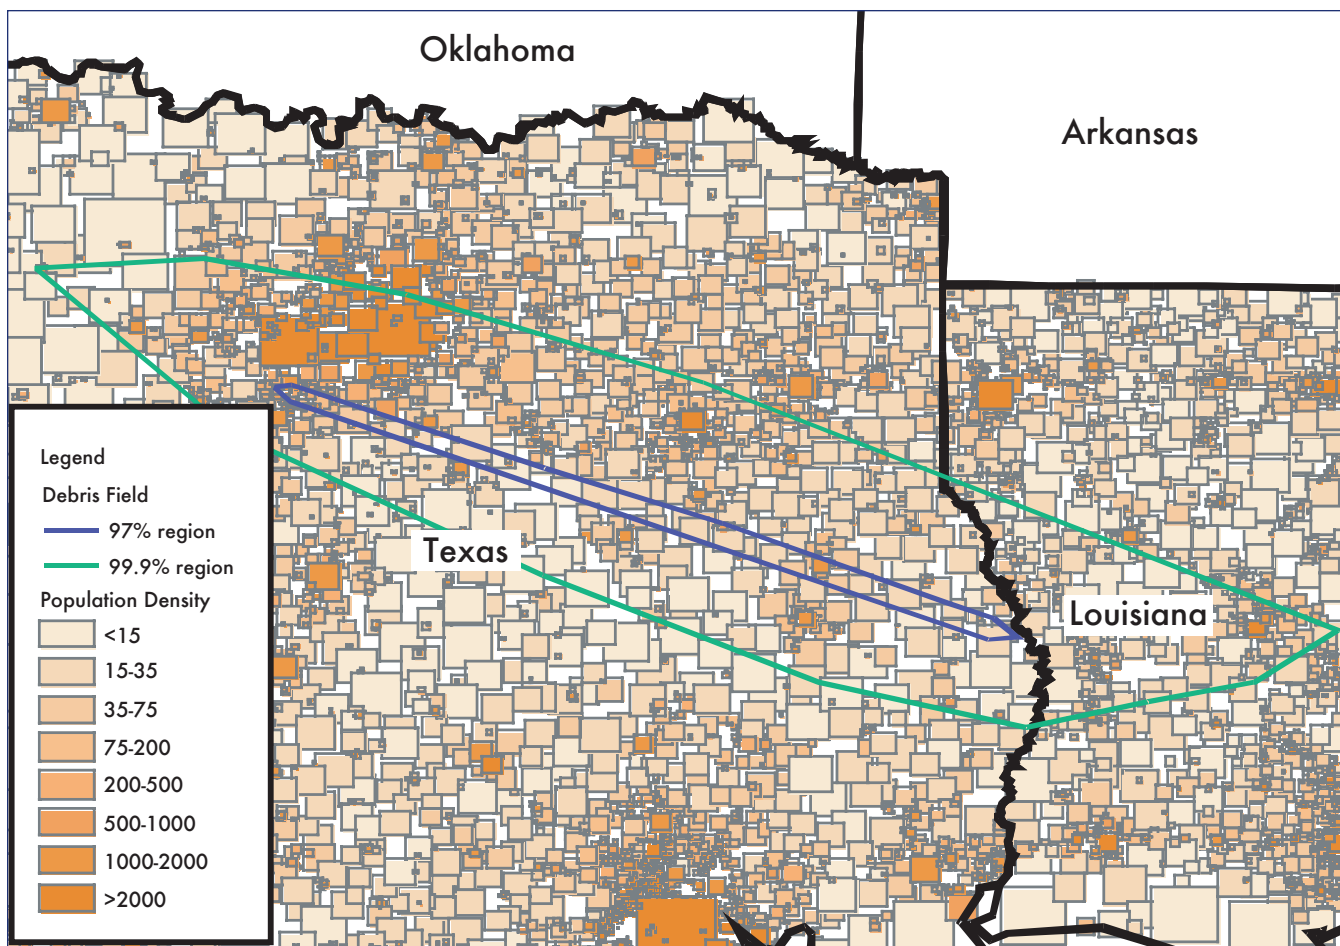
Figure 5-3. Population Model and Impact Area Defined by Recovered Debris.

The resulting population model with sheltering is shown in Figure 5-2, along with polygons to show the major debris

regions. The blue region shows the main debris field where over 97% of all recovered debris was found. The green region shows a region where all credible Columbia debris was found—a few obvious erroneous coordinates have been excluded. The population map represents each population center as a square, with the size corresponding to the area of the population center, and the color the density of people in the region. Some population centers overlap others, as some census regions completely encircle others. Dallas/Ft. Worth can be easily seen just above the left edge of the blue region, and Houston is at the bottom center of the region.
