COLUMBIA

ACCIDENT INVESTIGATION BOARD

REPORT VOLUME II
OCTOBER 2003

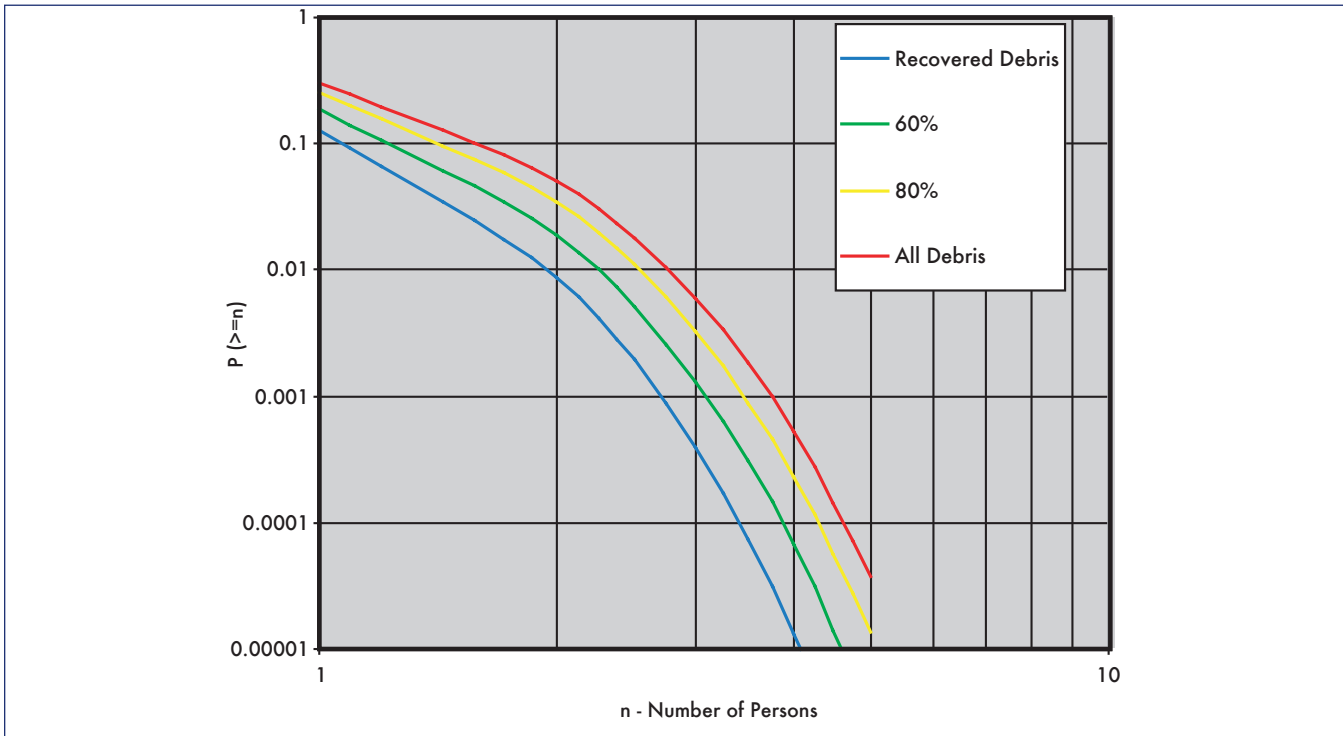
Figure 6-2. Debris Risk Profiles for Different Percentages of Surviving Debris.

If we assume that the Columbia broke up, but all fragments survived, and assume the recovered debris is representative of the “un-recovered debris,” then the E_c due to all debris surviving is 0.29. These assumptions are considered quite conservative because (1) it is almost certain that some debris burned up during re-entry, and (2) much of the un-recovered debris is likely to be smaller than the recovered fragments, and thus not potentially casualty producing. Table 6-2 shows that the E_c ranging from recovered debris, to 60, 80 and 100% surviving. Table 6-2 also contains the probability that there will be one or more casualties.

Figure 6-2 shows the risk profile, $P(\geq n$ casualties) as a function of n, for each of the debris cases.
