COLUMBIA ACCIDENT INVESTIGATION BOARD (CAIB)/
NATIONAL AERONAUTICS AND SPACE ADMINISTRATION (NASA)
ACCIDENT INVESTIGATION TEAM (NAIT)

WORKING SCENARIO

FINAL VERSION: JULY 8, 2003

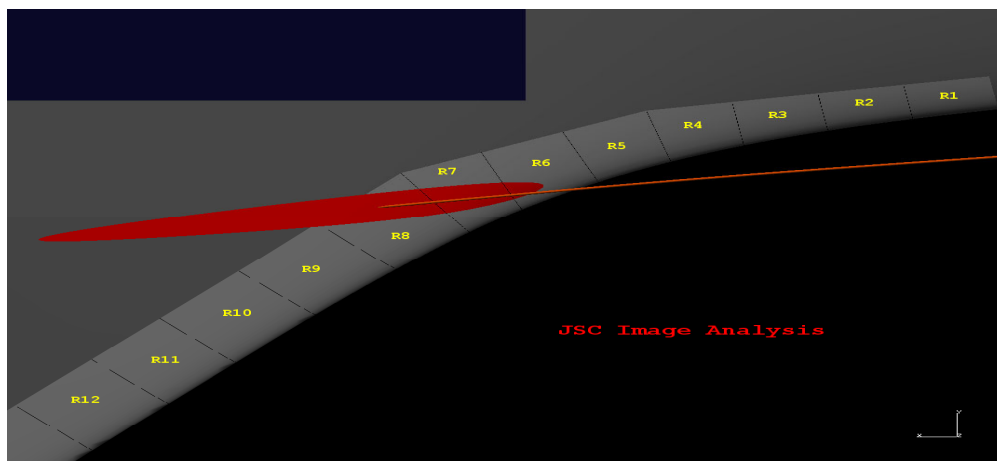
Video and Computer-Aided Design (CAD) analysis determined that the most likely impact location was leading edge RCC panels 6 through 8 (Figure 3-5). Due to the foam size, RCC panels 5 and 9 must also be included in this impact zone. The best estimate of the foam size, based on imagery measurements, is 21 to 27 inches long and 12 to 18 inches wide. The precise foam shape and thickness cannot be determined from the available imagery; however, a reasonable estimate is that it was a plate-like shape and several inches thick. The foam tumbled at a minimum rate of 18 times per second based on the imagery, although the actual rate may never be known more accurately. Figure 3-6 illustrates a portion of the photographic analysis techniques used to determine the size of the foam.

Figure 3-5. Multiple analyses determine foam impacted lower RCC panels 6 through 8 area

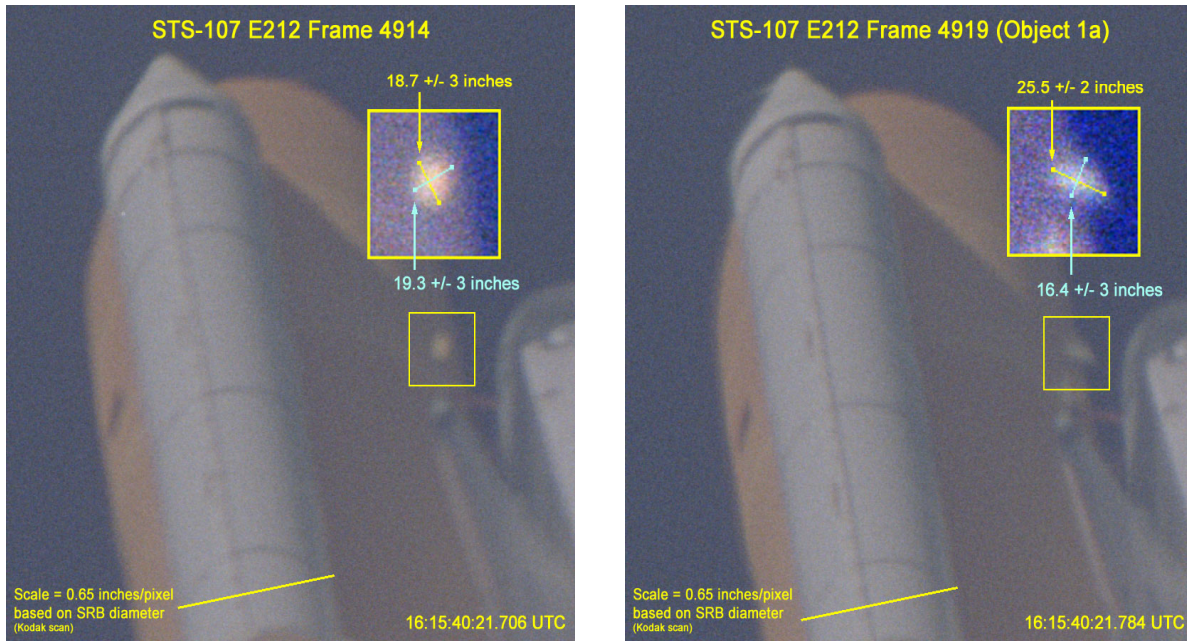
Figure 3-6. Photographic analysis techniques determined foam size: debris appears almost circular in frame 4914 and elongated in frame 4919

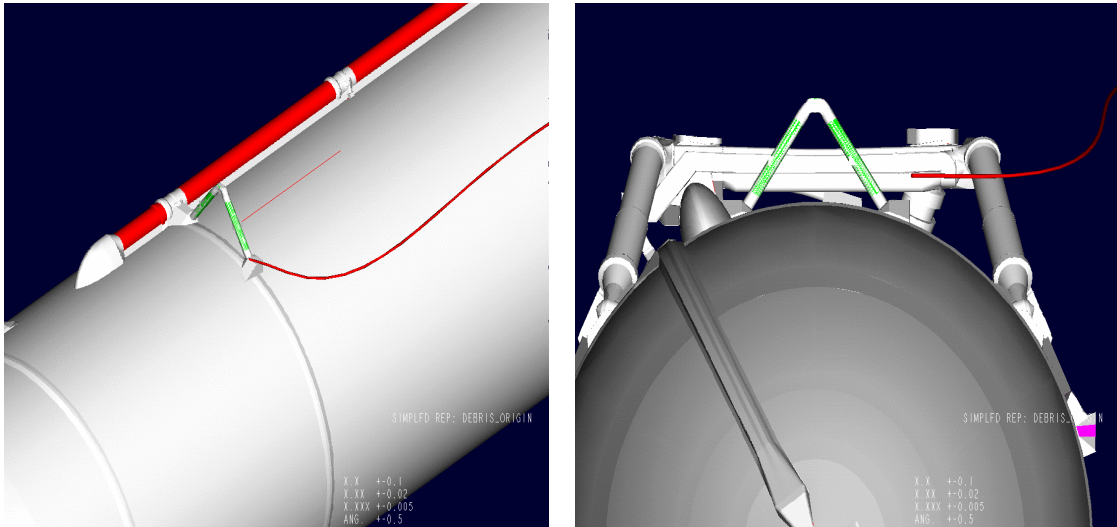
There is significant visual and debris trajectory information to implicate the left bipod ramp area as the source of debris. In Figure 3-9, the red line depicts the estimated foam trajectory as it moved from the bipod ramp area toward the left wing. In addition to locating the impact in the RCC panels 6 through 8 region, the video analysis has also shown that the impact was below the apex of the RCC panels since no foam or post impact debris was observed to traverse over the top of the wing. This is indicative of an impact below the wing leading edge aerodynamic stagnation line (Figure 3-10). The stagnation line, or dividing streamline, is the line along the leading edge of the wing where the airflow comes to rest; above this line, airflow moves over the upper wing surface and below this line, the airflow moves over the lower wing surface.

Figure 3-9. Multiple analyses indicate foam is from ET left bipod area. Red line depicts the estimated foam trajectory as it moved from the bipod ramp area toward the left wing.

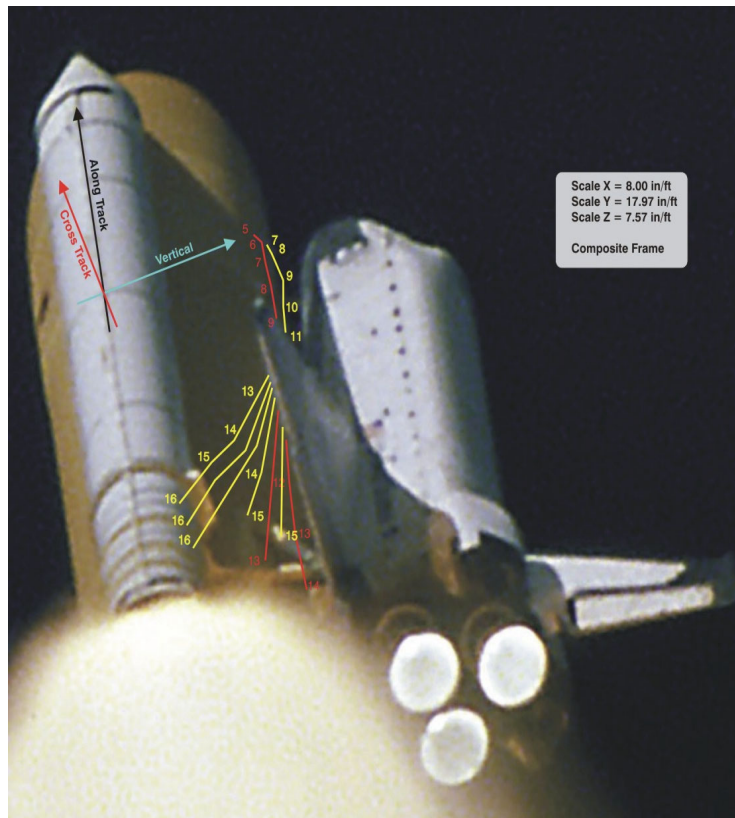
Figure 3-10. Video analysis shows impact is below wing leading edge stagnation line. Trajectories of particles are depicted after the impact.

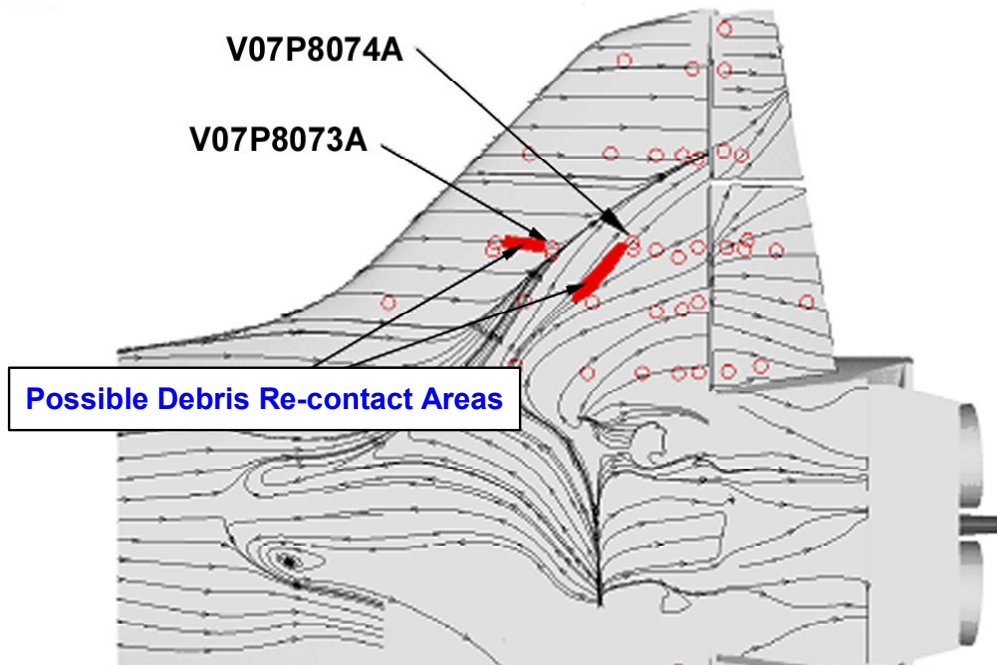
There are two other indications that the foam impact occurred in the panels 6 through 8 area. Two Modular Auxiliary Data System (MADS) lower surface pressure measurements behaved anomalously immediately after the time of the impact. Figure 3-13 shows the location of these measurements along with possible areas for post-impact debris re-contact in the vicinity of the sensors. The unusual behavior of one of the sensors is shown in Figure 3-14.

Figure 3-13. CFD surface flow with lower left wing pressure sensors

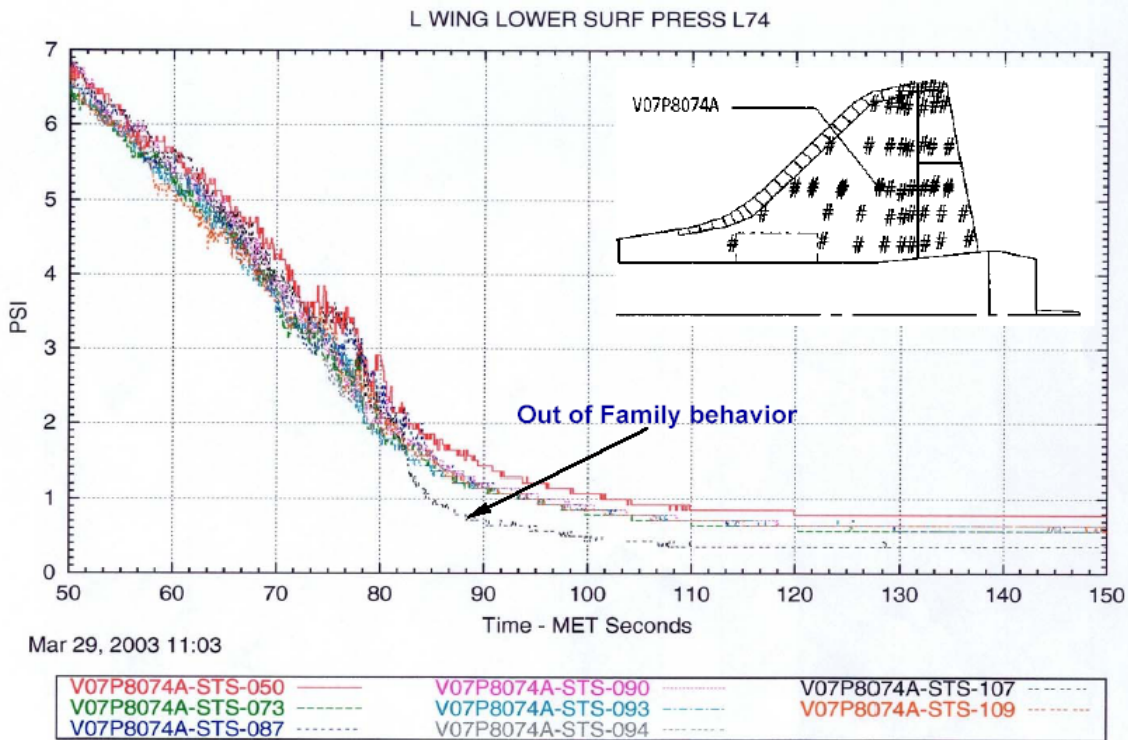
Figure 3-14. Unusual behavior of pressure sensor V07P8074A

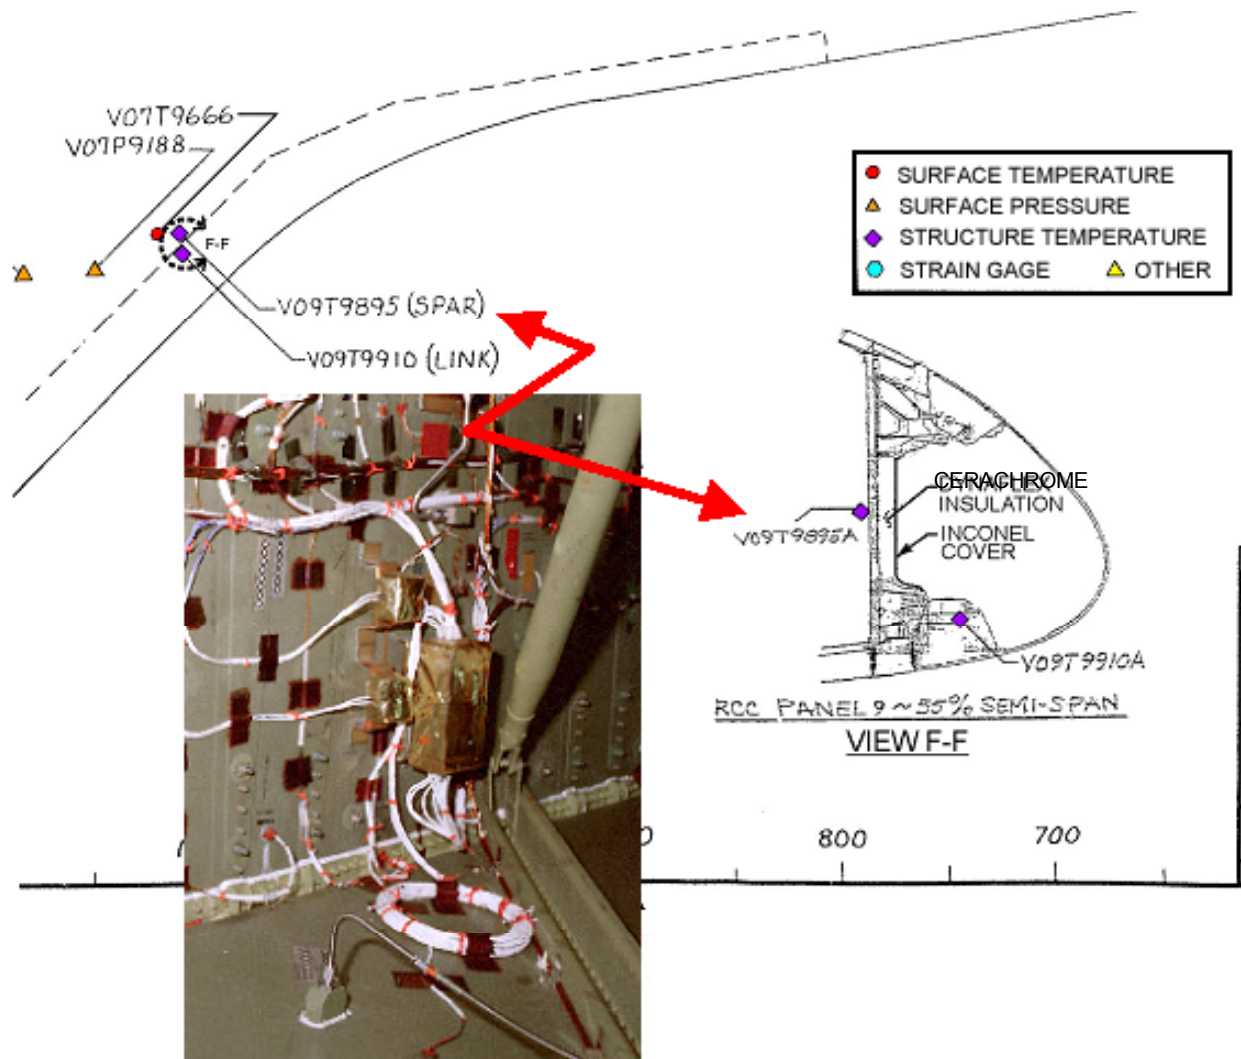
Additionally, there is another MADS measurement that had an off-nominal signature during the ascent timeframe. The temperature sensor on the leading edge spar behind RCC panel 9 showed a slightly higher temperature rise than seen on any previous Columbia flight. Figure 3-15 shows the location of the temperature sensor behind the wing leading edge spar inside the wing. The slight temperature rise can be seen in Figure 3-16. Note that most flights show a small rise in this temperature during ascent due to aerodynamic heating.

Figure 3-15. Close-out photo shows RCC panel 9 wing leading edge temperature measurement

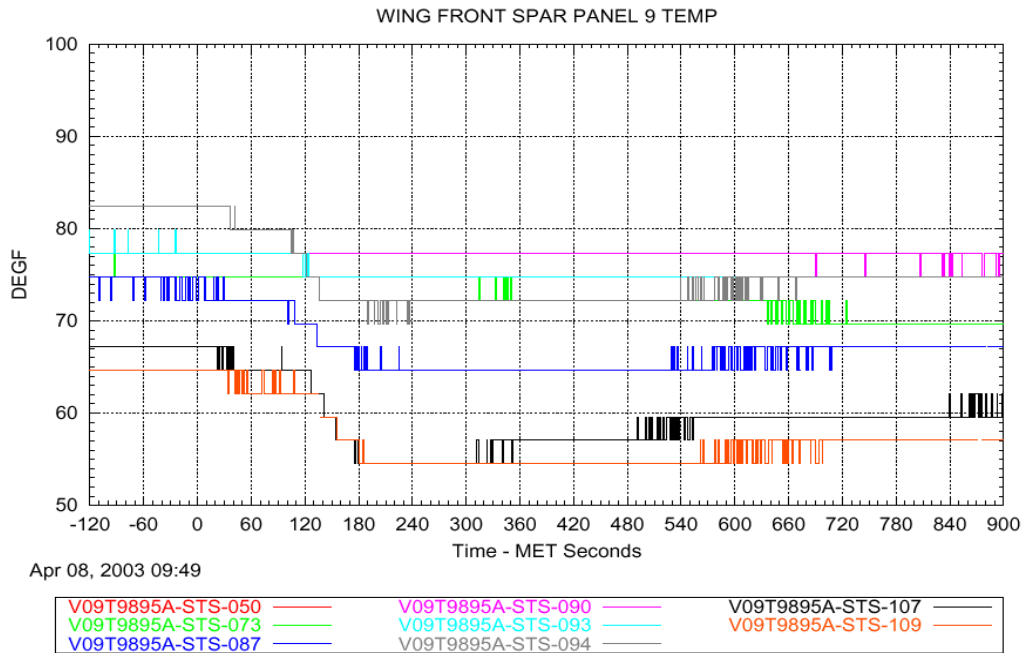
STS-107 had a 7.5 degree Fahrenheit rise that started very early during ascent (five to six minutes after launch). Although the data do not prove that the RCC was breached during ascent, the data are consistent with a possible flow path into the RCC cavity via damage in the RCC panels 6 through 8 area. A simplified thermal math model was constructed and verified with flight data from STS-5. The model was then correlated to the flight data from STS-107. Assuming the equivalent heating from a 10 inch diameter hole in RCC panel 8, this model nearly predicts both the ascent and entry temperature profiles for the wing leading edge spar temperature sensor. Figure 3-17 compares the model with the flight data for both ascent and entry. For comparison, Figure 3-18 shows the overall heating rate of the STS-107 ascent and entry environments on RCC panel 9. As shown, the heating on the wing leading edge is much greater during the entry profile than during the ascent profile.

Figure 3-16. Three-bit rise (7.5 degrees F) on MADS wing leading edge spar temperature measurement (V09T9895A) during ascent

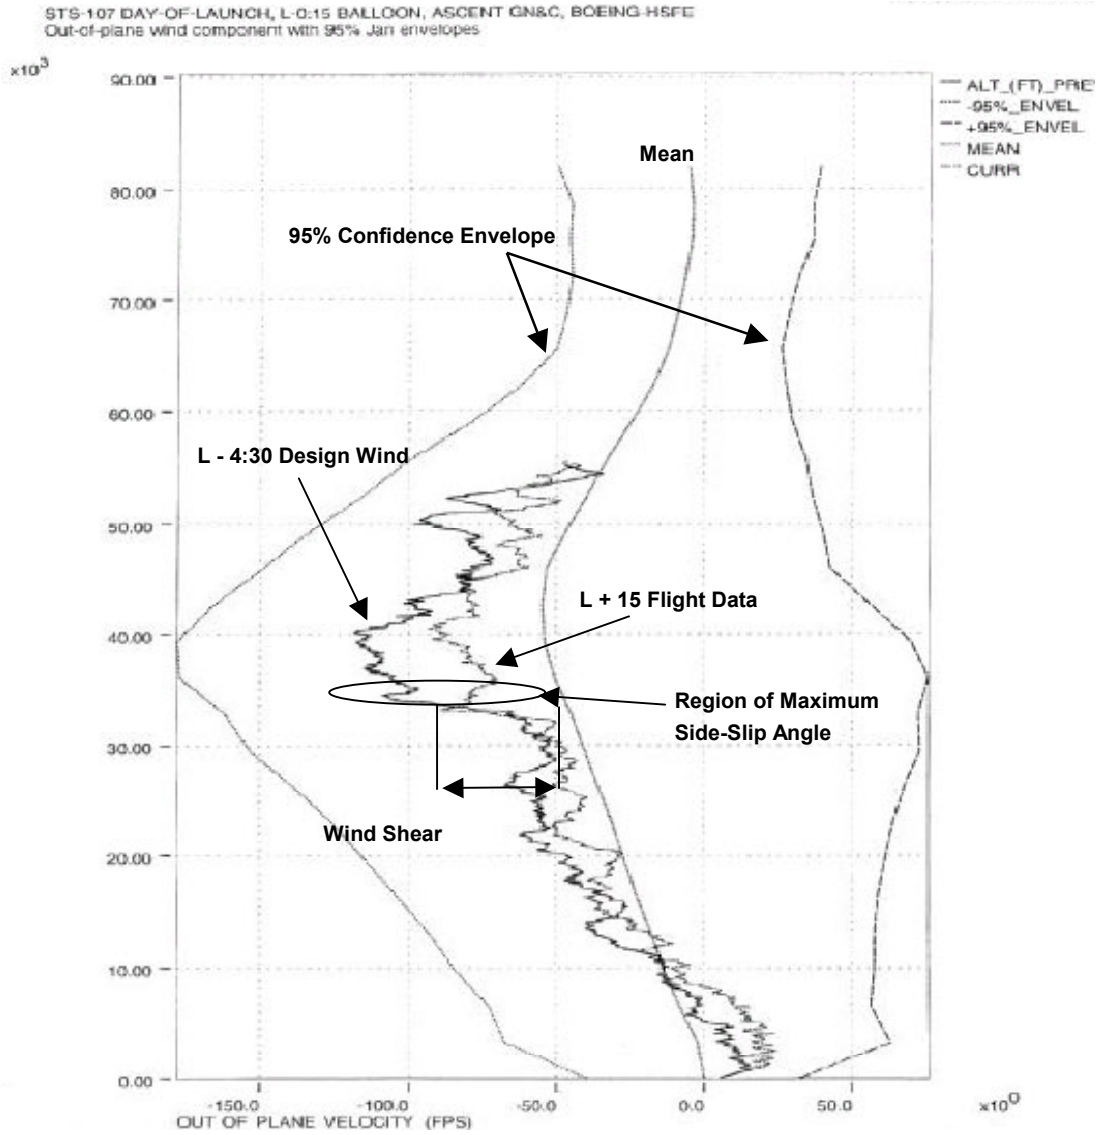
STS-107 experienced a wind shear during the period of maximum dynamic pressure starting at 57 seconds MET (Mach 1.27). The wind shear was due to a rapid change in the out-of-plane wind velocity of -37.7 feet per second over a 1200 foot altitude range starting at approximately 32,000 ft (as shown in Figure 3-21). Immediately after the vehicle flew through this altitude range, its side-slip angle began to increase in the negative direction, reaching a value of approximately -1.75 degrees at 60 seconds. This value of side-slip angle is a new flight experience value for MET 60 seconds (as shown in Figure 3-22). Post-flight data review indicates that the new flight experience side slip event not the result of the wind shear itself. Instead, it was the direct result of a difference in the L - 4:35 minutes balloon measurement, upon which orbiter guidance commands were updated on launch day, and the actual winds flown through by the orbiter during launch and ascent. Figure 3-21 highlights the difference in these two winds in this altitude region (a 25 foot per second increase in out-of-plane magnitude pre-launch compared to a 12 foot per second reduction in magnitude as experienced by the vehicle)

Figure 3-21. Out-of-plane wind velocity

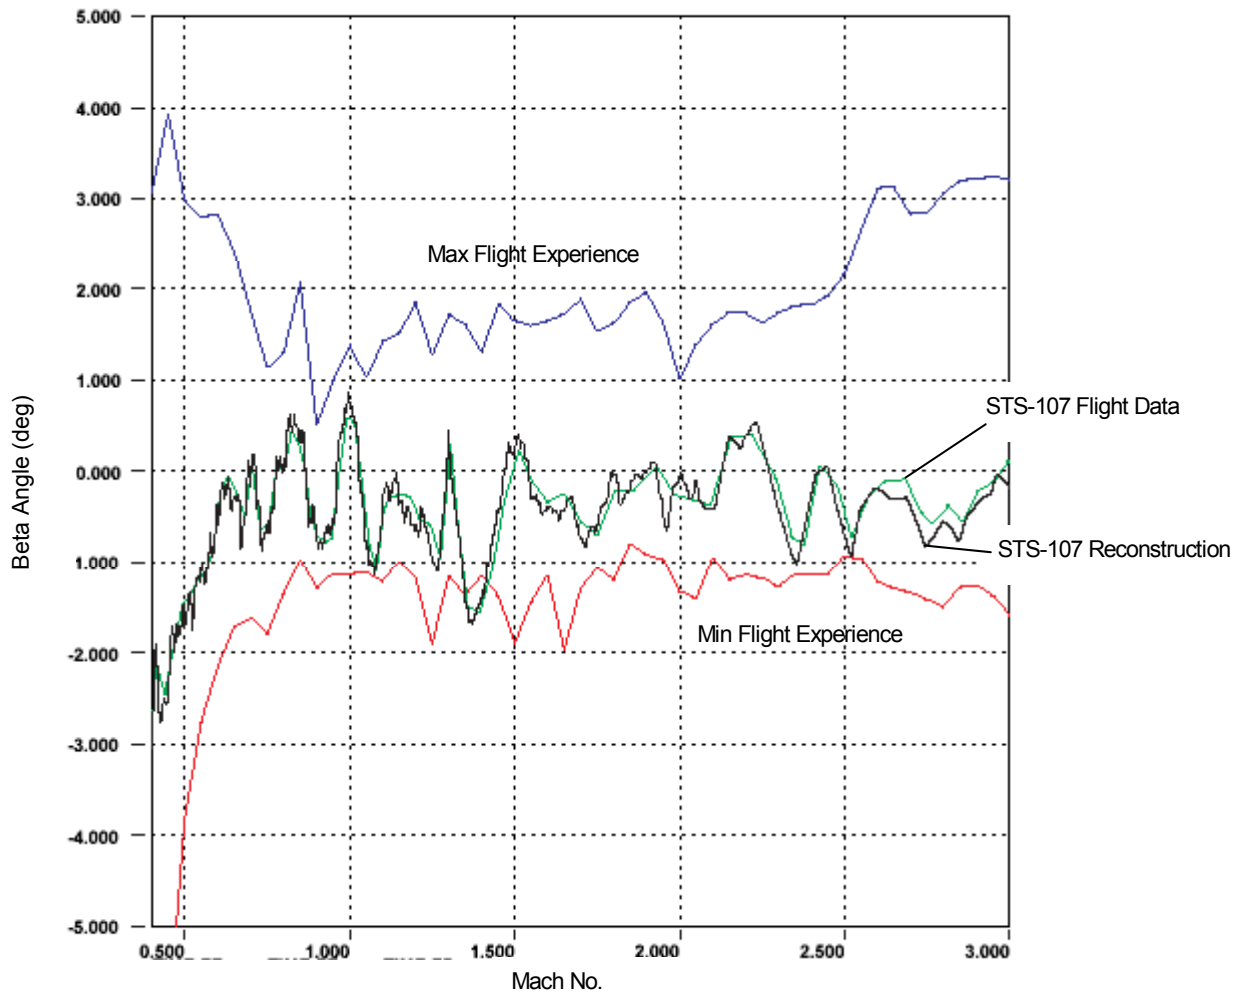
Figure 3-22. Side-slip angle

Several theories consider this wind shear event and the difference between the balloon data to be significant. A negative side-slip angle places the wind vector on the left side of the orbiter, pushing the orbiter to the right, changing the complex aerodynamic flow pattern characteristics in the left ET bipod area. To better understand the conditions on the ET left bipod, several studies were conducted. The studies (1) compared flight data for missions that had ET bipod foam liberation; (2) compared flight data for missions that flew a Light Weight Tank (LWT) in combination with ascent Performance Enhancements (PEs), a package of vehicle software and hardware changes designed to increase overall weight to orbit capability for the ISS; (3) analyzed external aerodynamic loads on the ET forward attach bipod ramp; and (4) studied integrated orbiter/ET vehicle loads.

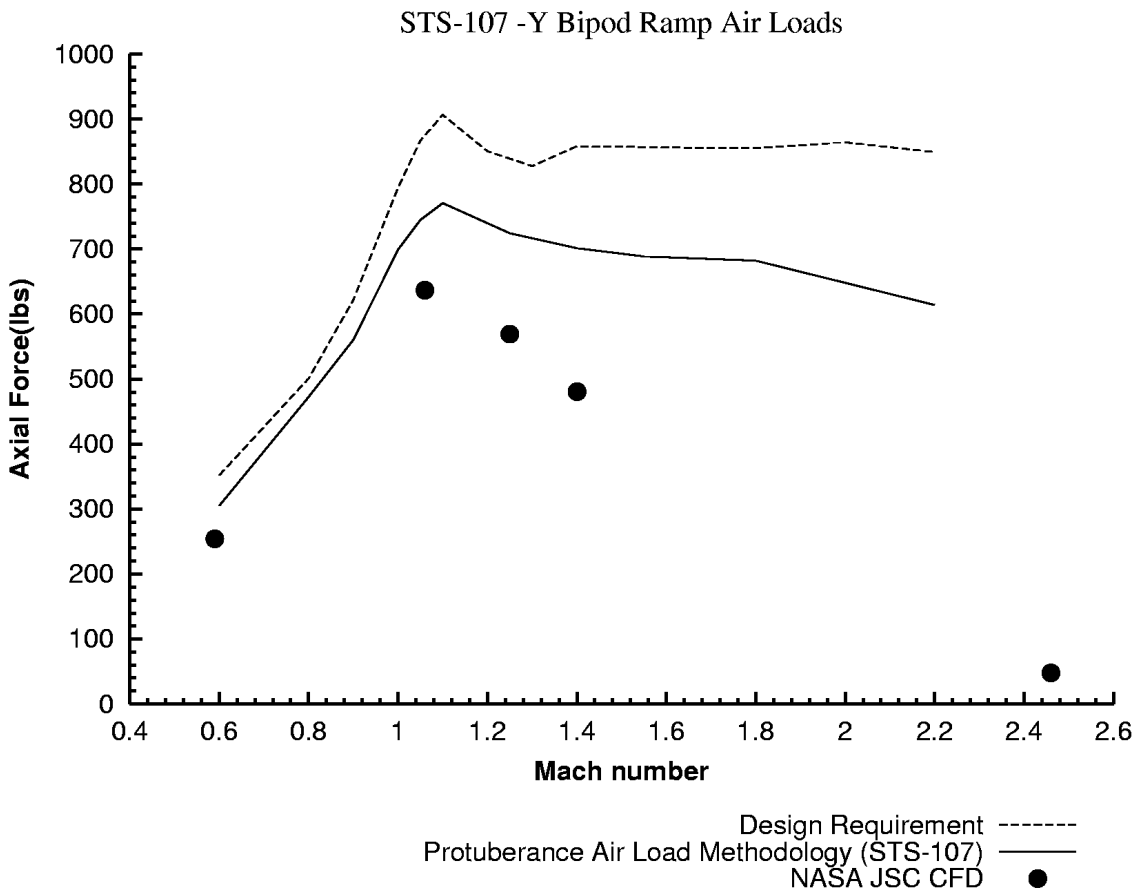
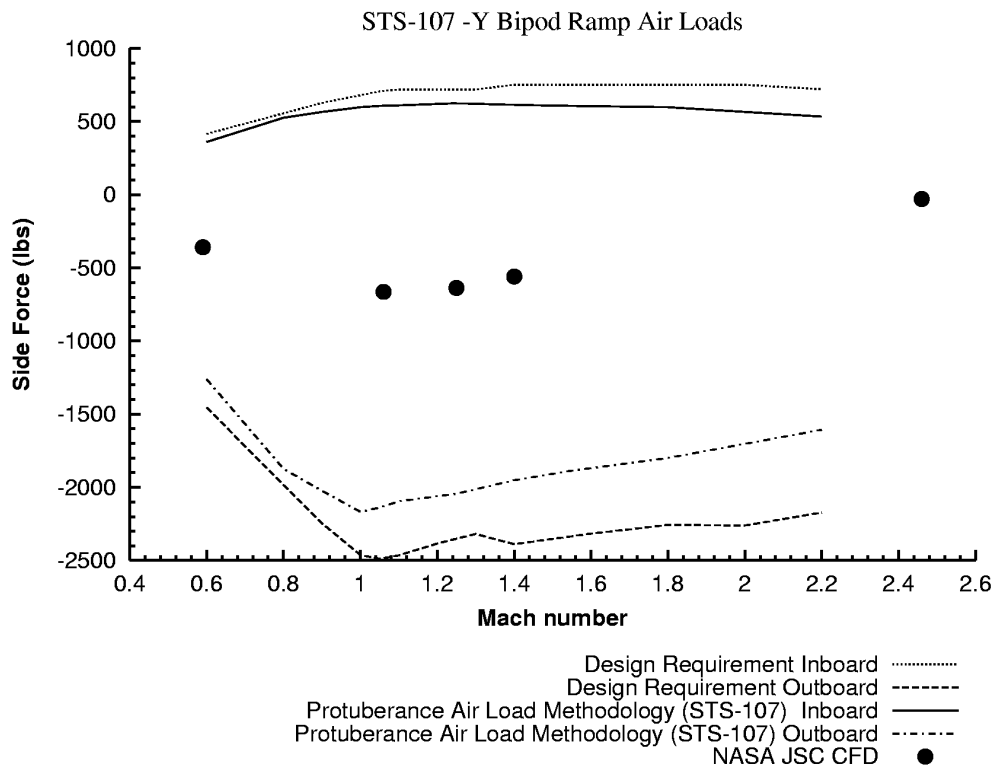
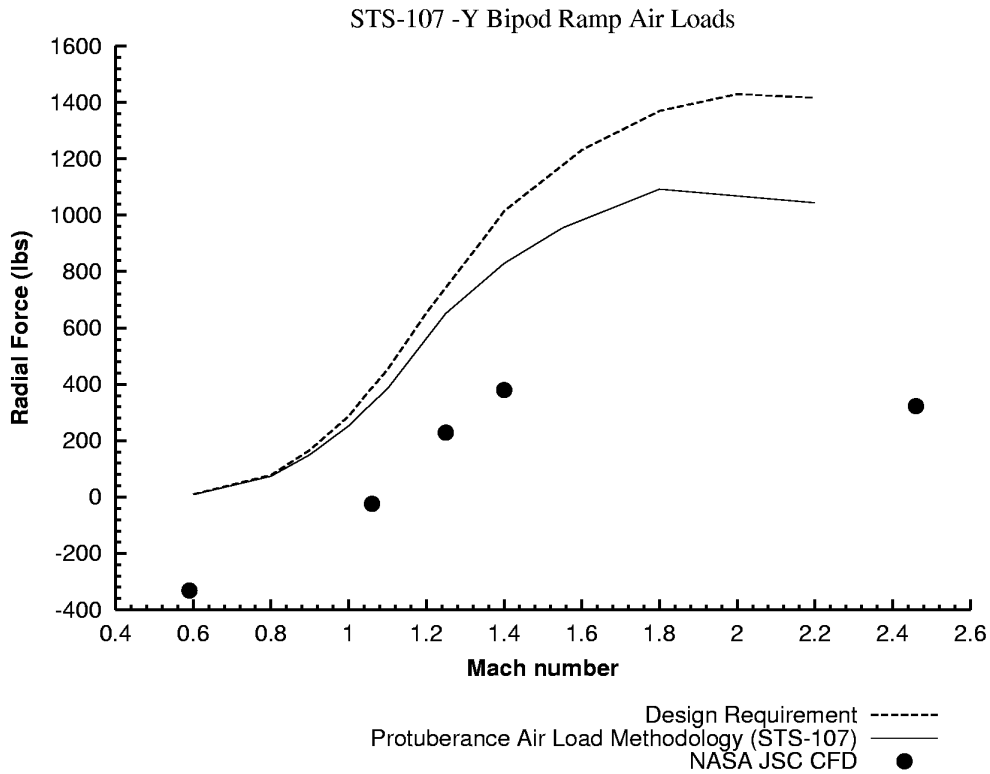
The external aerodynamic loads on the ET forward attach bipod were analyzed using a CFD simulation. The simulation produced axial, side-force, and radial loads as shown in Figure 3-26, Figure 3-27, and Figure 3-28, respectively. The CFD assessment of the bipod area indicated that the external air loads were below the design limit during the Hi-Q region and at the time of the bipod foam liberation.

Flexible body simulation results indicate that all vehicle elements and associated loads were within required limits. The reconstruction loads analyses indicate that the ascent environment-induced loads alone did not cause the ET bi-pod foam loss.

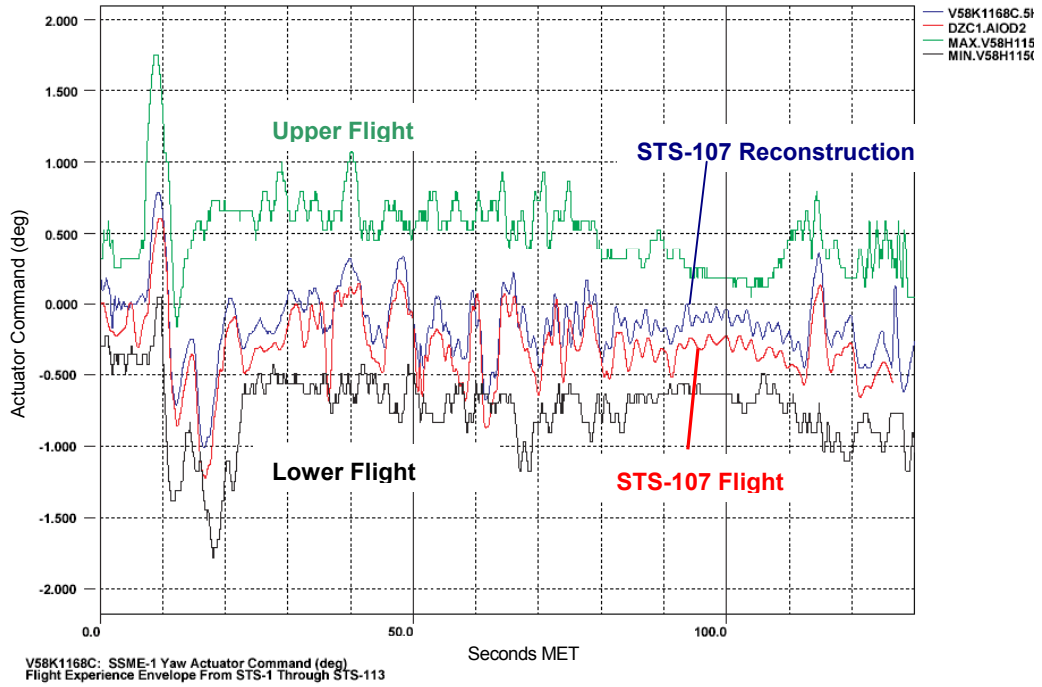
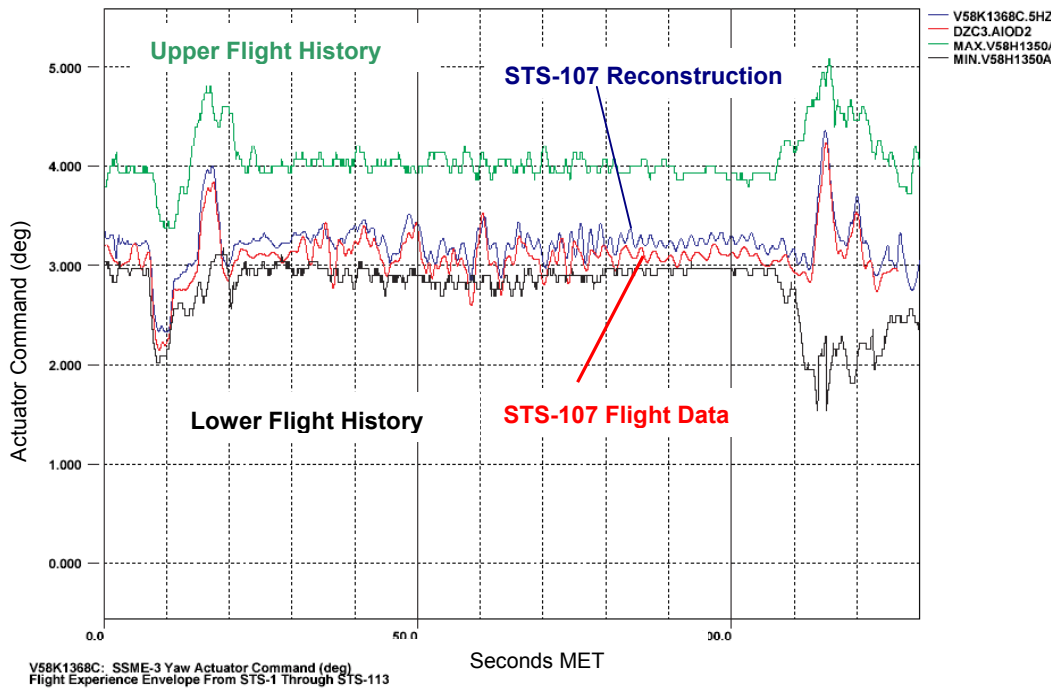
A review of the STS-107 ascent data identified two discrete points in time when the SRB and SSME nozzle positions exceeded the flight experience envelope for those respective times in the ascent profile. The first event occurred when the center and right SSME yaw deflections exceeded the previous flight experience envelope during the period of maximum dynamic pressure, as a result of the differences between predicted and actual flight wind conditions (as shown in Figure 3-31 and Figure 3-32).

The large offset in the Center and Right SSME yaw positions at 62 seconds MET was the reaction of the flight control system to the wind shear event and day-of-launch wind differences as compared to the DOLILU design. The nozzle motion was within the capability of the Shuttle flight control system, and the system operated as designed. As discussed in Section 3.5.1, the reconstruction loads analyses indicate that the ascent environment-induced loads alone did not cause the ET bipod foam loss.

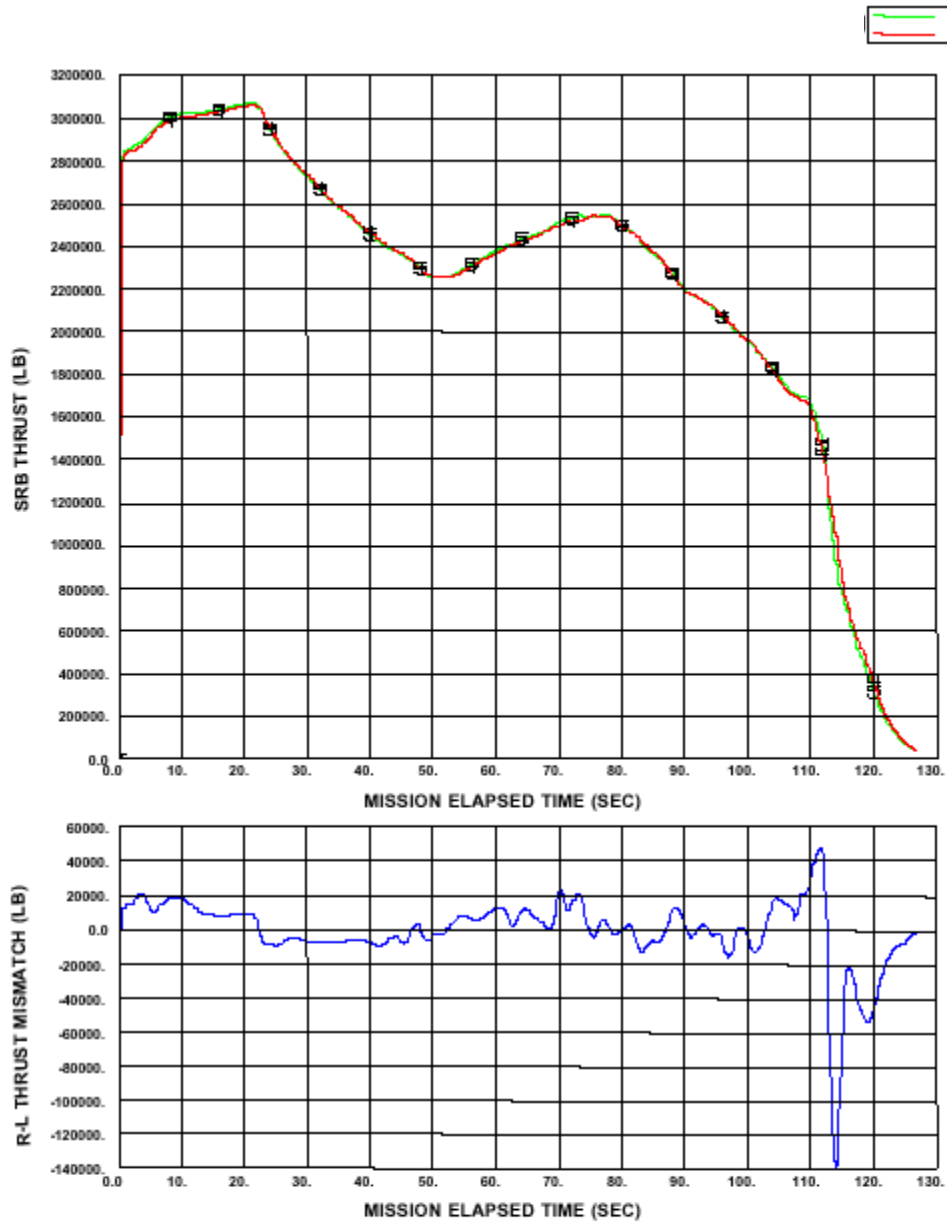
Figure 3-34. SRB thrust mismatch

The SRB thrust mismatch observed during tail-off was well within the design margin of the flight control system, and similar occurrences have happened numerous times during previous flights.

The data indicate that the SRB thrust mismatch on STS-107 was a direct result of SRB burn rate differences between the left and right SRB. The thrust mismatch observed on STS-107 and the new flight experience nozzle positioning occurred after the foam shedding event. The SRB thrust mismatch occurred on the majority of flights in both families of flights, including those that did not shed foam.

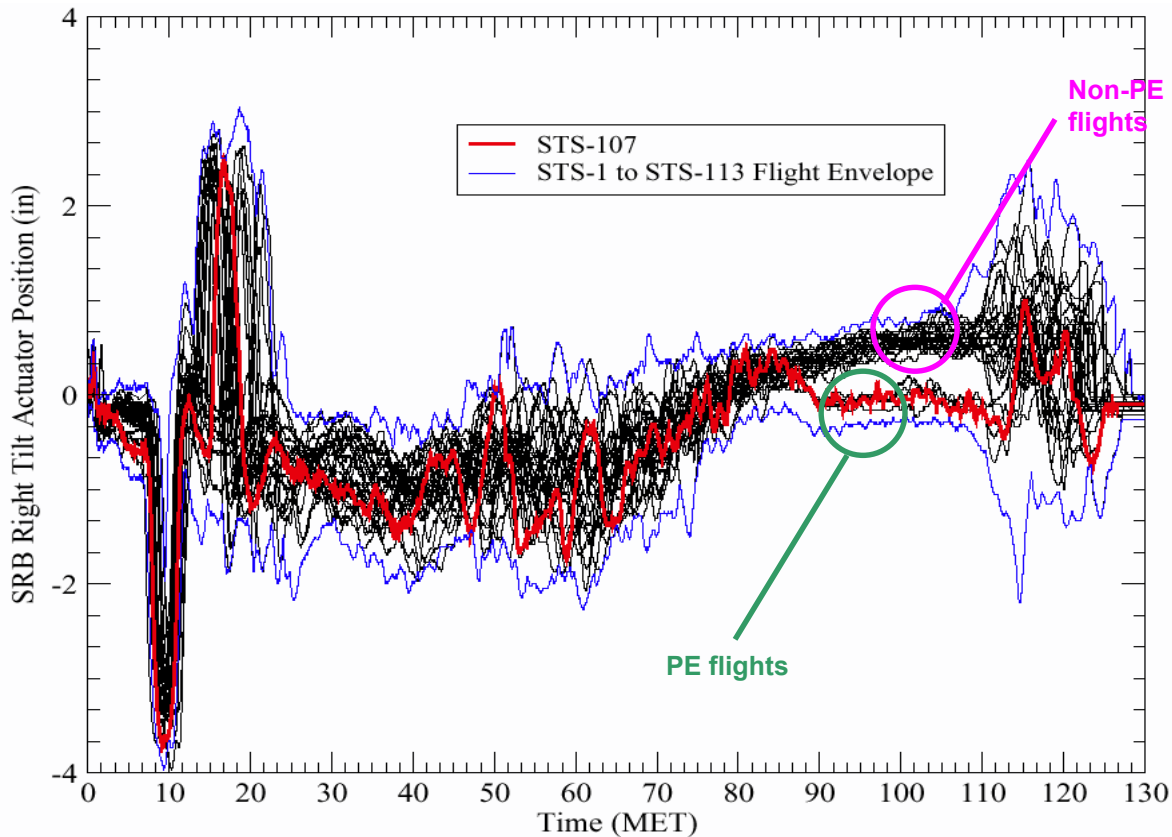
Figure 3-35. SRB nozzle position for PE flights versus non-PE flights

Due to flight control gain settings unique to PE flights, PE flights have a nozzle position closer to zero inches deflection from 85 to 110 seconds MET. The flight data that coincides with the STS-107 data are all from PE flights, seen clearly in the 85 to 110 seconds MET timeframe in Figure 3-33. The other grouping of flights in this same timeframe (85 to 110 seconds MET) are all non-PE flights and have larger pitch nozzle deflections.

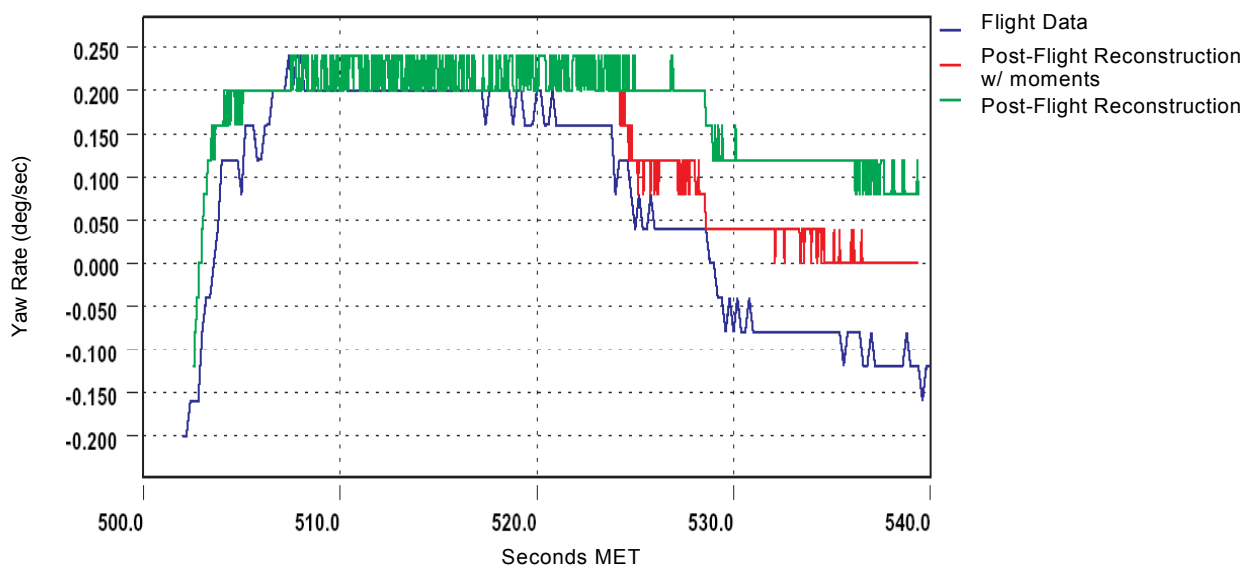
A higher than typical negative yaw rate was observed at ET separation during STS-107. The yaw rate, shown in Figure 3-36, was approximately -0.12 deg/sec and near the edge of the flight experience envelope. The negative yaw rate is noteworthy because it does not correspond to the flight control system's thruster activity, known vent forces, or any other explained mission activity. Furthermore, the rate appears at the time of physical separation between the orbiter and external tank, which indicates that it is related to the structural release between the two objects. Although the negative yaw rate was unusual, it was well within the design and certification envelope for ET separation. This rate was also well within the flight limits (± 0.7 deg/sec) for ET separation to occur.

Figure 3-36. ET separation yaw rate

A fault tree analysis narrowed down the cause of the negative yaw rate to a release of strain energy at ET separation due to either (1) a misalignment of the orbiter and external tank at structural mating, or (2) a build up of strain energy in the ET structure

Data indicate that the yaw rate at ET separation did not result in re-contact between the orbiter and the ET after separation. This observation is based on high rate telemetry (25 Hertz) orbiter body rate data, and MADS accelerometer data analyzed post-flight. The yaw rate was within the expected range of vehicle body rates when taking into account all known error sources, including rate sensor noise. The data indicates that no correlation exists between observed yaw rate at ET separation and bipod ramp foam loss.

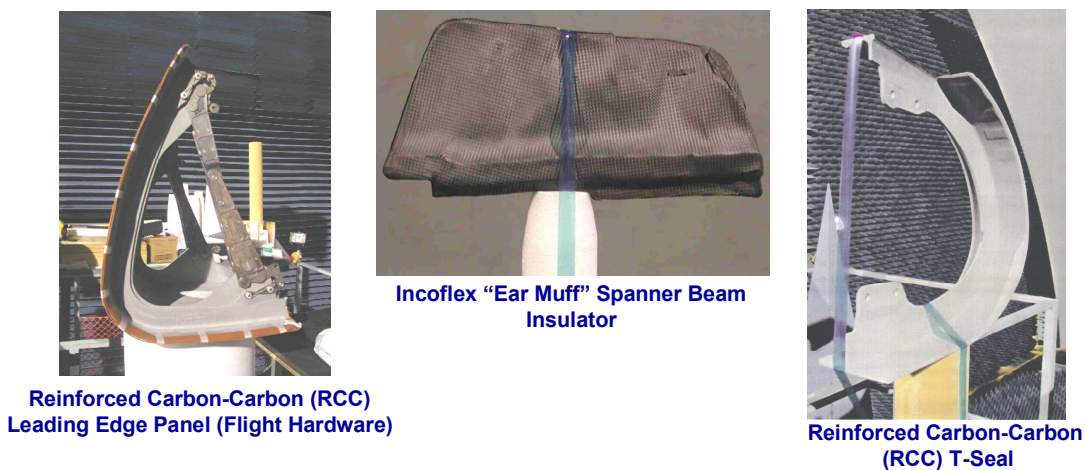
The results of this radar testing and ballistics analysis have excluded all external Shuttle materials with the exception of 1) a whole Tee seal, 2) a Tee seal fragment that includes an attachment flange and/or apex segment, or 3) RCC panel acreage no less than 90 square inches and roughly square in shape (+/- 20%), although curvature is possible, with a thickness on the order of 0.33 inches. An RCC panel segment matches the RCS and ballistic performance characteristics observed during the STS-107 mission.

A Tee seal fragment with an apex segment matched the RCS characteristics extremely well in any spin orientation; however, the ballistic match required a very specific spin orientation that was shown to be feasible in one analytical simulation. Therefore, it is possible that the flight day 2 object was either a partial Tee seal or RCC panel acreage piece. The Incoflex spanner beam “ear muff” insulation was also a good match for both ballistics and RCS. Because the “ear muff” is situated behind the RCC panel, it is excluded from being considered a very likely candidate because of the lack of a mechanism for exposing it to the space environment. If the damage to the wing were actually a 10-inch diameter, uniformly round hole, then an “ear muff” would be a more plausible candidate. However, it is considered unlikely that the wing damage was a 10-inch diameter round hole. The damage is considered to be the equivalent of that which would provide the same thermal response during entry as a 10-inch diameter hole did in the analyses and simulation. It is not likely that the actual wing damage was geometrically uniform. The damage was more likely a combination of cracks and holes, or a slot, such as a Tee seal or partial Tee seal missing or displaced. Therefore, the ear muff is not considered to be a good candidate for the flight day 2 object. Figure 4-6 shows the three leading edge components that match both RCS and ballistics analysis. It should be noted that a full Tee seal and RCC panel are shown in these photos while there are specific partial Tee seal and RCC panel configurations that match the test results.

Figure 4-6. Leading edge structural subsystem components matching RCS and ballistics

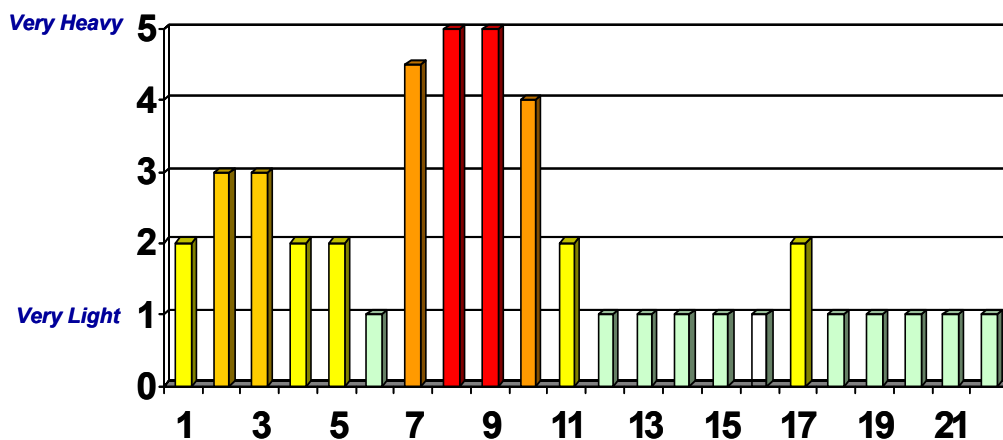
The forensic data indicate that the panel 8/9 area was subjected to extreme entry heating over a long period of time leading to RCC rib erosion, severely slumped carrier panel tiles, and a substantial slag deposition on the upper portion of RCC panels 8 and 9. Figure 5-2 shows the slag deposition (both metallic and oxide) in the RCC panel 8/9 area relative to the other parts of the wing leading edge, and Figure 5-3 shows samples of the severe slag deposition on the panel 8 rib. A review of all recovered debris indicates that this is the most probable area of a breach into the wing since there are no other debris pieces that exhibit the unique characteristics observed in this area.

Figure 5-2. Slag deposition in the RCC panel 8/9 area relative to the other parts of the left wing leading edge

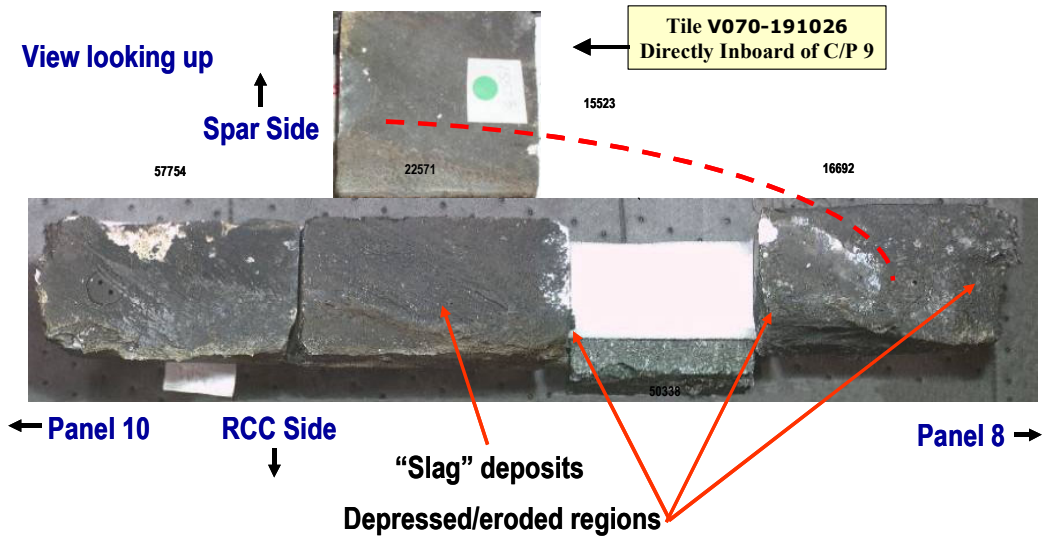
Based on the slag deposition on the upper RCC panel 8 and the rib erosion at the panel 8/9 interface, the most likely area of damage was the bottom portion of RCC panel 8. The outboard apex on the panel 8 upper inboard rib shows knife edge erosion, and the rib tapers from a design thickness of 0.365 inches to 0.05 inches. The surface of the panel 8 outboard rib and matching heel piece show a similar sign of erosion, as does the panel 9 upper inboard rib. The erosion on both the panel 8 and 9 rib is on the inboard side, indicating that flow is coming from the panel 8 location. Additionally, several lower carrier panel tiles in the RCC panel 9 area also show significant slumping and erosion that is consistent with a hole or breach in the lower part of RCC panel 8. Figure 5-4 and Figure 5-5 show an example of the rib erosion and the flow on the lower carrier panel 9.

Figure 5-5. Flow on the lower carrier panel 9 tiles

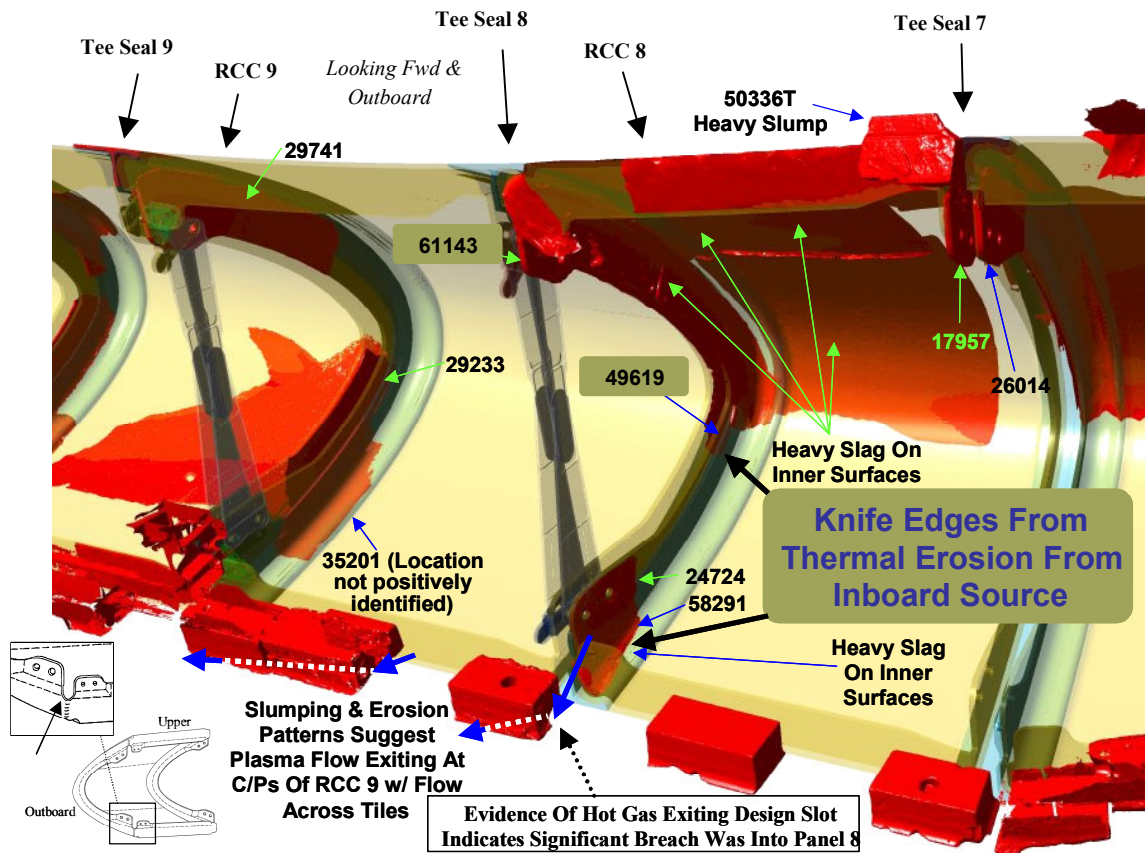
Figure 5-6 is a CAD drawing of the recovered debris showing overall slag deposition and erosion patterns. The drawing is a view from behind the RCC panels since this provides the best view of the erosion and slag deposition. Three full Tee seals can be seen in this drawing; the leftmost, Tee seal 9, divides panel 9 and 10; Tee seal 8 in the center divides panel 8 and 9; the rightmost, Tee seal 7, is the division between panel 7 and 8. The drawing shows the heavy slag deposition of the upper portion of panel 8 indicating that the probable breach area was the bottom of panel 8. The severely eroded RCC ribs are also visible near the RCC panel 8/9 Tee seal. The heavy slag on

these inner surfaces indicate flow from the panel 8 direction toward panel 9. This is also consistent with the knife-edge erosion shown in Figure 5-4 below. The proposed flow direction leading to the erosion and slag deposition on the lower carrier panel 9 tiles can be seen in this view as well. The detailed flow, erosion, and deposition are best viewed in Figure 5-5. The last significant feature in Figure 5-6 is the heavy slumping that is observed on the upper carrier panel 8 tile (50336T) in the upper right portion of the drawing.

Figure 5-6. CAD drawing of the recovered debris showing overall slag deposition and erosion patterns

The data shown in Figure 5-6 is important when combined with the analysis of the slag deposition. The slag deposition on the upper RCC panel 8 was analyzed using sophisticated cross sectional optical and scanning electron microscopy, microprobe analysis, and x-ray diffraction to determine the content and layering of the slag deposition. This analysis indicated that the materials in this area were exposed to extremely high temperatures, since Cerachrome insulation was deposited first and its melting temperature is greater than 3200 degrees Fahrenheit. The analysis also showed no presence of Aluminum 286 in the slag indicating that the RCC attach fittings were not in the direct line of the breach and that the Inconel 718 spanner beam was one of the first internal items to be subjected to heating. Inconel slag was prevalent in much of the analyzed slag indicating melting of the spanner beam, foil, and associated insulation. Aluminum was found in the last deposited layer indicating the wing honeycomb spar was the last area to be subjected to hot gas flow.

This forensics analysis further corroborates the breach location to be the lower portion of RCC panel 8 below the apex, approximately midway between the apex and where the RCC panel meets the carrier panel. Based on the flow patterns, the breach was in an area that caused the flow to impact the spanner beam associated with Tee seal 8 and create the knife edge erosion shown in this area in Figure 5-6.
