COLUMBIA ACCIDENT INVESTIGATION BOARD (CAIB)/
NATIONAL AERONAUTICS AND SPACE ADMINISTRATION (NASA)
ACCIDENT INVESTIGATION TEAM (NAIT)

WORKING SCENARIO

FINAL VERSION: JULY 8, 2003

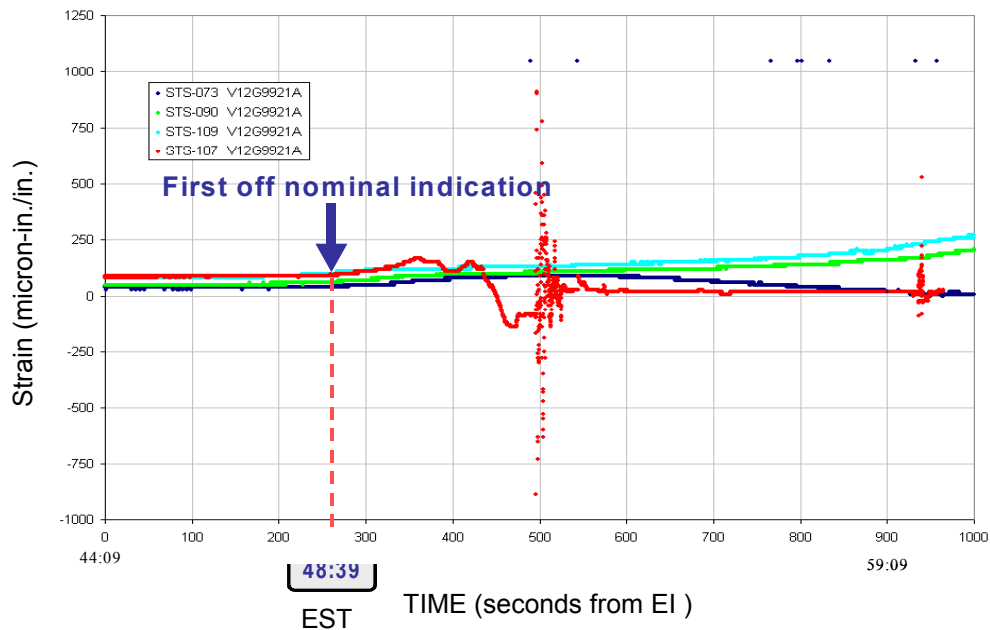
At approximately 8:48:39 EST (EI + 270 sec.), a left wing leading edge spar strain gauge began a small off-nominal increase. Figure 5-11 shows the STS-107 response of this strain measurement along with three other previous Columbia missions. Figure 5-12 shows the location of this sensor (WLE Strain V12G9921) and others on the wing leading edge. The damage in lower RCC panel 8 is believed to be the cause of this strain increase. The breach allowed hot gas intrusion onto the panels 8 through 9 wing leading edge spar area leading to extreme heating and thermally induced strain. The strain increase grew over time and reached a maximum at approximately 8:50:09 EST (EI + 360 sec.). Thermal and structural analyses indicate that a breach would need to be within approximately 15 inches of the strain gauge to create the observed strain increase.

Figure 5-11. Left wing RCC panel 9 strain gauge is first measurement to indicate an off-nominal event. Note that EI was at 8:44:09 EST.

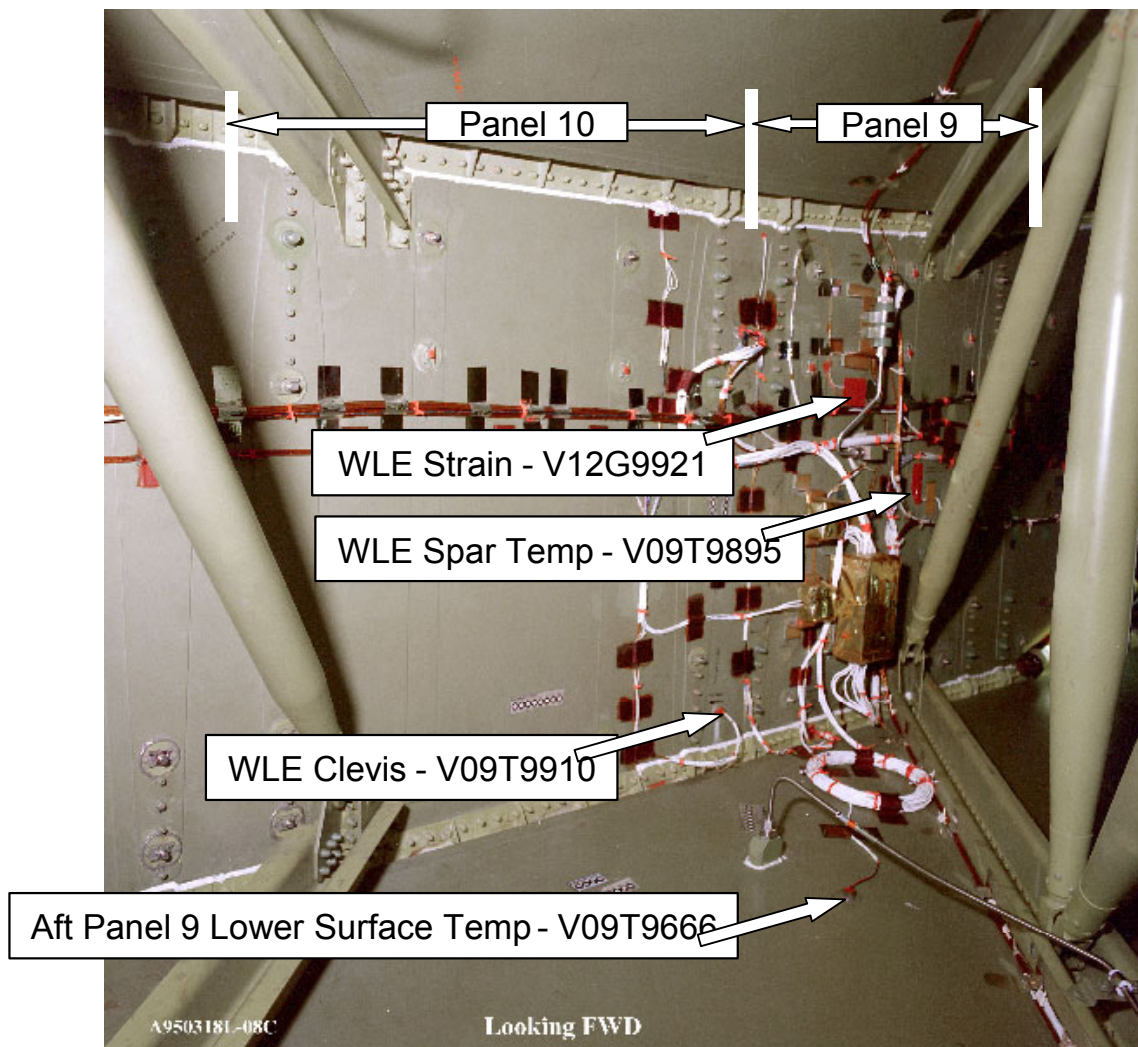
Figure 5-12. MADS sensors inside left wing

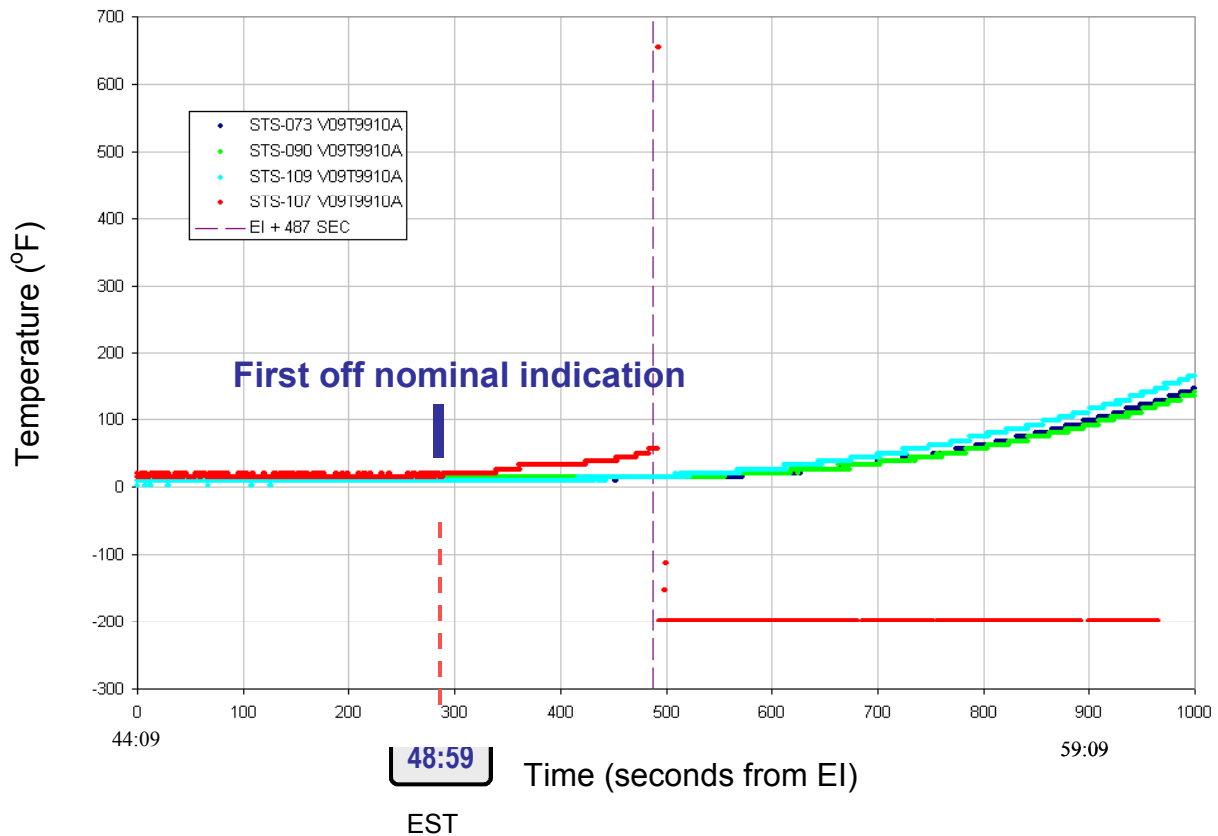
Twenty seconds later at 8:48:59 EST (EI + 290 sec.), the left wing lower attach clevis temperature sensor (between RCC panel 9 and 10) began an early off nominal temperature trend. Figure 5-13 shows the abnormal temperature response when compared to other Columbia missions. This temperature rise is consistent with an early entry of hot gas into the RCC cavity. This Modular Auxiliary Data System (MADS) measurement (V09T9910) is the only temperature measurement located in the RCC cavity along the left wing leading edge. It is positioned on the lower attach fitting between panel 9 and 10 and is well protected thermally by Inconel foil insulation. The sensor is also thermally isolated since it sits on the attach fitting away from other structure as shown in Figure 3-15. In order to get an early temperature rise for this sensor, unlike that observed on any other flight, there must be a path in the RCC cavity to allow hot gas to reach the sensor.

A thermal analysis was performed with heating rates from various hole sizes in the bottom of RCC panel 8 in an attempt to match this temperature rise. The analysis used a thermal math model of the wing leading edge (Inconel Cerachrome insulation, Inconel 718 and A-286 steel attach fittings, and aluminum honeycomb spar). The results indicated that the heating equivalent of a 6 to 10 inch diameter hole with a 10 percent “sneak flow” around the insulation would be required to match the thermal response of the clevis temperature. In the same timeframe several MADS lower surface temperatures on the left wing showed a slight off nominal early temperature rise when compared to previous flights of Columbia of the same inclination.

Figure 5-13. Left wing RCC panel 9/10 clevis temp sensor is second measurement to indicate an off-nominal event

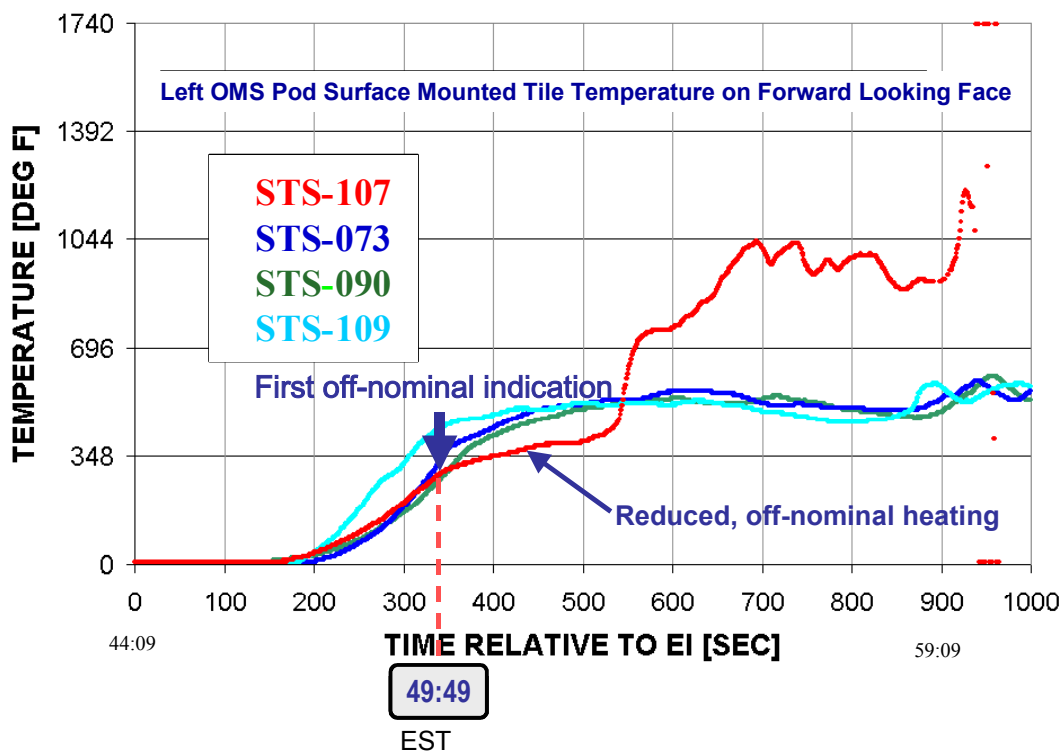
Columbia executed a nominal roll to the right at 8:49:32 EST (EI + 323 sec.) as the entry guidance software began to actively control energy (i.e., closed loop guidance) to land at KSC. This initial roll command is also timed to ensure atmospheric capture by reducing the lift on the vehicle. Within 17 seconds of this maneuver, at 8:49:49 EST (EI + 340 sec.), four left OMS pod surface temperature measurements showed an off-nominal trend with lower temperature rises when compared to similar Columbia missions. A sample of these measurements compared to other Columbia missions is shown in Figure 5-14, and the location of these measurements on the left OMS pod forward face can be found in Figure 5-15.

Figure 5-14. Typical off-nominal OMS pod thermocouple (V07T9220A)

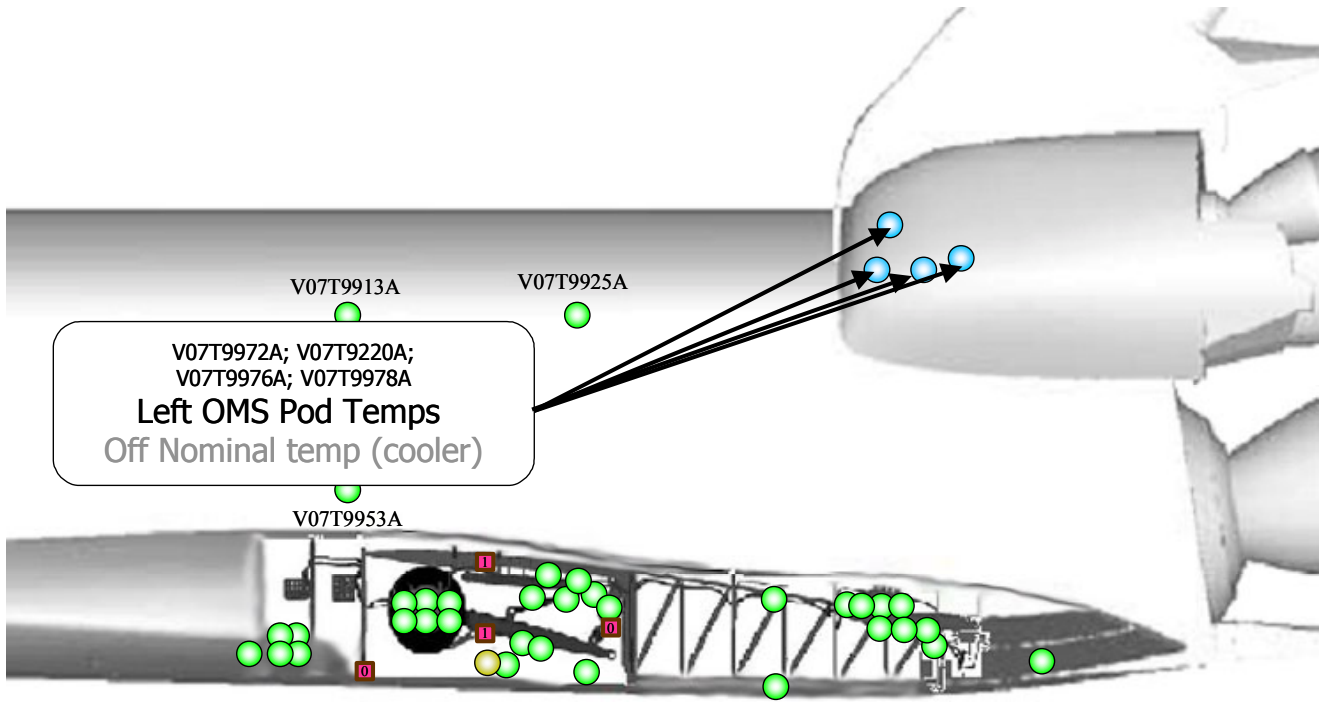
Figure 5-15. Location of OMS pod thermocouples off-nominal low

The reduced heating is not completely understood since the weak aerodynamic flow field on the upper surface of the orbiter is difficult to model and is extremely sensitive to disturbances. The best explanation for this reduced heating is that flow into the RCC cavity was venting through to the upper surface of the wing through an existing 0.1-inch vent between the RCC and upper surface carrier panels. This vent exists all along the leading edge from RCC panel 1 through panel 22 and has an approximate area of 66 square inches. This upper surface RCC venting and the flow disturbance created by the panel 8 and upper carrier panel 8 damage caused the vortices from the canopy or area where the wing meets the orbiter fuselage to move from their normal positions, thus reducing the heating on the OMS pod. Figure 5-16 depicts the change in the upper wing surface vortices and the weak upper surface flow.

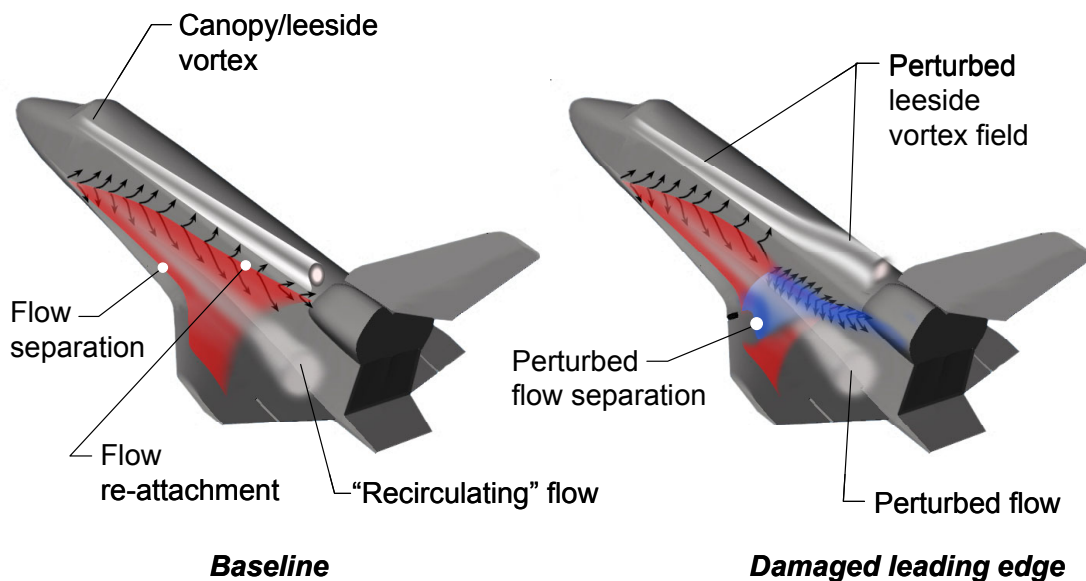
Wing leading edge damage perturbs leeward flow separation and re-attachment locations as well as leeward embedded shocks (not shown)

Figure 5-16. Postulated orbiter leeside flow field associated with wing leading edge damage

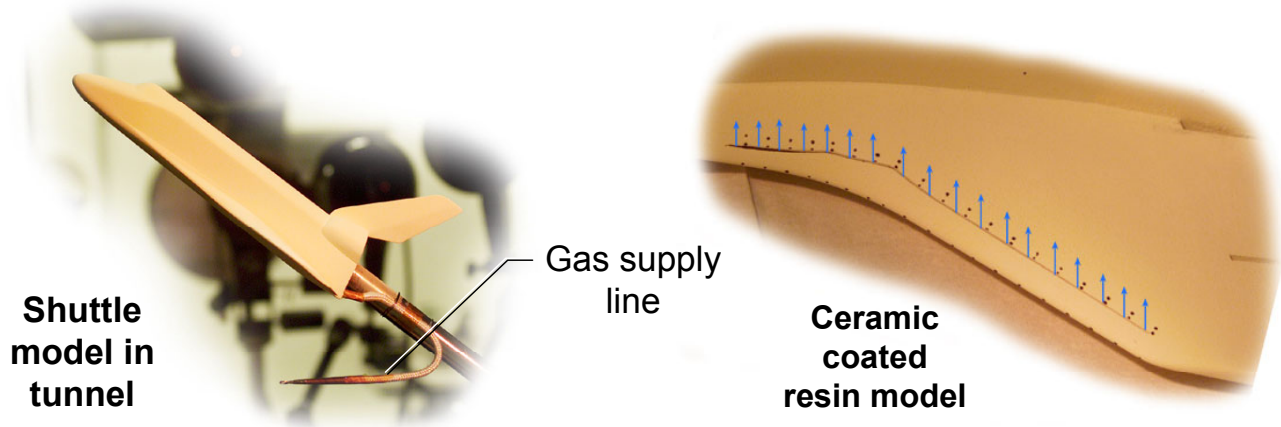
In order to verify this theory of a weak upper surface flow being disturbed from venting on the upper surface, several wind tunnel tests were performed in the NASA Langley Research Center Mach 6 Tetrafluoromethane (CF₄) Wind Tunnel. The use of CF₄ as the gas for the flow analysis is required to best replicate the Mach number environment during this timeframe. These wind tunnel tests used a ceramic model and a 0.01-inch leading edge vent to mimic the postulated venting. Nitrogen gas was allowed to flow through this upper surface vent via a gas supply line. A picture of this model is shown in Figure 5-17. Results of this testing show that it is feasible to obtain reduced heating on both the left OMS pod and the left fuselage as a result of flow through the RCC upper surface vent. Figure 5-18 shows the change in heating as the vent velocity is altered.

Figure 5-17. Orbiter wind tunnel model with vent gap along wing leading edge

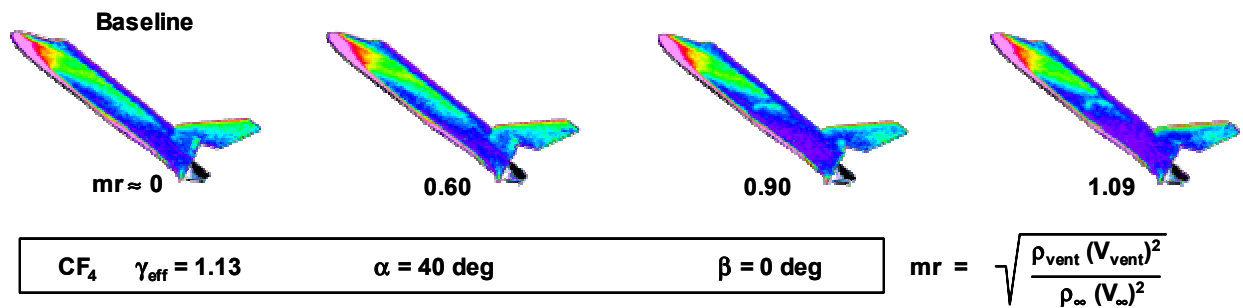
Figure 5-18. Wind tunnel model results for sensitivity of orbiter side fuselage and OMS pod heating patterns to mass addition along WLE leeside vent gap

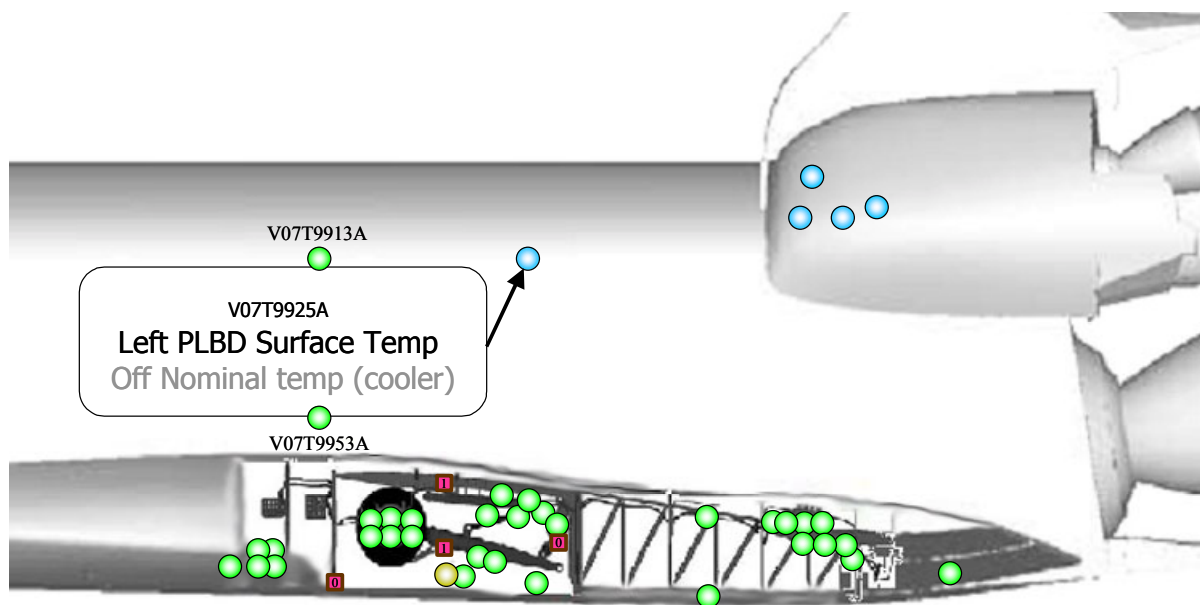
In the same timeframe, at 8:50:09 EST (EI + 360 sec.), a left payload bay fuselage MADS surface temperature measurement (Figure 5-19) showed an off-nominal temperature trend. This trend is a reduced rise rate when compared to other previous Columbia missions, as shown in Figure 5-20. The previously discussed theory of venting and or disturbed flow due to panel 8 damage, causing a shift in the vortices on the upper surface of the wing, is also believed to be the cause of this off-nominal behavior. The flow field and venting on the upper surface rate are constantly increasing since the mass flow rate into the RCC breach is increasing as the orbiter descends lower into the atmosphere.

Figure 5-19. Location of left sidewall temperature sensor

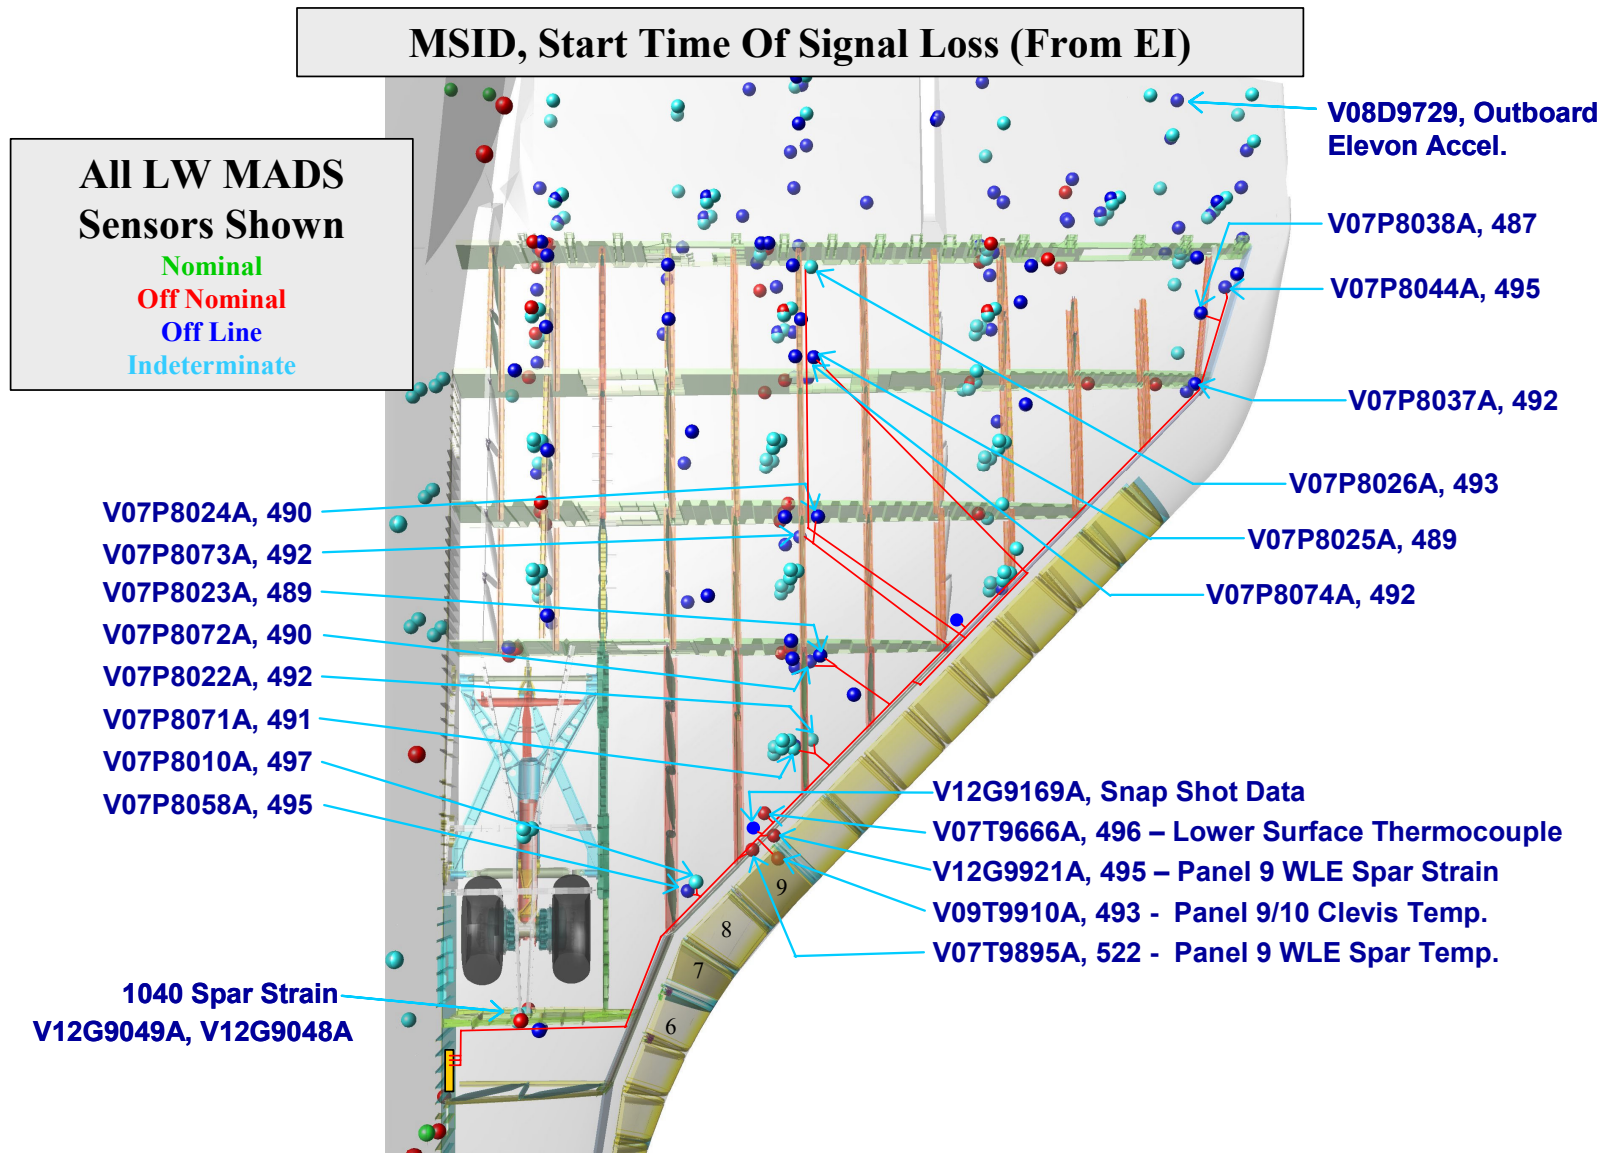
Figure 5-22. Left wing MADS sensors, including Measurement Stimulation Identification (MSID) number, and start time of loss of signal (EI + sec.)

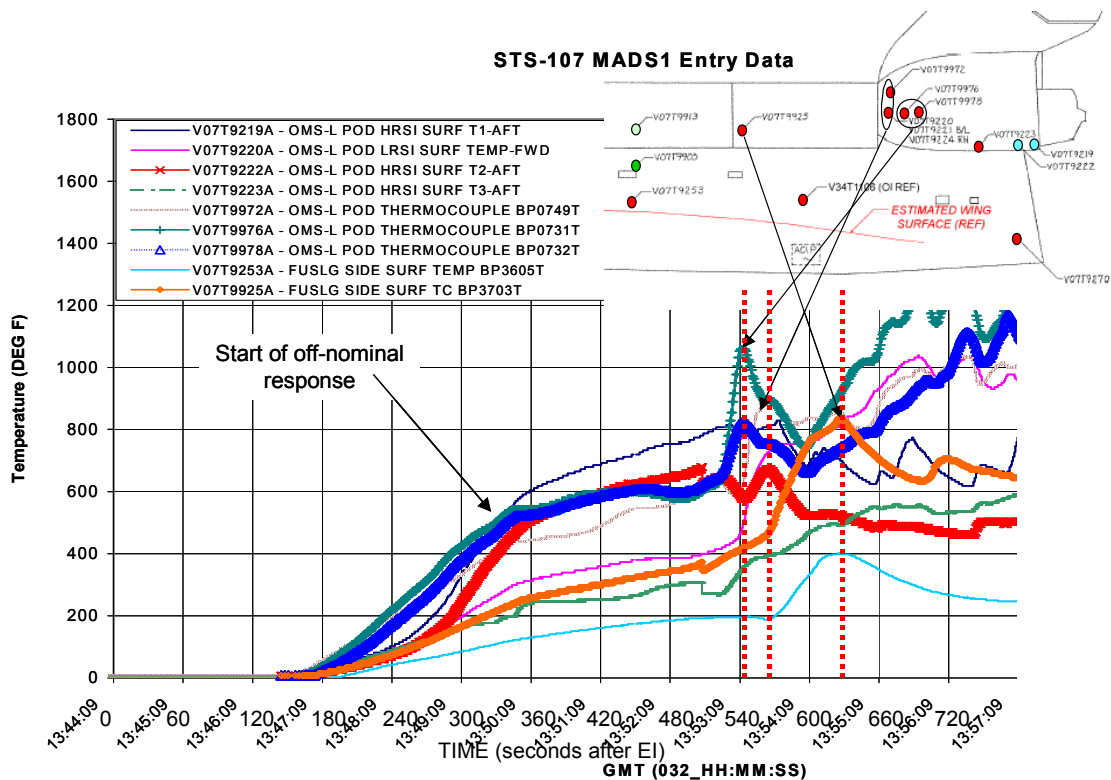
Figure 5-25. Left side fuselage/OMS pod off-nominal responses indicate increased heating

These off-nominal temperature rises were caused by a change in the flow field along the upper portion of the left wing as the wing leading edge (WLE) and wing spar damage progressed. The mechanism was a shift in the vortices due to venting on the upper portion of the wing and is similar to the previous discussions on lower than expected OMS pod temperatures. Wind tunnel testing and CFD analysis confirmed that WLE damage on RCC panels 8 and 9 could cause increased heating to the OMS pod due to disturbed upper surface flow or flow impingement caused by re-directed flow from the lower surface. Additionally, the molten Inconel 718 and A-286 spray onto this area are indications that this flow is the cause of these temperature rises. Figure 5-26 (from wind tunnel test results) is a representative example of increased heating on the left fuselage and OMS pod due to RCC panel 9 damage from wind tunnel test results. Figure 5-27 shows a similar picture of the left side as determined by CFD analysis. Note that neither the wind tunnel testing nor the CFD analysis accounts for increased heating that is likely due to molten metal contacting the OMS pod.

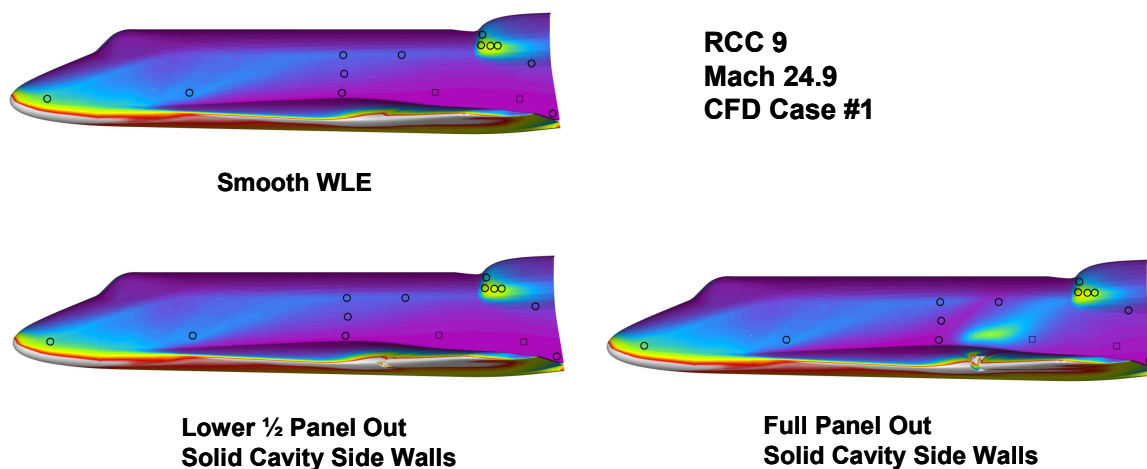
Figure 5-27. CFD results for no damage, partial damage, and full damage to RCC panel 9 show increased heating on side fuselage and OMS pod

The increased heating implies that damage/erosion to the RCC panel 8 area had increased or that at least one carrier panel had been lost. The increased heating is also consistent with an increased mass flow rate due to the nature of the entry environment. The dynamic pressure and stagnation heat flux had more than doubled by this timeframe when compared to a few minutes after EI. There are three additional communication dropouts that follow at approximately 8:52:09 EST to 8:52:31 EST (EI + 480 to 502 sec.). Again, these dropouts are consistent with molten aluminum and other metals being released into the environment surrounding Columbia.

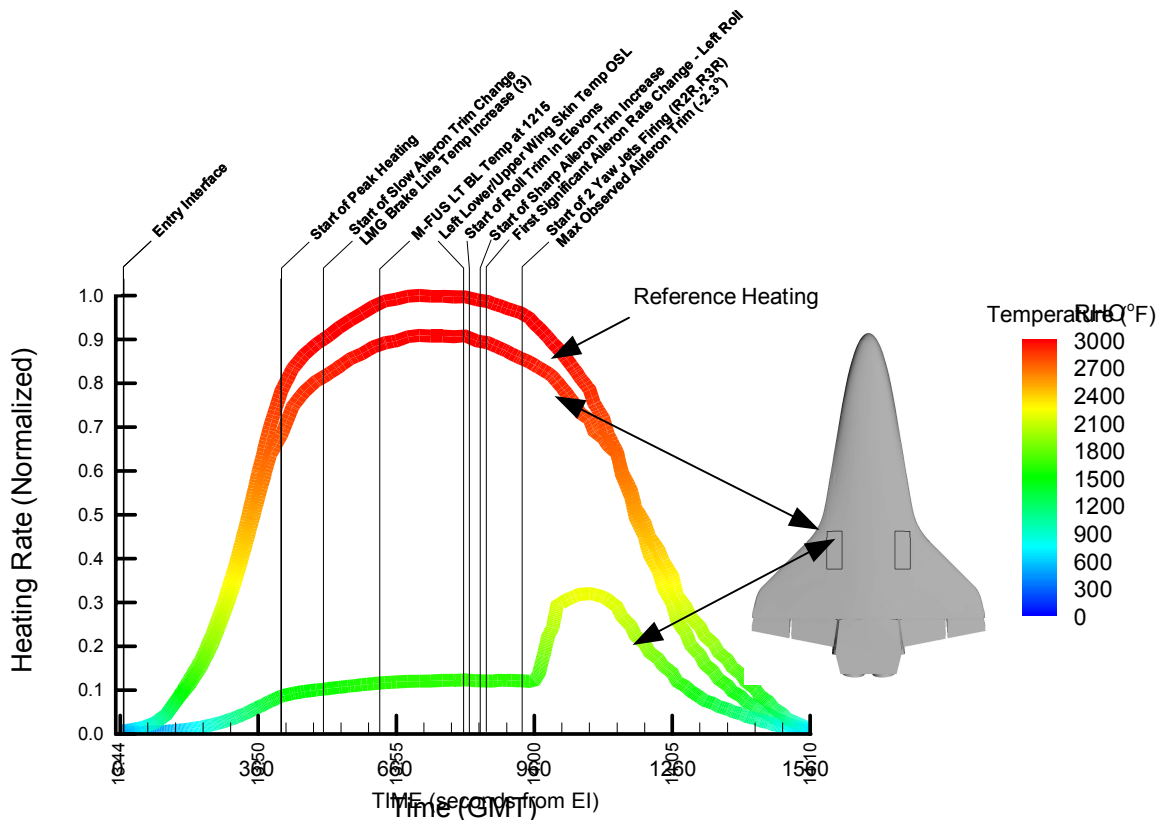
The next significant event was a breach through the left wing leading edge spar leading to many wire measurement failures and eventual deformation of the left wing. As discussed in Section 5.4.2, by approximately 8:52:00 EST (EI + 471 seconds), strain and temperature measurements indicated that hot gas had begun to weaken the wing spar. Figure 5-28 shows that the orbiter has entered the peak-heating region during this timeframe and would remain there for many of the ensuing events that will be discussed later.

Figure 5-28. STS-107 entry heating rate profile

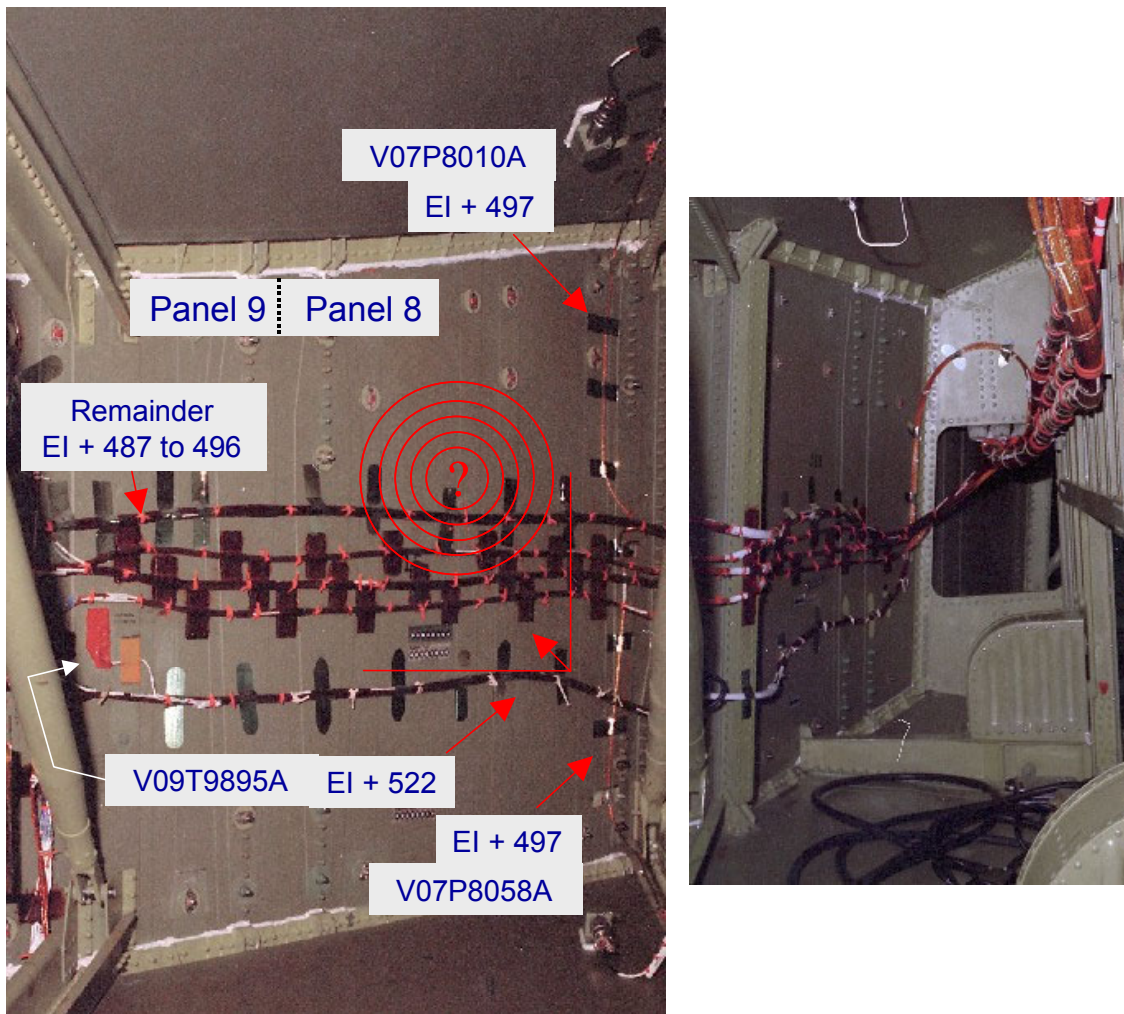
Figure 5-29. Cable routing on wing leading edge and wheel well wall

The final technique used was an examination of the wire failures on the wing leading edge spar. These wire runs are shown in Figure 5-29. The first measurement loss was a MADS upper left wing pressure measurement, which failed at approximately 8:52:16 EST (EI + 487 sec.). This measurement is contained in the upper wire bundle in the left photo in Figure 5-29. The combination of these three separate and distinct analyses results in a range of wing spar breach times as early as 8:51:14 EST and as late at 8:52:16 EST (EI + 425 to 487 sec.).

Immediately after the breach, hot gas inside the wing began to heat the remaining wire bundles that contained real-time telemetry and the recorded MADS measurements. Figure 5-29 shows an inside-the-wing view of the approximate breach location based on this wire failure analysis. The view on the left is of the panel 8/9 spar location. This area is not visible in the right photo, which contains the transition spar and a view of the three wire bundles along the outside of the wheel well wall. Figure 5-31 shows the overall spar breach location with respect to the rest of the wheel well. The distance from the spar to the wheel well wall in this area is approximately 56 inches, as shown in Figure 5-32. Figure 5-33 shows a sketch of the venting of the left wing into the payload bay, driving the direction of the internal flow depicted in Figure 5-31. Note the 142 square inch vent into the midbody fuselage located forward of the wheel well.

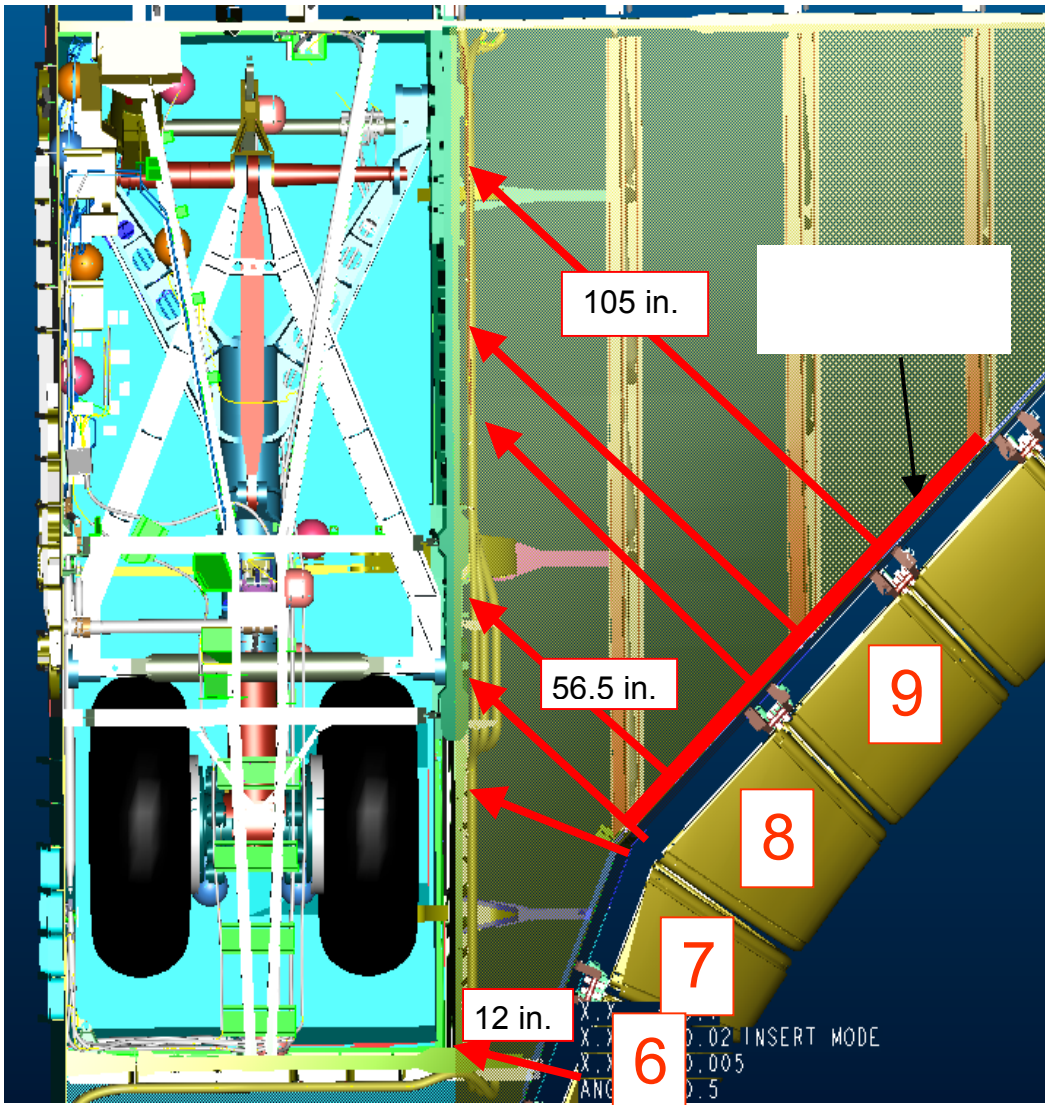
Figure 5-32. Columbia LH wing and wheel well geometry

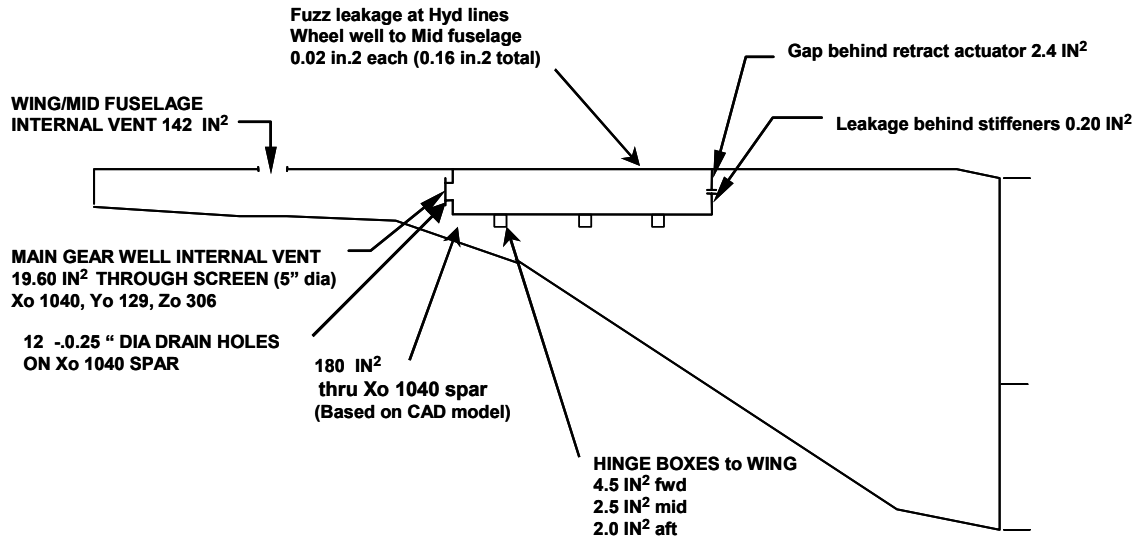
Figure 5-33. Columbia LH wing and wheel well vent model (wheel well leak paths based on Atlantis test comparison)

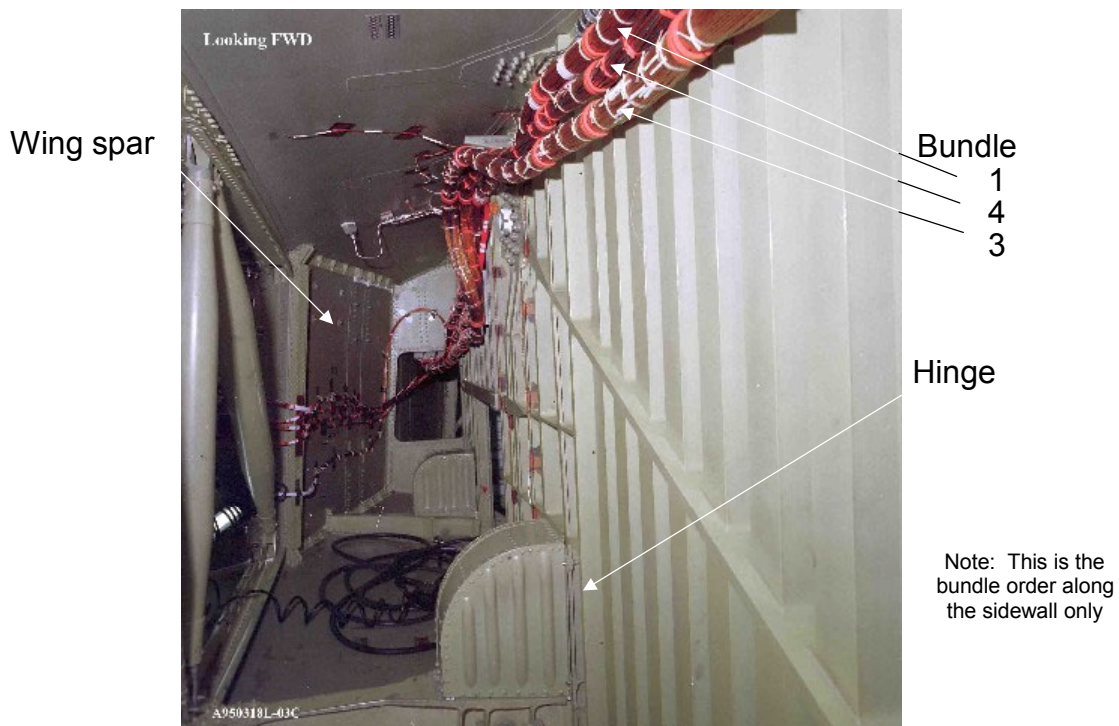
Figure 5-35. View of cables running along outside of wheel wall cavity bulkhead

Four additional measurements failed after 8:54:16 EST (EI + 605 sec.) with the last starting to fail at 8:56:24 EST (EI + 735 sec.). This last measurement failure took over a minute to fail completely. Figure 5-34 and Figure 5-35 show the measurement loss timing and the wire bundle runs along the wheel well. Although almost all measurements internal to the wing failed, two strain measurements on the 1040 spar (forward of the wheel well) were unaffected and produced data until loss of all MADS data at 9:00:13 EST (EI + 964 sec.). Figure 5-36 shows the location of the sensors on the forward wheel well spar. The fact that these measurements are available until loss of data are important indicators that the RCC breach could not be forward on the panel 6 area since these measurements would have been lost as well (see Figure 5-32). These measurements also record key changes in strain that help indicate some of the changes that the left wing underwent as the remainder of the entry events unfolded.

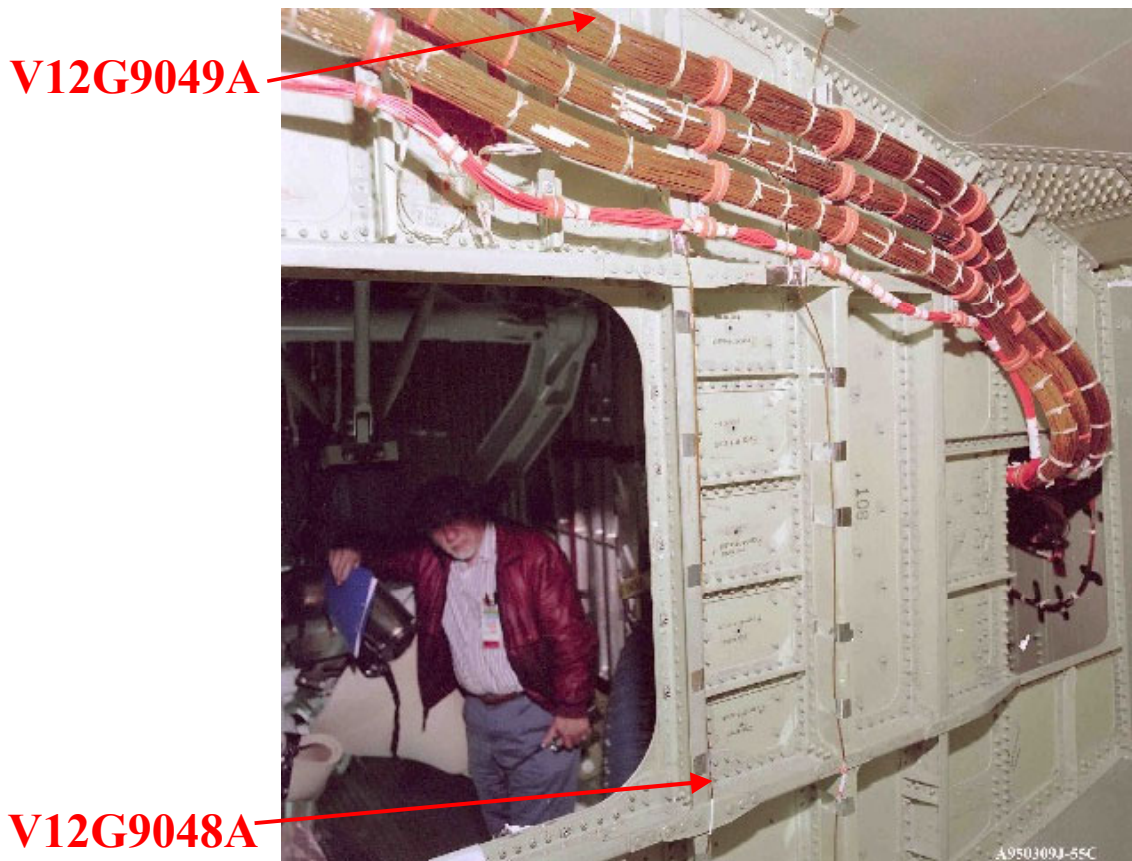
Figure 5-36. Strain measurements on 1040 spar

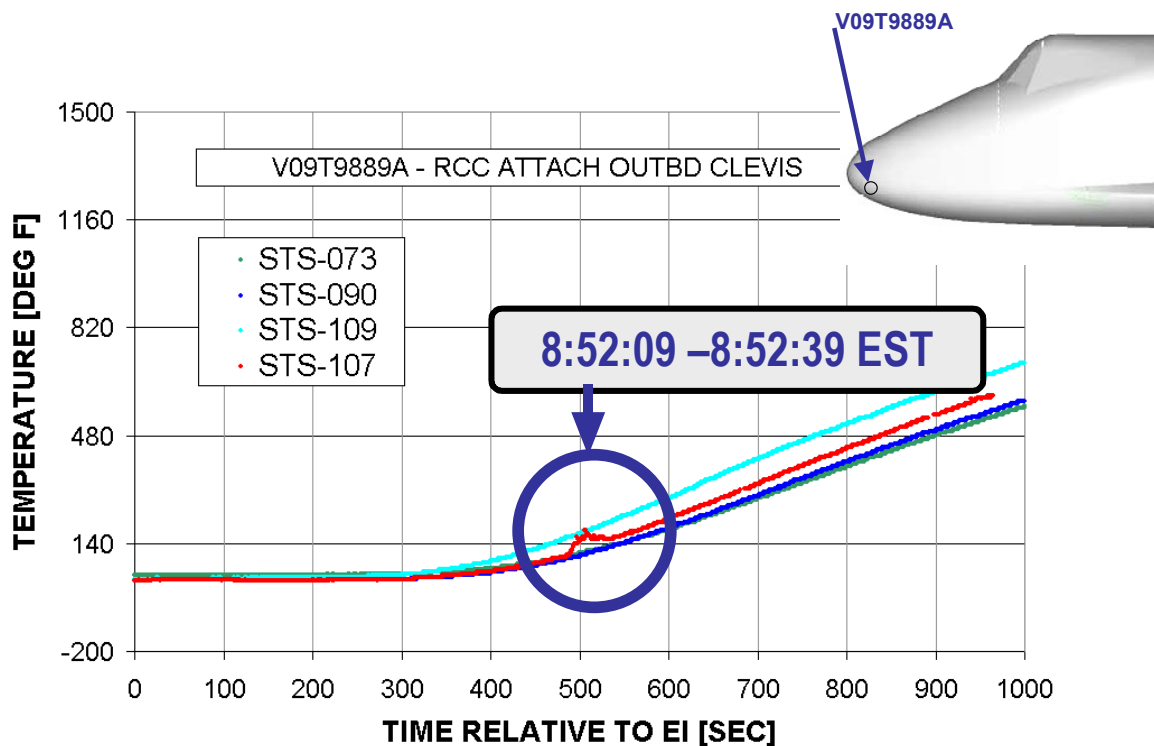
Coincident with the spar breach at approximately 8:52:09 EST (EI + 480 sec.), the nose cap RCC attach clevis temperature had an off-nominal change in rise rate when compared to previous missions. This rise rate was abnormal for approximately 30 seconds and ended at 8:52:39 EST (EI + 510 sec.). The exact cause of this abnormal temperature rise is not known, but the timing is coincident with the breach of the wing leading edge spar. An explanation is that the abnormal rise is an instrumentation anomaly caused by multiple wire failures in this timeframe. This measurement response is shown in Figure 5-37 along with the same measurement for several other Columbia missions. This figure also shows the location of this internal nose cap measurement on the very forward portion of the left fuselage.

Figure 5-37. Off-nominal temperature rise rate in nose cap RCC attach clevis

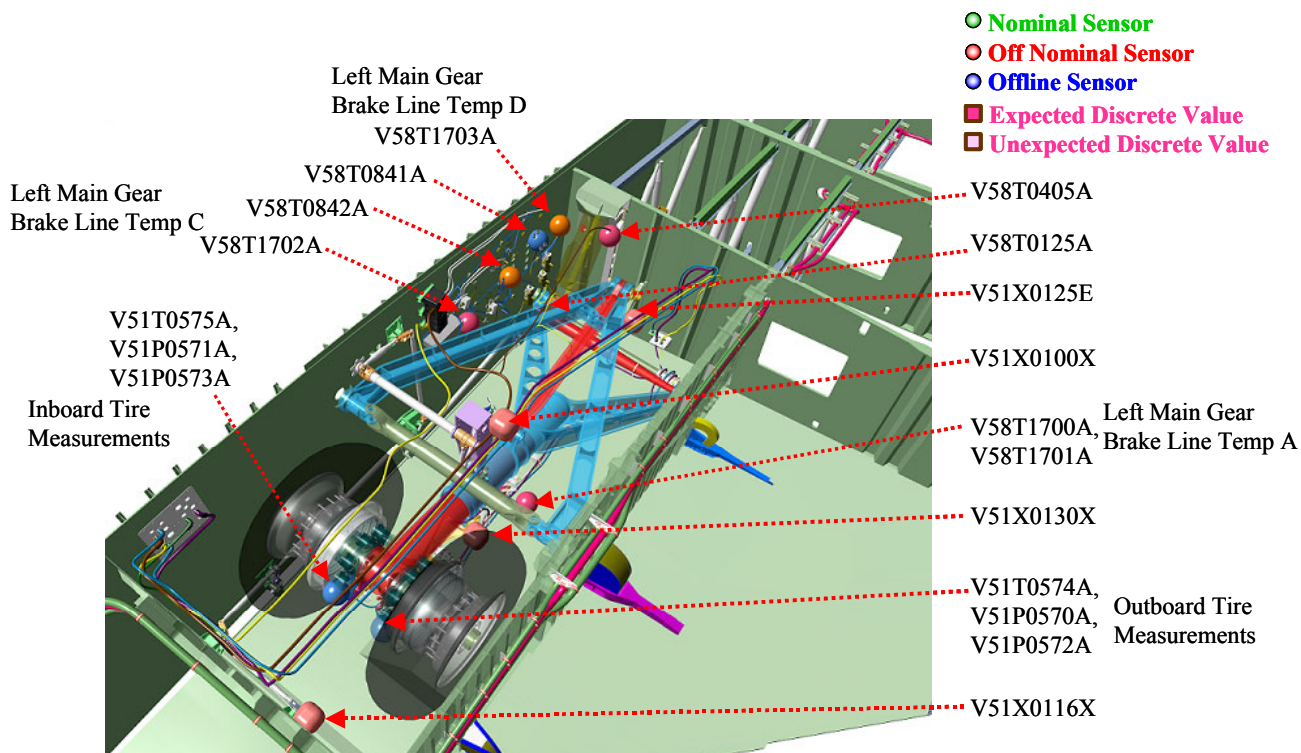
Until approximately 8:52:17 EST (EI + 488 sec.), there was no indication of any off-nominal situation that could be observed by the MCC or the crew in real-time. The flight control response and all orbiter telemetry measurements were nominal. The first indication of any anomalous Operational Instrumentation (OI) was a small increase in the left main gear brake line temperature D measurement at this time (see Figure 5-38). Within one second of this time, there is a lower 1040 spar (forward wall of the wheel well) strain measurement that shows an off-nominal increase in strain (see Figure 5-39). These are both indications that the breach in the wing leading edge spar had allowed hot gas to reach the wheel well area, most likely through vent paths around the hinge covers, which allowed hot gas into the wheel well cavity.

Figure 5-38. Location of sensors in the LH wing wheel well

At the same time as the stress was relieved on the lower 1040 spar, two left main gear outboard tire pressures began trending toward an off-scale low reading. This was preceded by a slight upward trend at 8:57:19 EST (EI + 790 sec.) for both pressure measurements. This is an indication of extreme heating of both the left outboard tire and the surrounding instrumentation. The tire has significant thermal mass and substantial heating would be required to produce the slight temperature rise. By 8:58:56 EST (EI + 887 sec.), all left main gear inboard and outboard tire pressure and wheel temperature measurements were lost indicating a rapid progression of damage or wire burning inside of the wheel well. Figure 5-38 shows the location of these pressure sensors.

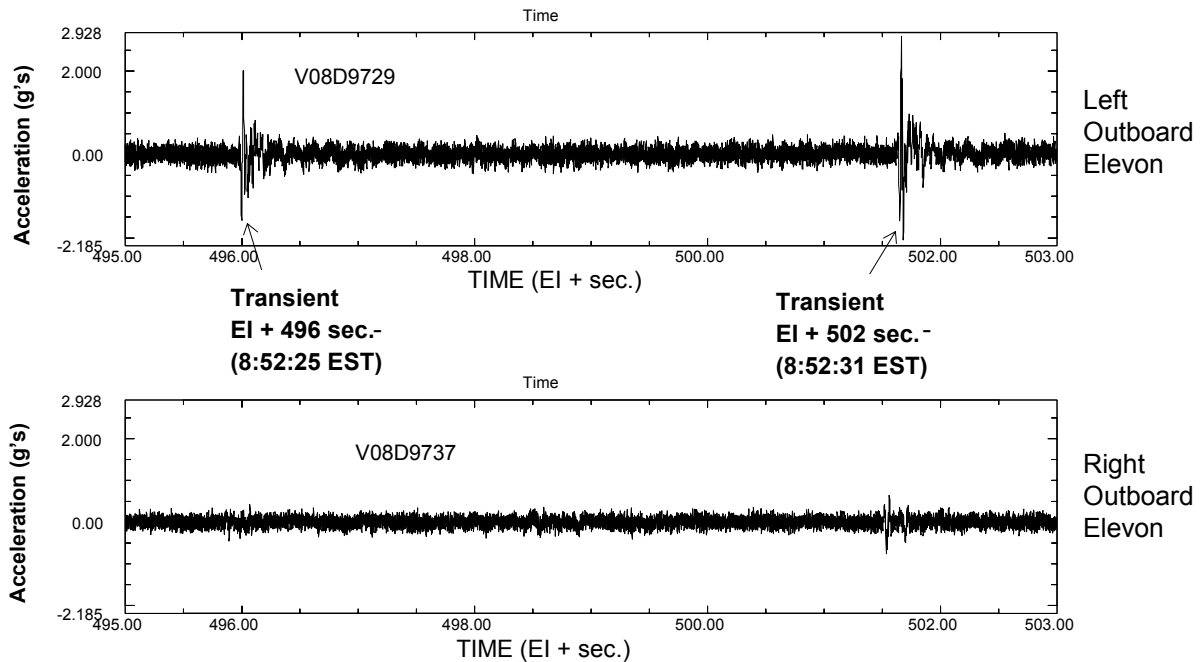
At approximately 8:52:25 EST (EI + 496 sec.), the left outboard elevon wideband accelerometer showed an unusual 2 g peak-to-peak acceleration (see Figure 5-40). This is consistent with the timing of the many wire failures within the left wing and the timeframe when the spar breach occurs. Additionally, there are two unexplained communication dropouts in this same timeframe. Another 3 g peak-to-peak acceleration anomaly was observed at 8:52:31 EST (EI + 502 sec). Additional temperature measurements (left main gear brake line temp A and C) in the wheel well area (see Figure 5-38) began an off-nominal rise at 8:52:41 EST (EI + 512 sec.).

Figure 5-40. Outboard elevon accelerometer responses at 8:52:25 and 8:52:31 EST (EI + 496 and 502 sec.)
