COLUMBIA ACCIDENT INVESTIGATION BOARD (CAIB)/
NATIONAL AERONAUTICS AND SPACE ADMINISTRATION (NASA)
ACCIDENT INVESTIGATION TEAM (NAIT)

WORKING SCENARIO

FINAL VERSION: JULY 8, 2003

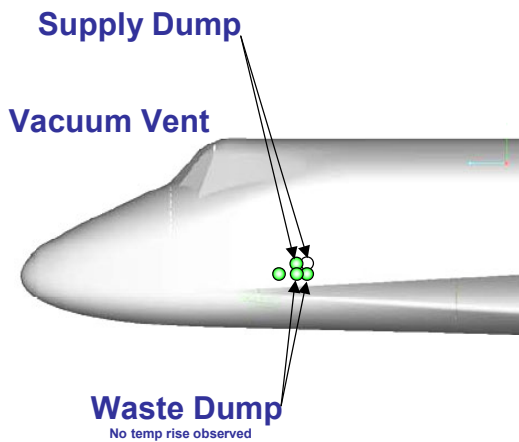
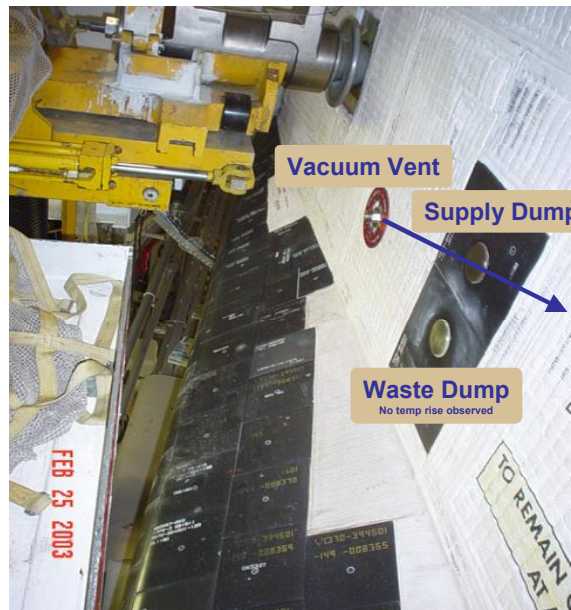
Figure 5-41. Location of supply dump and vacuum vent nozzles

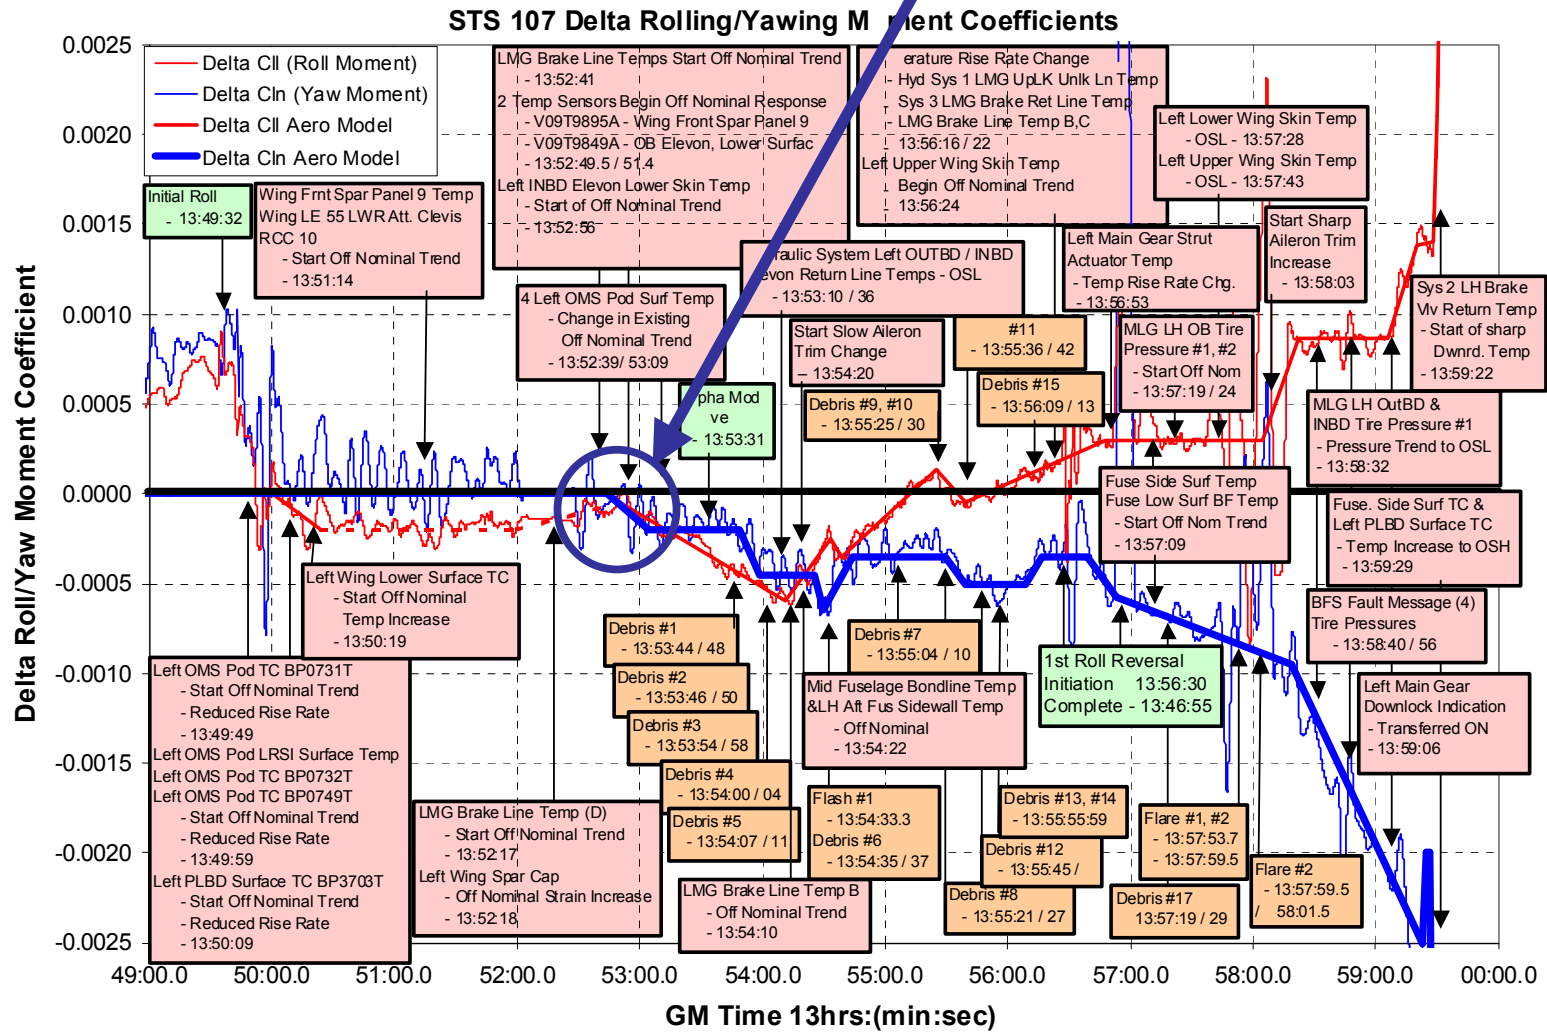
Off-Nominal Roll & Yaw

Immediately following these events, at 8:52:44 EST (EI + 515 sec.), the aerodynamic roll and yaw coefficients that have been extracted from the flight data showed a slight negative trend (see Figure 5-43). This is indicative of more drag and decreased lift on the left wing.

Figure 5-43. First noted off-nominal aero event (Greenwich Mean Time, GMT, is EST + 5 hours)

Hypersonic wind tunnel tests indicate that both the slight negative roll and yaw deltas can be explained by leading edge damage in the lower half of RCC panel 8. This will be discussed in more detail in Section 5.4.5.

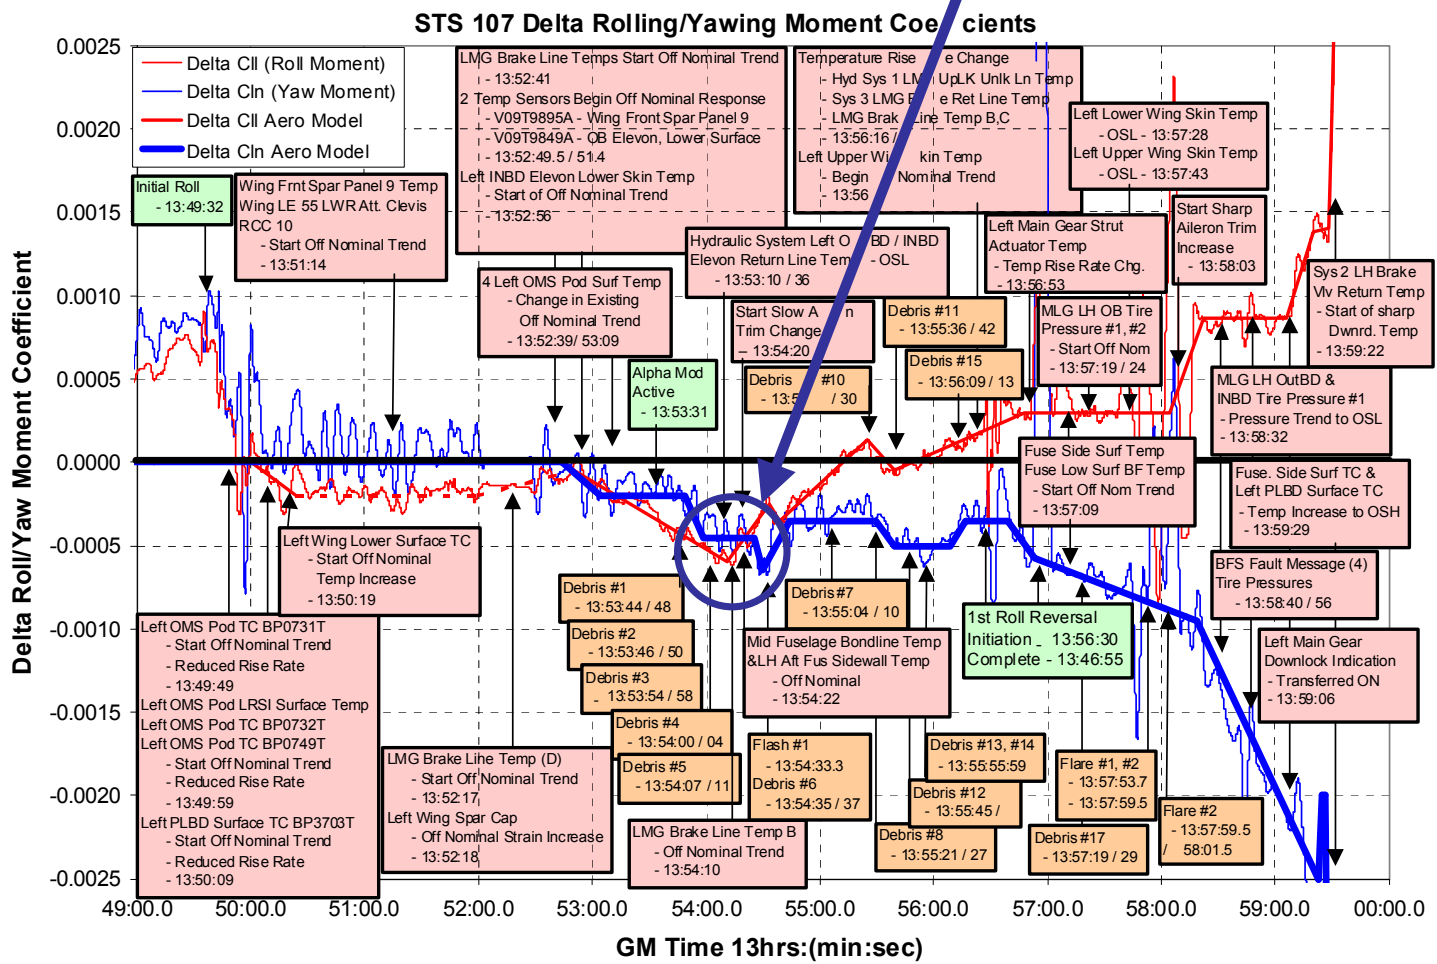
Sharp Change in Rolling Moment

In the 8:54:10 to 8:54:35 EST (EI + 601 to 626 sec.) timeframe, several key events occurred. The first event at 8:54:10 EST (EI + 601 sec.) was an indication that the temperatures in the wheel well had a greater rise rate, indicating the sneak flow or breach into the wheel area had increased. The roll moment trend changed sign at 8:54:11 EST (EI + 602 sec.) almost simultaneously with the change in wheel well temperature rise rate as shown in Figure 5-44, followed by a debris flash event at 8:54:33 EST (EI + 624 sec.). A large debris item, labeled debris event six, was seen leaving the orbiter two seconds later. This debris event and the roll moment trend change are believed to be created by growing damage to Columbia's left lower wing.

Figure 5-44. Sharp change in rolling moment (GMT is EST + 5 hours)

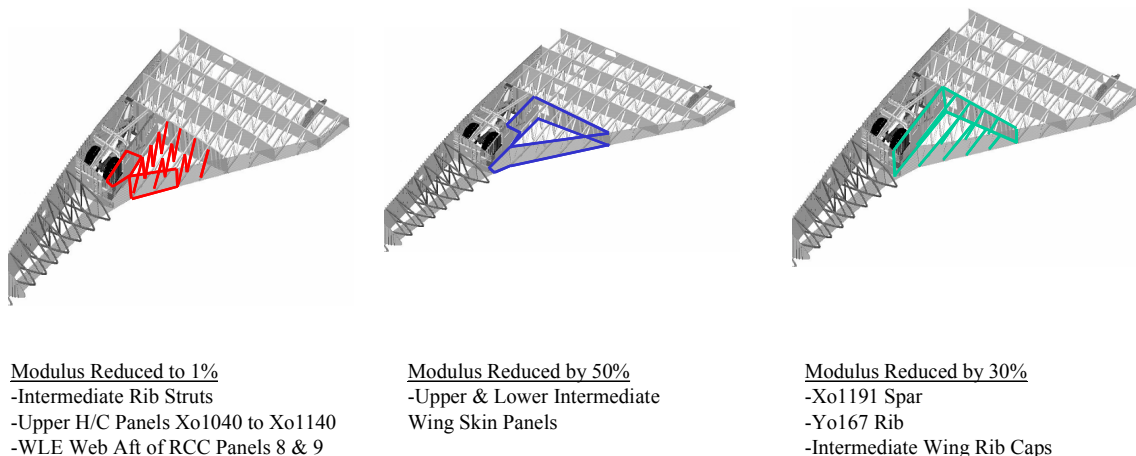
Figure 5-45. Modeling results show potential area of damage and that significant deformation of the intermediate wing area and/or a recession in the lower surface are possible

Structural and aerodynamic analysis of wing deformation was performed without any type of recession in the wing lower surface. An assumption of 70 pounds per square foot was used for wing loading. Heat transfer coefficients were updated from previous coupled venting and thermal models for the left wing. A structural model was used along with the heating equivalent of a 10 inch diameter breach in the wing spar beginning at 8:52:16 EST (EI + 487 sec.) assuming 100 percent of the energy from this hole was transferred to the wing interior. Two different cases were analyzed: one with no breach in the upper wing skin and another with a 5 inch diameter breach in the upper skin at 8:54:37 EST (EI + 628 sec.) when a significant visual flash event was observed. Both cases showed that the temperatures of the wing skins, wing spars, and the wheel well wall were high enough by 8:58:19 (EI + 850 sec) that significant damage to the wing structure would occur. Figure 5-45 shows the potential area of damage and that significant deformation of the intermediate wing area and/or a recession in the lower surface is possible.

Based on the structural analysis, it appears feasible that a wing recession occurred and resulted in the large positive slope in the delta rolling moment. The recession was caused by severe prolonged heating internal to the left wing that melted many of the support struts. Once the struts were lost, the wing skin lost structural support, a concave cavity developed, and some lower surface tiles may have been lost. Wind tunnel testing has shown that this type of cavity can cause the change in delta aero moments derived from the aerodynamics reconstruction in this timeframe. The aero moment change is a negative yaw moment due to increased drag and a positive roll moment due to increased lift on the left wing. This testing will be discussed in more detail in the next section.

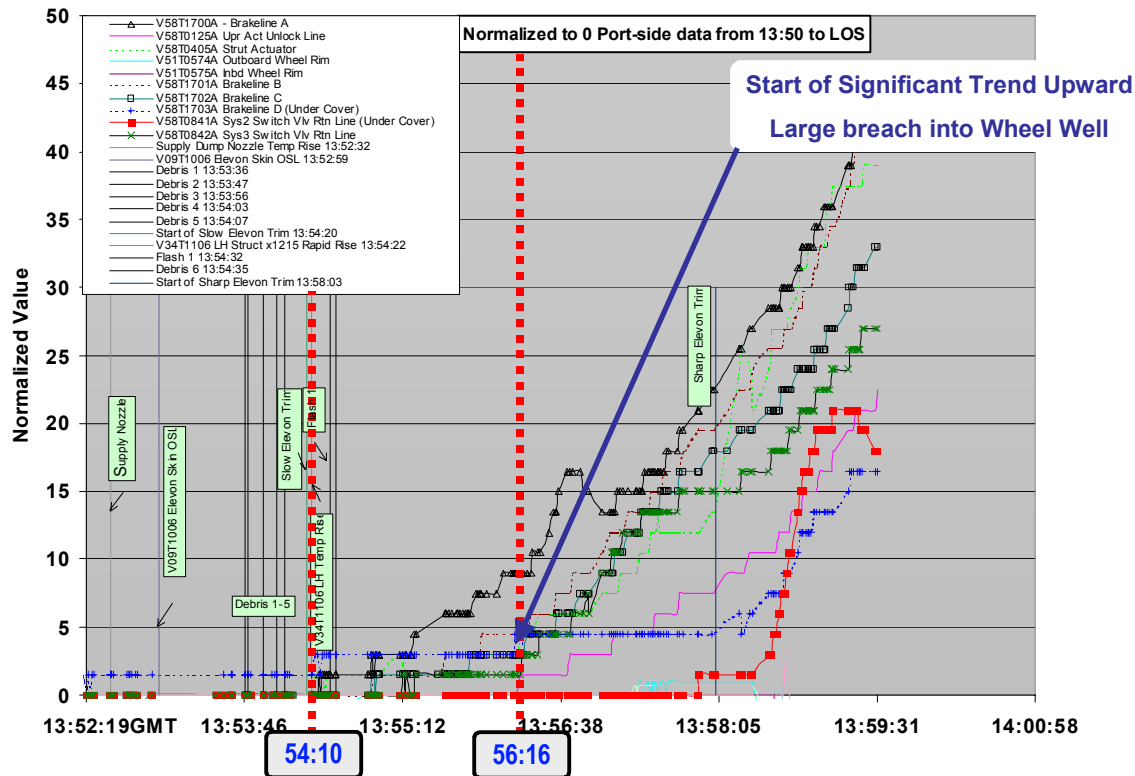
Figure 5-46. Temperature data in left wheel well trends up (GMT is EST + 5 hours)

By 8:56:16 EST (EI + 727 sec.), hot gas had penetrated the wheel well wall as indicated by off-nominal rates rise rates in several hydraulic line temperatures (see Figure 5-46). Preliminary analysis indicates that it is feasible to have had some gas intrusion into the wheel well area as early as 8:52:39 EST (EI + 510 sec.) since a honeycomb access panel could melt as quickly as 22 seconds after the wing spar is breached. Additionally, there are various vent paths into the wheel well around the landing gear door hinge covers.

The centerline of the plume contained enough energy to begin melting the exterior of the wheel well wall by approximately 8:54:00 EST (EI + 594 sec.). The modeling described in the previous sub-section assumed the heating equivalent of a 5 inch diameter hole in the leading edge spar, but does not include the complex thermal interaction with struts and other wing spar structure internal to the wing. The intent of the analysis is to show that it is feasible to obtain the temperature response shown in Figure 5-46, including the early response that was seen in the 8:54:10 to 8:55:10 EST (EI + 601 to 666 sec.) timeframe, when several left main gear brake line temperatures and strut actuator temperatures began an off-nominal rise.

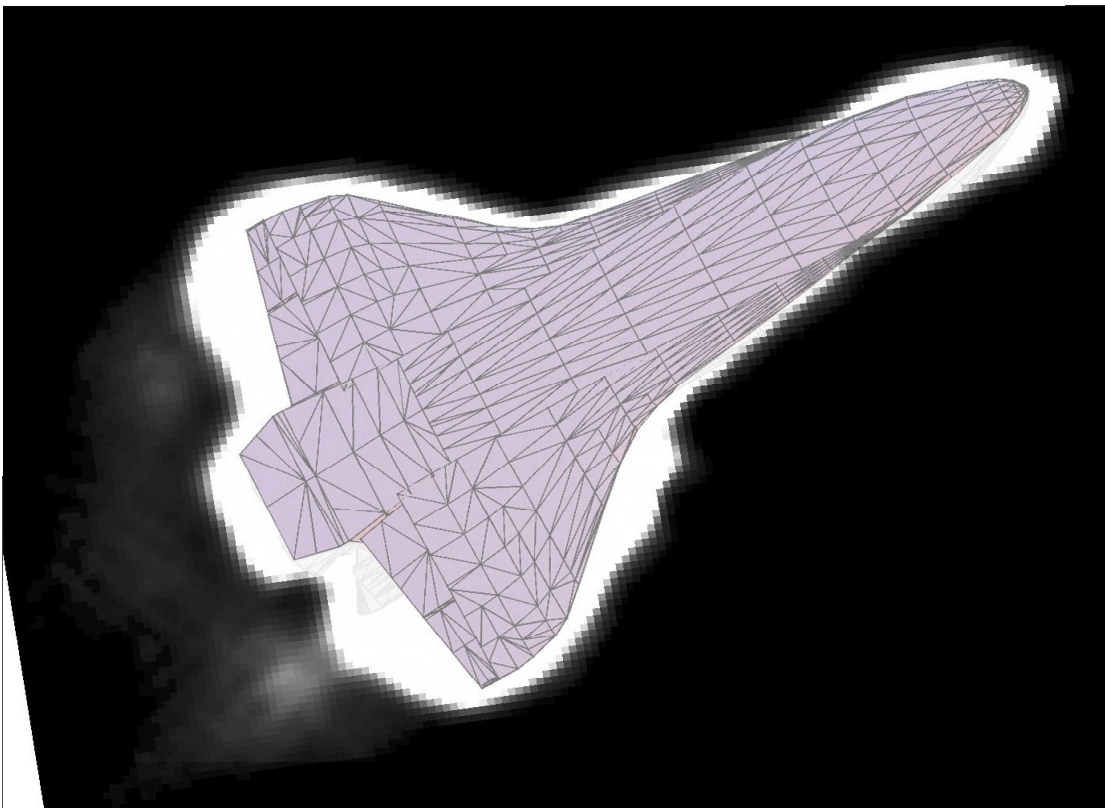
Figure 5-48. Kirtland photo

Imaged at 8:57:14 EST (EI + 785 sec.), the Kirtland photo could indicate a flow disturbance on the leading edge of the left wing and/or flow leaving the leading edge of the left wing (see Figure 5-48). It also appears to show a disturbed flow leaving the trailing edge of the left wing. Other images, not shown here, also show disturbed flow on the upper side of the left wing, indicating that the damage and venting through the upper RCC vent was deflecting the flow upward. The Kirtland photo is a digital still image taken by off-duty employees of the Starfire Optical Range at Kirtland Air Force Base, New Mexico, during the STS-107 entry using a 3.5 inch telescope through a computer controlled 1 meter rotating mirror.

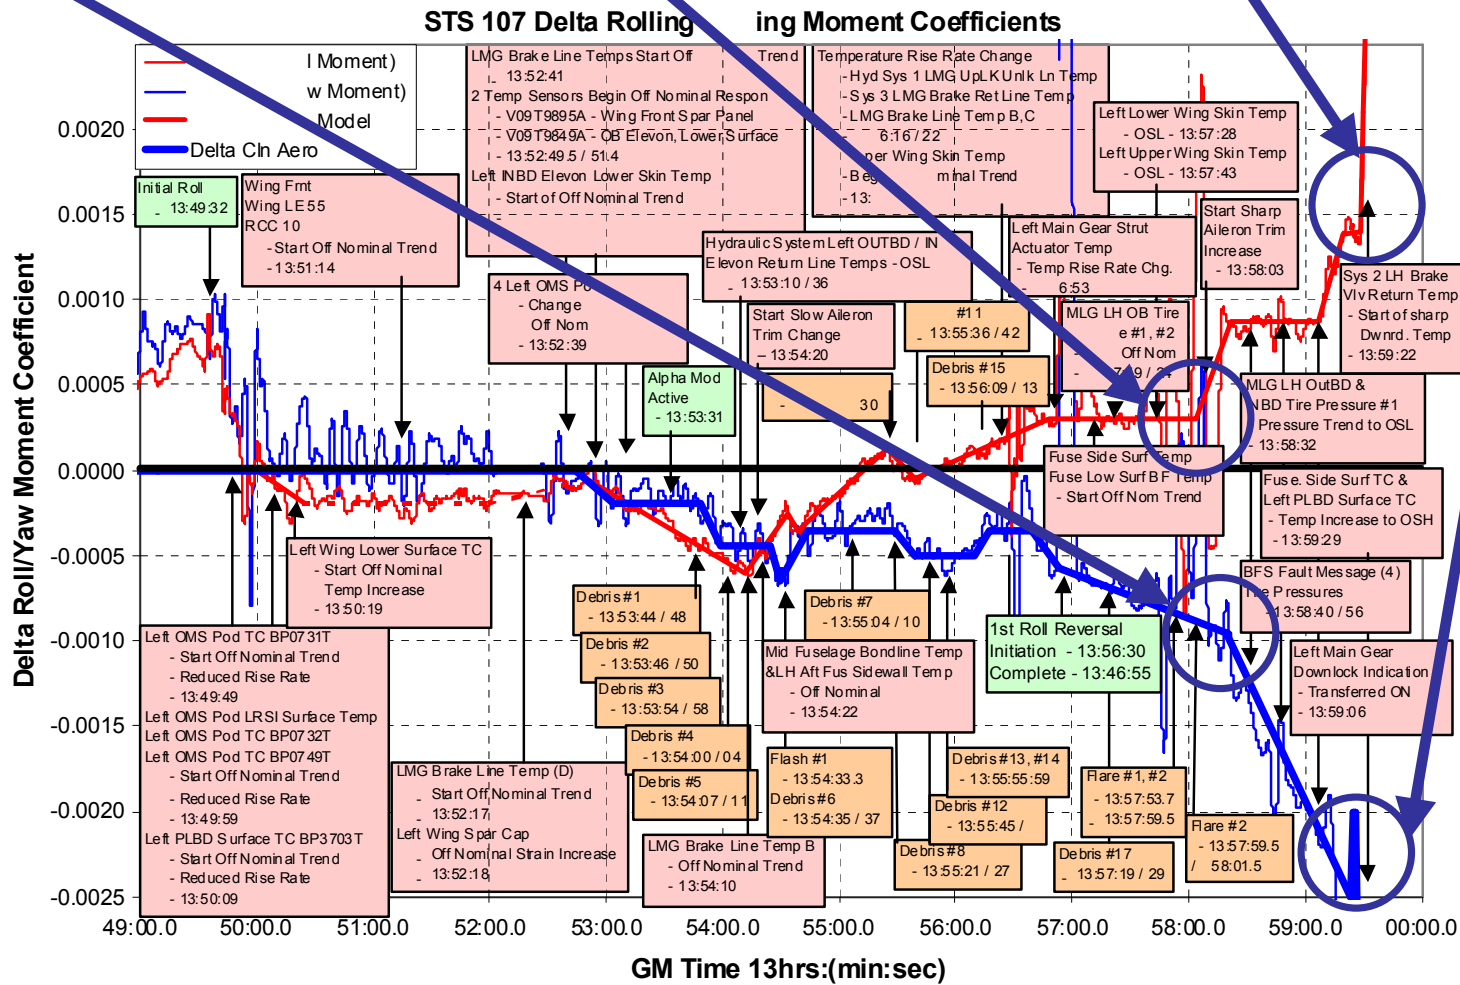
Figure 5-49. Increased wing deformation and wing recession leads to significant vehicle aerodynamic changes (GMT is EST + 5 hours)

As shown in Figure 5-49, this strain response appears to be consistent with another sharp change in the slope of the derived delta rolling moment coefficient that occurred slightly earlier at 8:58:03 EST (EI + 834 sec.), along with several additional debris events. The vehicle responded to this event with a sharp change in the aileron trim. These events indicate that there was another significant change to the left wing configuration at this time. Wing deformation and an increase in the lower surface recession along with a loss of additional bottom tiles are possible explanations for this behavior.

As shown in Figure 5-49, there was another abrupt change in the vehicle aerodynamics caused by the continued progression of left wing damage at 8:59:26 EST (EI + 917 sec.). This change was a significant increase in the positive delta roll moment and negative delta yawing moment, indicating increased drag and lift from the left wing. Columbia attempted to compensate for this by firing all four right yaw jets. By this point the MCC had lost all telemetry data at 8:59:23 EST (EI + 914 sec.). Even with all four right yaw jets and a maximum rate of change of the aileron trim, Columbia was unable to control the side-slip angle that was slightly negative (wind on the left side of the fuselage) during much of the entry. The side-slip angle changed sign at 8:59:36 EST (EI + 927 sec.) indicating that vehicle loss of control was imminent (side-slip angle is an aerodynamics terms for the angle between the relative wind velocity and the vehicle direction of motion, or velocity vector).

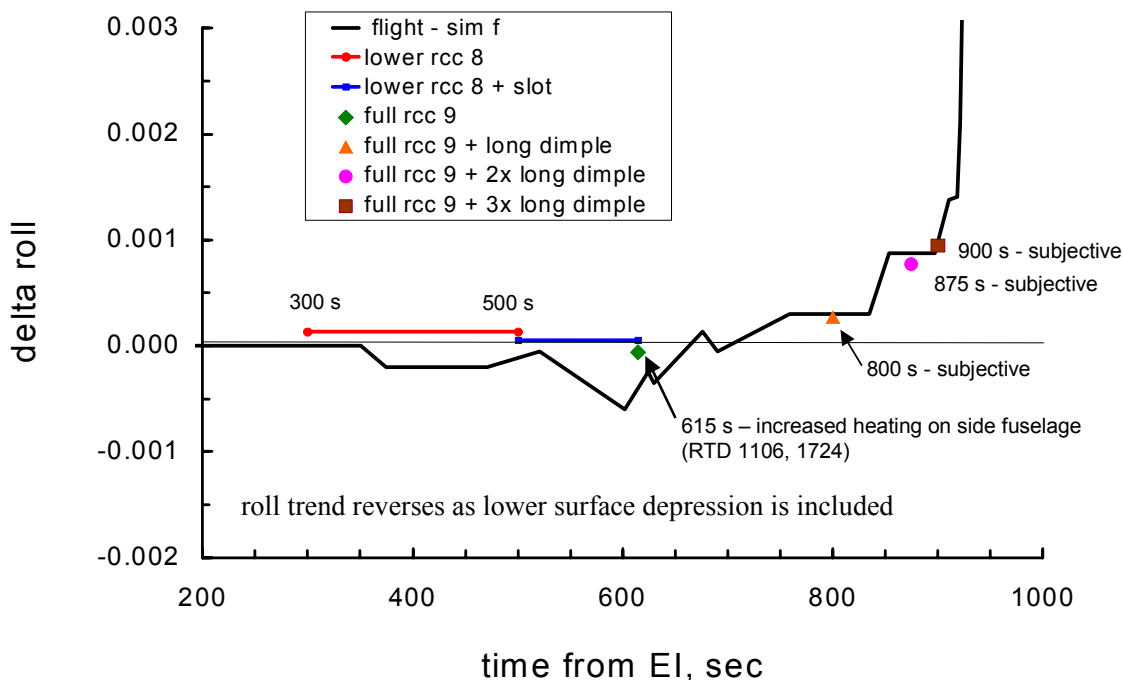
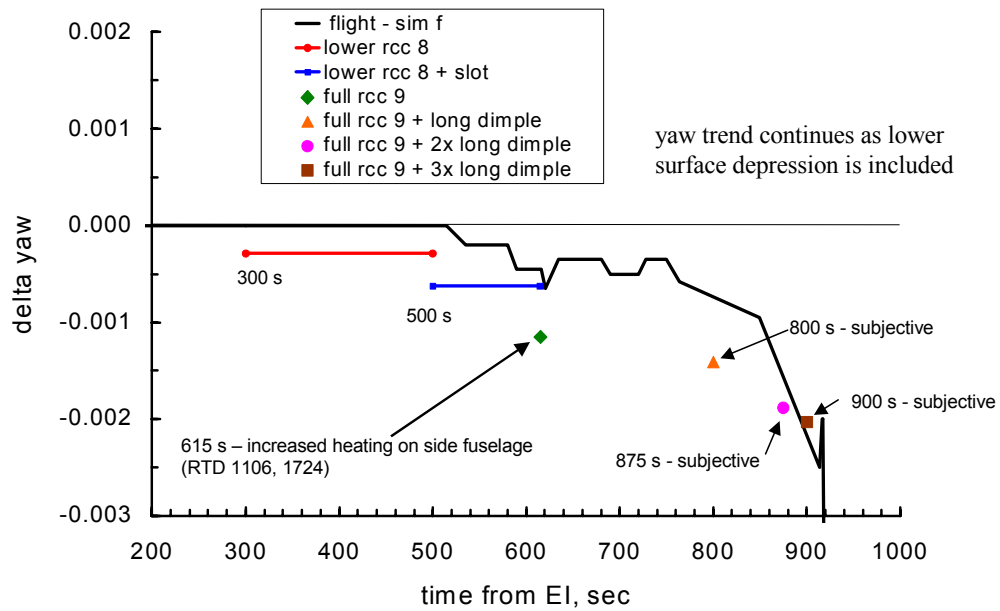
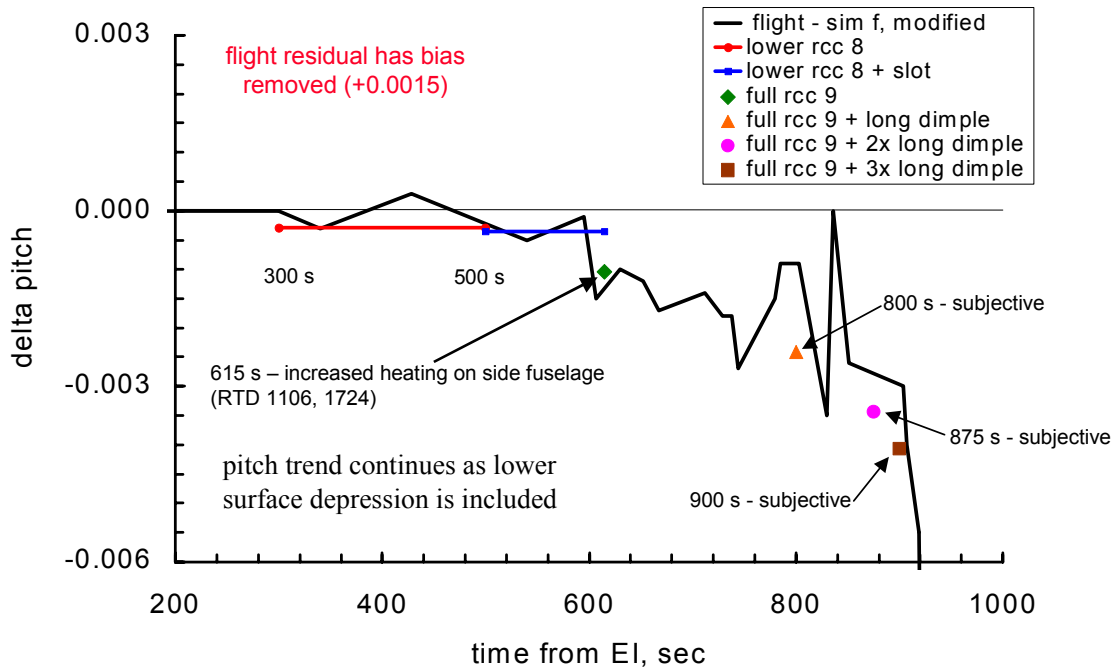
Figure 5-50 through Figure 5-52 show the flight derived delta roll, yaw, and pitch aerodynamic moments, respectively, along with the tested damaged configuration results that are consistent with the flight data. The intent of the remainder of this section is to briefly discuss the CFD analysis and wind tunnel testing used to replicate the derived delta aero moments. Note the time scale on these plots is in seconds from EI.

Initially, the recessed area would have been relatively small; however, it would gradually grow over time to cause the delta roll moment to increase. By 8:57:29 EST (EI + 800 sec.) wind tunnel testing showed that the depression has to be on the order of 20 feet long, two feet wide, and 5.3 inches deep along with panel 9 missing in order to duplicate the delta roll coefficient shown in Figure 5-50. This configuration provides a delta yaw moment that is slightly larger than was observed, but is consistent with a decreasing negative delta yaw moment observed in this timeframe (Figure 5-51).

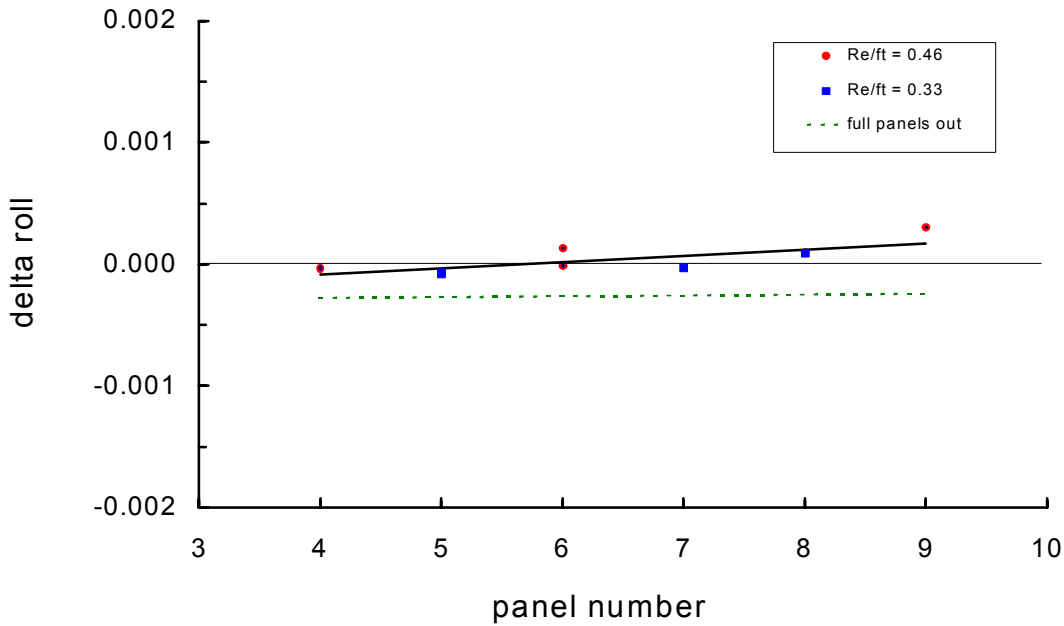
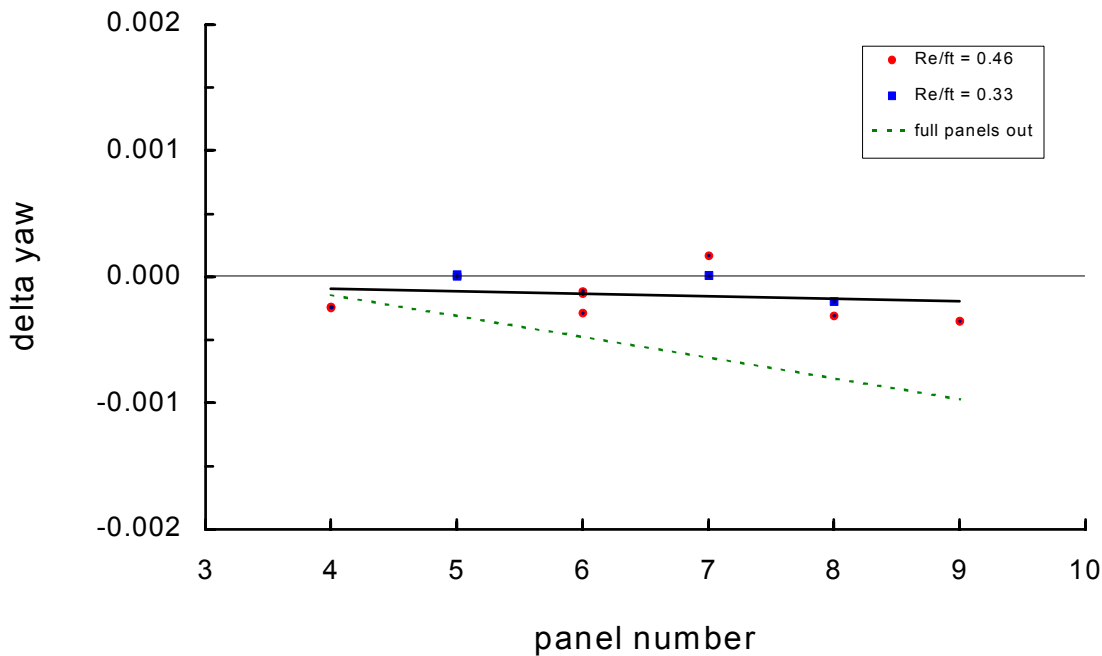
As discussed previously, the reconstructed aerodynamic moments showed little to no change due to damage through 8:52:29 EST (EI + 500 sec.). Based on the forensics data discussed in Section 5.3, the most likely region of initial damage was in the lower part of RCC panel 8. Wind tunnel testing in the Langley Research Center (LaRC) CF4 tunnel indicated that a missing bottom part of RCC panel 8 (from the apex to the lower carrier panel) matches the initial aerodynamic increments, which show a minimal effect on the overall vehicle aerodynamics. In fact, even a full missing panel 8 produces only a small change to the roll and yaw aero moments. Figure 5-53 and Figure 5-54 show the results of this LaRC evaluation.

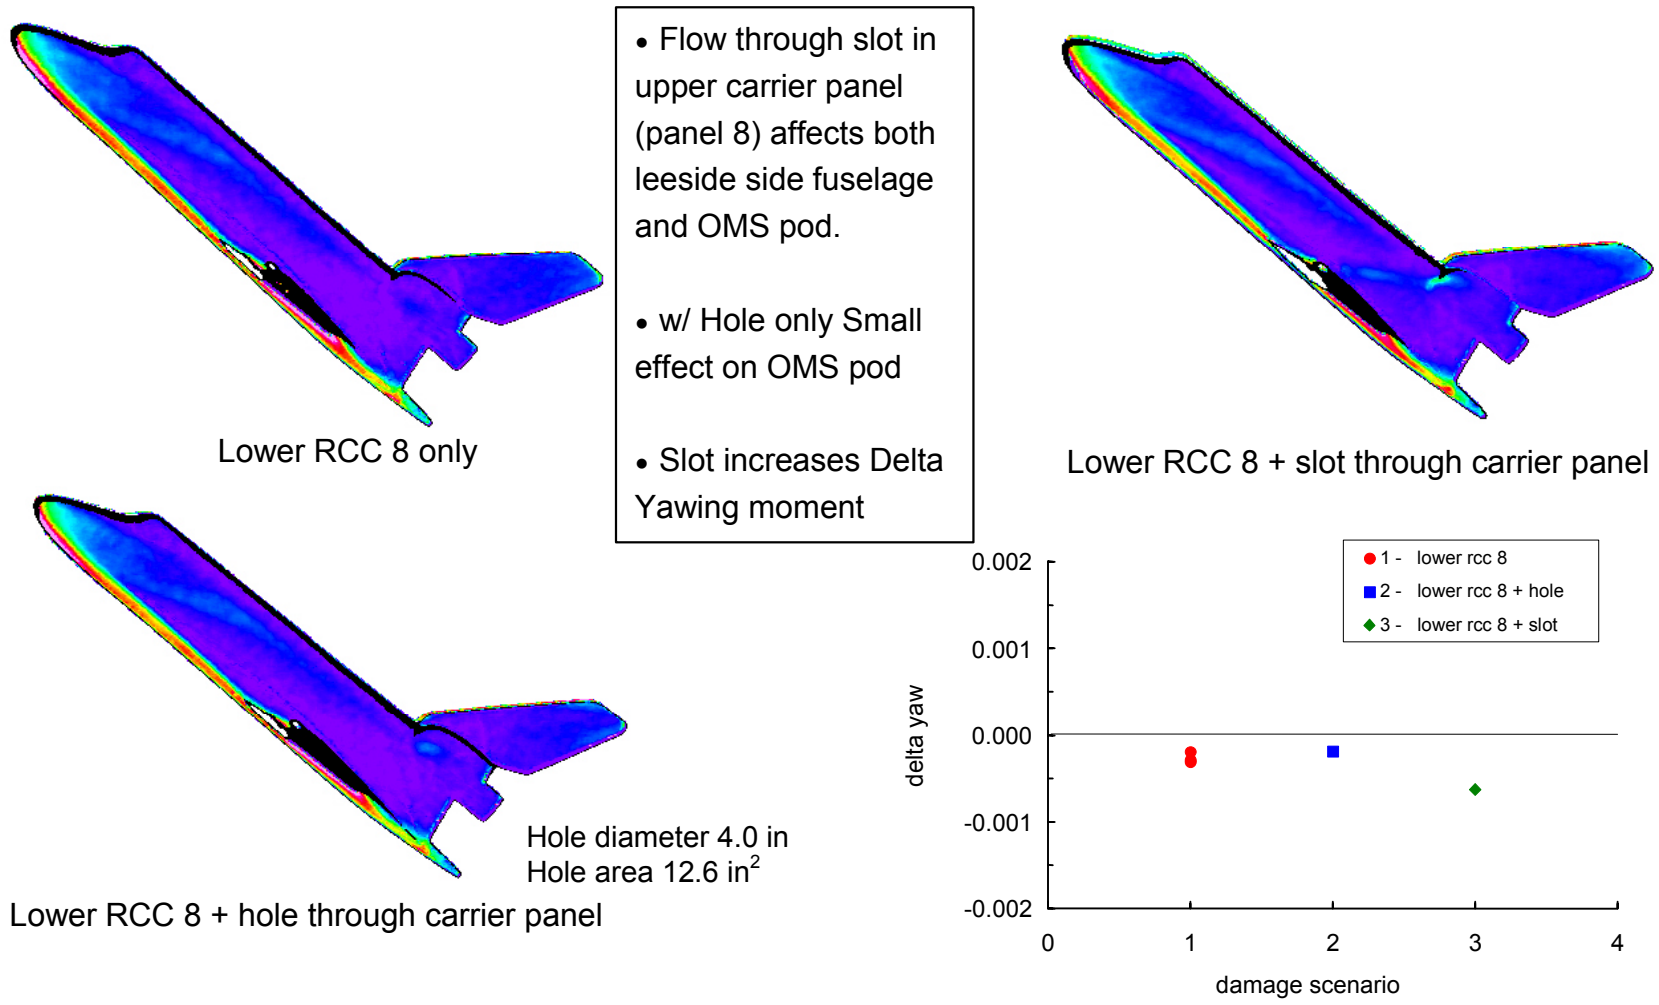
Figure 5-55. Wind tunnel testing results for missing lower carrier panel 8 and a slot and hole through wing

The left wing spar was breached in the 8:51:14 EST (EI + 425 sec.) to 8:52:15 EST (EI + 487 sec.) timeframe. Initially, the spar breach had little to no effect on the derived aero moments. Over time the leading edge damage progressed and a slot or upward deflection of the flow through the upper carrier panel 8 developed. The combination of flow through the wing leading edge and flow through a slot onto the upper carrier panel is consistent with the first observed aerodynamic response, which occurs at 8:52:29 EST (EI + 500 sec.). This can be observed in Figure 5-50 and Figure 5-51 as a slow negative trend in delta roll and yaw. Figure 5-55 shows the wind tunnel test results for three different cases: missing lower RCC panel 8, missing panel 8 combined with a 4 inch diameter hole in the upper carrier panel 8, and missing RCC panel 8 with a slot through the upper carrier panel. The slot was shown to produce the increased delta yaw observed during flight as well as the upper surface flow disturbances on the OMS pod and left side fuselage, which were also observed during flight by abnormal temperature rise rates.

It is possible that a hole through the upper wing developed in the 8:54:11 EST (EI + 600 sec.) to 8:54:31 EST (EI + 630 sec.) timeframe. This is consistent with a lull in the measurement failure rate in the wire bundle along the wheel well that was discussed earlier in Section 5.4.3. Wind tunnel testing and CFD analysis have shown that sizable holes through the wing have little to no effect on the aerodynamics and heating on the left side of the fuselage and OMS pod. A representative sample of this work is shown in Figure 5-55 as damage scenario number 2.

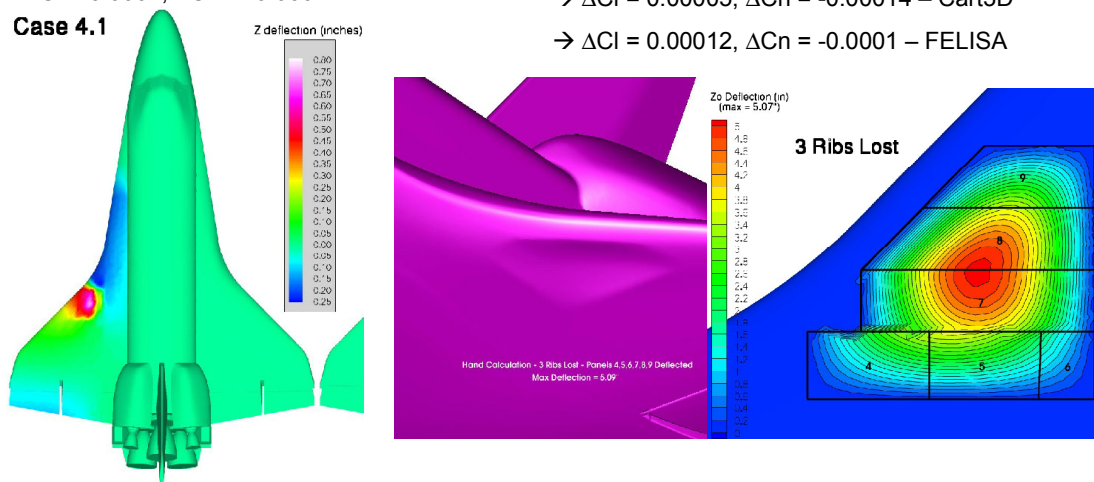
Figure 5-56. CFD analysis of wing deformation

The next significant aerodynamic event occurred at 8:54:11 EST (EI + 602 sec.) when a dramatic reversal of the aero rolling moment trend occurs. By this time hot gas and an internal plume environment had severely degraded the structural integrity of some of the intermediate wing support structure leading to wing deformation. Three different configurations were tested to validate the theory of wing deformation. The first involved global wing deflection of up to 0.79 inches due to damage and is depicted in Figure 5-56. CFD analysis of this configuration showed extremely small aero moment response for yaw and roll that does not match the flight derived data. More substantial local wing skin deformation with a maximum deflection of 5.1 inches due to three ribs missing along with other internal wing damage was examined using CFD tools. Again, these results produced only small aerodynamic moment changes, which did not match the flight-derived data.

- Case 4 Aerodynamic Increments – Global wing deflection due to damage
Max RMS Delta Δ Wing Deflection (Nominal – Damaged structure) is 0.79”
→ Δ Cl = 0.0001, Δ Cn = -0.0001
- Hand Calculation Increments – Local wing deformation due to damage
Max Δ Wing Deflection, $Z_0 = 5.1”$
→ Δ Cl = 0.000, Δ Cn = -0.0001 – Newtonian
→ Δ Cl = 0.00005, Δ Cn = -0.00014 – Cart3D
→ Δ Cl = 0.00012, Δ Cn = -0.0001 – FELISA

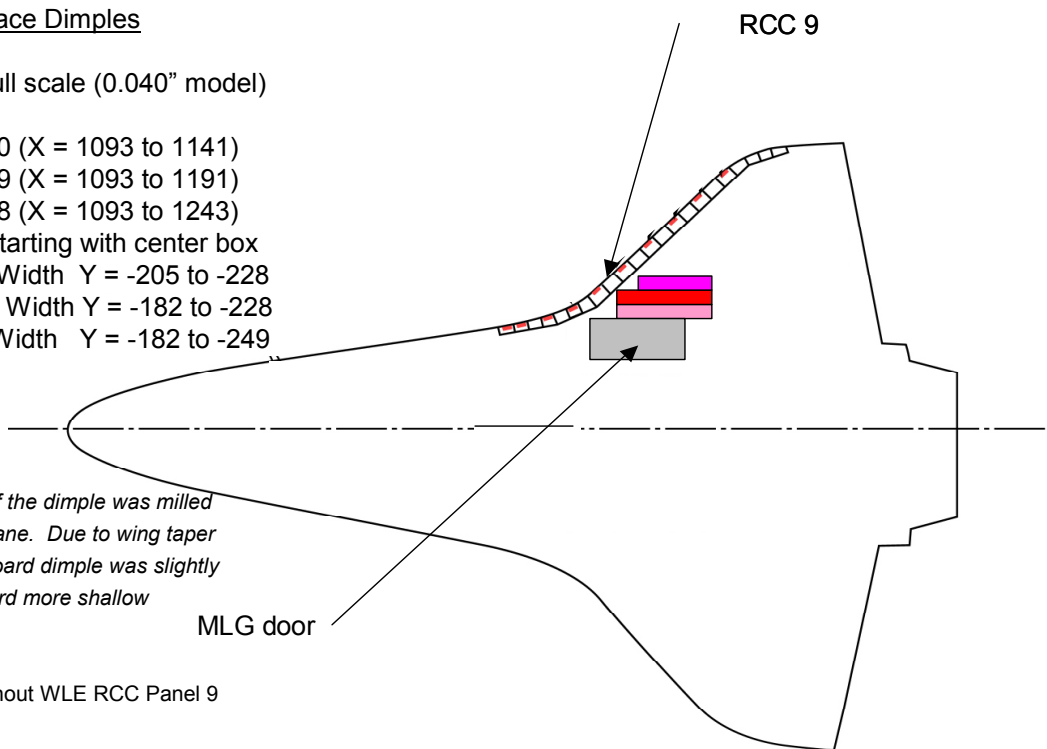
Figure 5-57. LaRC wind tunnel testing of lower surface depressions

structural damage that was most probable in this timeframe. LaRC wind tunnel testing and CFD analysis were performed for several different configurations of lower surface recessions shown in Figure 5-57. The data shows that it is feasible for a recession to cause the change in the rolling moment sign when combined with some portion of RCC panel 9 missing at 8:54:11 EST (EI + 602 sec.).

Note: the bottom of the dimple was milled parallel to the XY plane. Due to wing taper & dihedral, the inboard dimple was slightly deeper and outboard more shallow

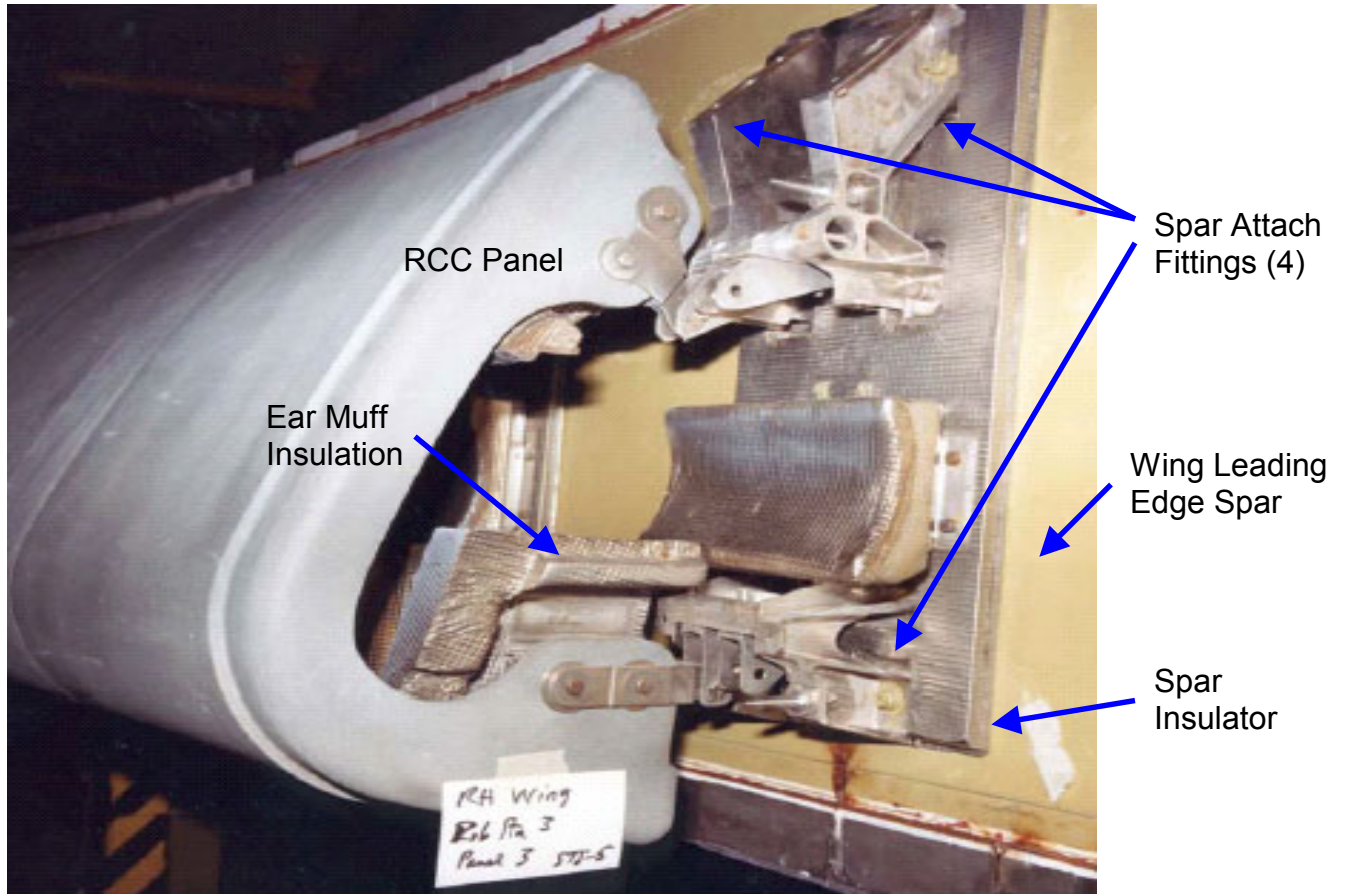
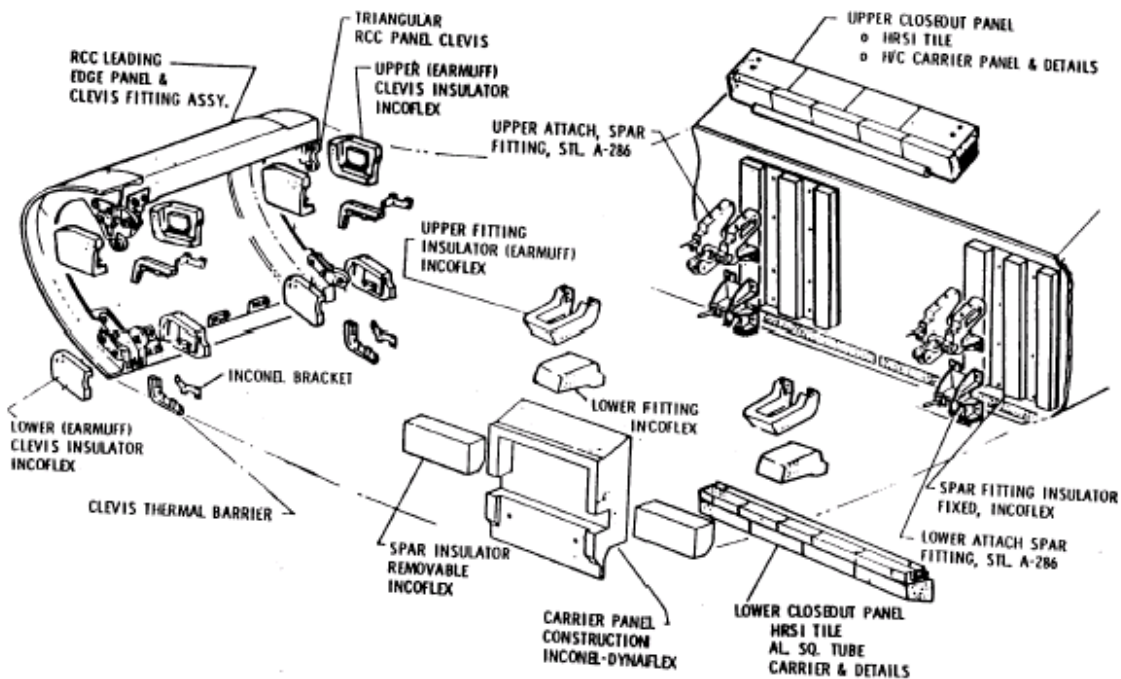
All Reinforced Carbon-Carbon (RCC) upper and lower wing Leading Edge Structural Subsystem (LESS) access panels, spar insulators, ear muff insulators, wing leading edge RCC panels, and spar fittings (see Figure 10-1 and Figure 10-2) were removed and inspected for discoloration and damage. Visual pinhole inspections were performed on each RCC panel and the wing leading edge spar was inspected for damage. Oversized pinholes were originally reported in RCC panels 8 and 19, but after further evaluation with an optical comparator, it was determined that the pinholes were acceptable. No other significant damage was noted. Leading edge RCC panels 6 and 13 through 17 were sent to the vendor (Vought) for refurbishment. New shims were installed to accommodate the reinstallation of the spar insulators.

The panels and spar fittings were reinstalled and all step and gap measurements were taken. At that time, gaps were found to be unacceptable in numerous locations. Wing leading edge RCC panels 11, 12, 17, and 18 were removed and additional anomalies were noted, which included insufficient step and gap, spar fitting shims not per design (too small), and the lower access panel nutplates debonded and/or with low running torque. The low torque was due to a combination of the shim problem and a procedural error on the torque sequence. All 22 RCC panels were removed a second time. The

nutplate issues were resolved by removing and replacing the nutplates that were accessible and securing with safety wire those that were not accessible. All anomalies identified were repaired, reworked, or accepted by Material Review (MR).

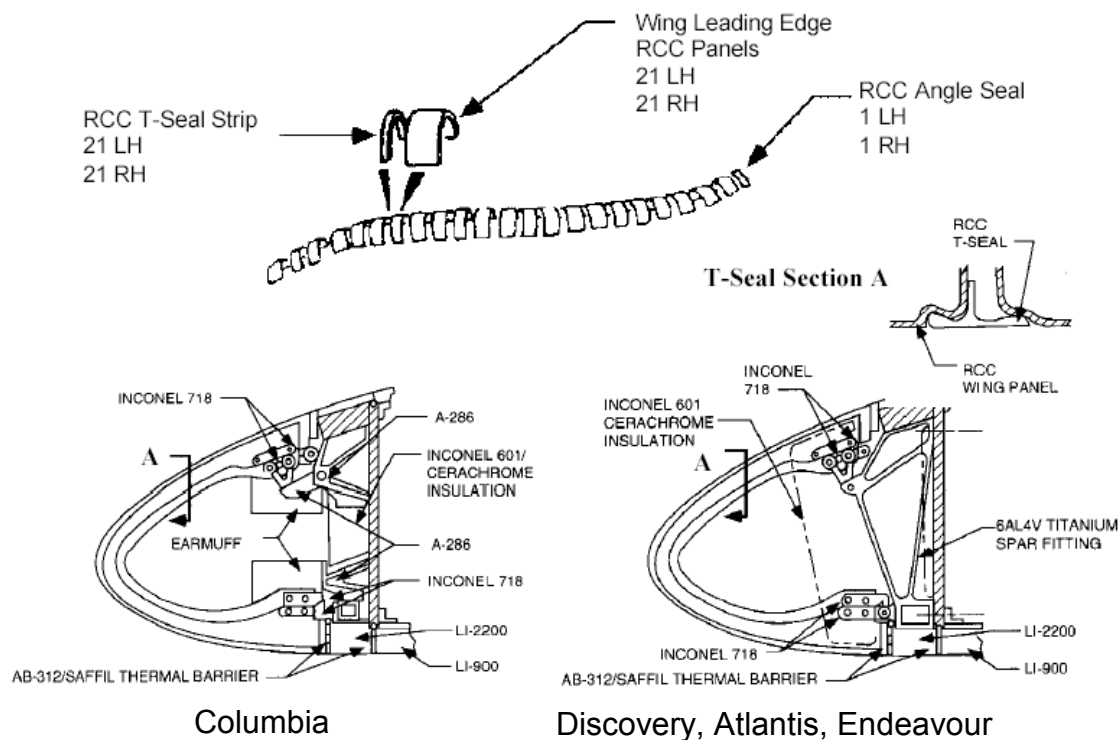
Figure 10-4. Wing leading edge RCC

The angle seal at RCC panel 1 on the left wing leading edge (see Figure 10-4) was removed to support the evaluation of the horse collar gap filler between the adjacent tiles. During the removal attempt, the upper bushing remained bound with the shipside clevis. During subsequent attempts, the angle seal was manually manipulated to try and remove the preload. During the KSC paper review, structures engineers realized that the load applied to the angle seal was specified to be kept below 20 pounds, but was never recorded in the paper. The RCC specification requires that RCC panel loads be kept below 30 pounds. Subsequent tests at KSC verified that the angle seal load was below the 30-pound requirement. The LESS prevention and resolution team is addressing the issue of how to measure the load and how to support the seal in future operations. Work continued on the elevon flipper doors. Flipper door 1 blade seal was not making contact with the rub channel, potentially leading to excessive venting from the elevon cove area. This issue surfaced twice during this flow and was Material Review (MR) accepted to fly as is. Modification was made to the Inconel trailing edge seal and bulb seal on the elevon. Additional work was performed on the elevon cove corrosion protection again to reduce the excessiveness of the application.

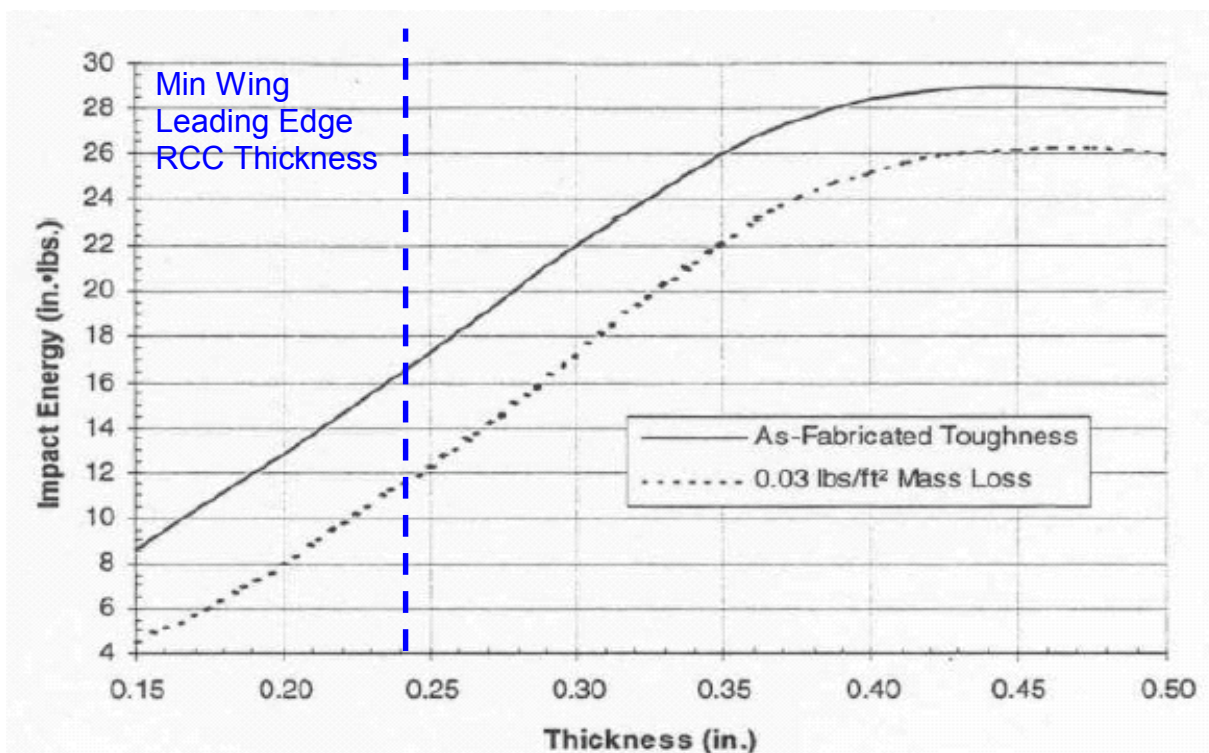
Figure 10-6. RCC impact resistance

The RCC was not considered part of the TPS for the purposes of impact resistance. The TPS was designed to accommodate particle impacts, such as from hail, rain, runway debris, etc., whose impact energy did not exceed 0.006 foot-pounds to the surface. The wing leading edge RCC impact resistance allowed no damage to the RCC with the application of up to 16 inch-pounds of energy. Figure 10-6 shows RCC impact resistance ranging from 4 to 26 inch-pounds depending on the increasing thickness of the RCC element. Different tests including low velocity and hypervelocity tests have been conducted to determine the actual impact resistance of the RCC. Test projectile materials have included nylon, glass, aluminum, steel, lead, and ice and have taken shapes of spheres, bullets, and cylinders. The test results vary widely and appear to be significantly dependent on impact velocity, projectile type, and angle of incidence of impact. Because of the variability of the test results, no actual impact resistance could be defined.

In support of the STS-107 investigation, RCC impact testing was performed at Southwest Research Institute in San Antonio, Texas, by propelling a large piece of foam at high velocity at a previously flown RCC panel. These tests were described earlier in Section 3 and show that RCC material can be damaged by ET foam at impact velocities matching STS-107 debris impact conditions.
