COLUMBIA ACCIDENT INVESTIGATION BOARD (CAIB)/
NATIONAL AERONAUTICS AND SPACE ADMINISTRATION (NASA)
ACCIDENT INVESTIGATION TEAM (NAIT)

WORKING SCENARIO

FINAL VERSION: JULY 8, 2003

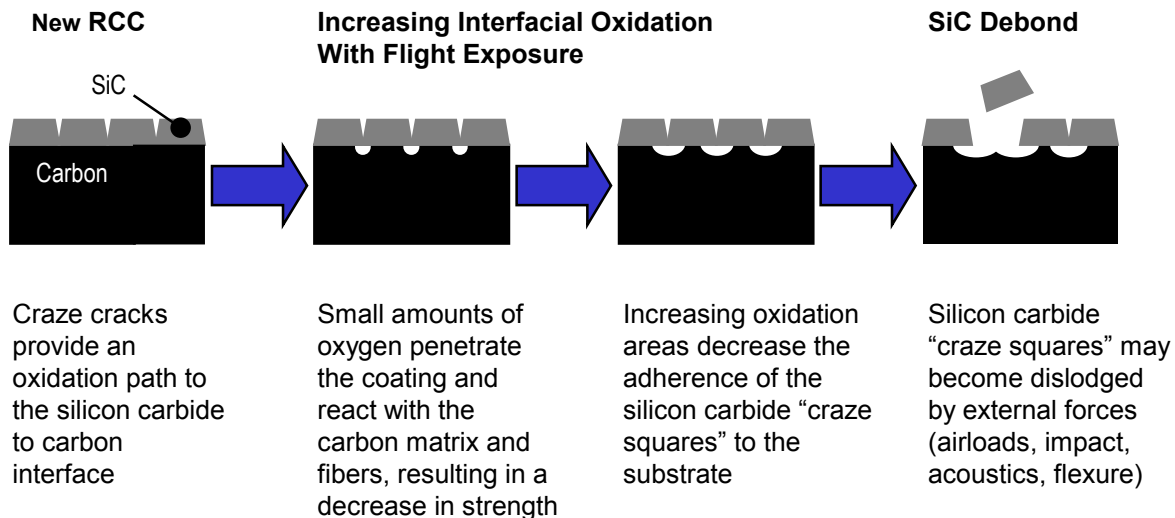
Figure 10-7. RCC corrosion process

Subsurface oxidation has been discovered beneath the silicon carbide surface cracks in the sealant and coating which allow the oxidation process to thrive. This process is considered to be an impact to RCC mission design life, but is not generally considered to be a safety of flight issue. This oxidation process (Figure 10-7) starts with the breakdown of the coating due to entry heating. Surface craze cracks allow oxygen to migrate to the subsurface carbon fibers and react with them. This increase in oxidation develops into larger crazed areas, which eventually allow pieces to become dislodged due to vibration, aerodynamic, or thermal loads. Once the pieces dislodge, they leave a large path for the oxidation process to continue.

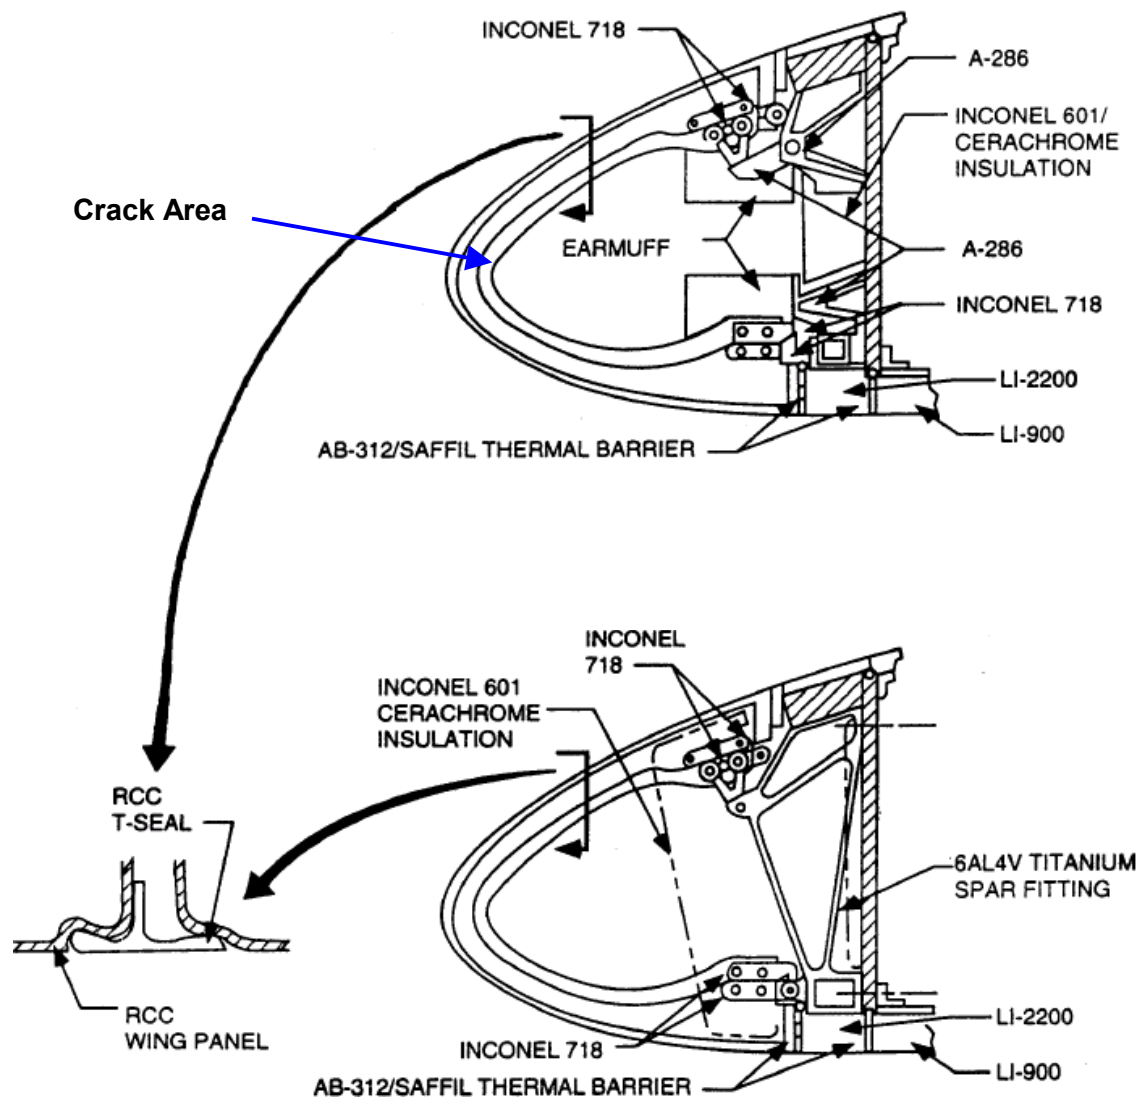
Figure 10-8. Tee seal crack location

Each wing leading edge RCC panel shares a Tee seal that is used to close the gap between adjacent RCC panels. Following STS-43 (Atlantis) in August 1991, routine inspections identified cracks in the web of a Tee seal. The cracks were in the silicon carbide coating and occasionally in the substrate, and were due to normal shrinkage. They were typically less than 1/2 inch long, were not visible to the naked eye, and usually occurred in the web of the seal, on the backside of the seal (Figure 10-8) near the apex rather than on the leading edge. Further examination of the remainder of the shuttle fleet identified 20 (of 132) cracked Tee seals. Columbia had 11 Tee seals identified with possible cracks. Detailed inspections determined that all the cracks were typical of the surface craze cracks in the coating. The Tee seal cracks were determined to be caused by warping of the substrate fabric during lay-up during the original build. The Tee seal cracking (Figure 10-9) leads to a reduction in mission life and loss of oxidation protection. All the seals were refurbished with new coating and sealant and were reinstalled. Failure analysis showed that cracks would form after excessive wishbone loading (bending) caused the brittle coating to crack. Crack testing was performed in 1991 on Tee seal 10 (attached to RCC panel 9) from the left wing of Columbia to try to determine the crack mechanism. The Tee seal was cycled 400 times in bending up to 70% of its ultimate load and no discernable damage was noted. After an engineering evaluation was performed on the health and strength of the Tee seal, it was subsequently reinstalled on Columbia.

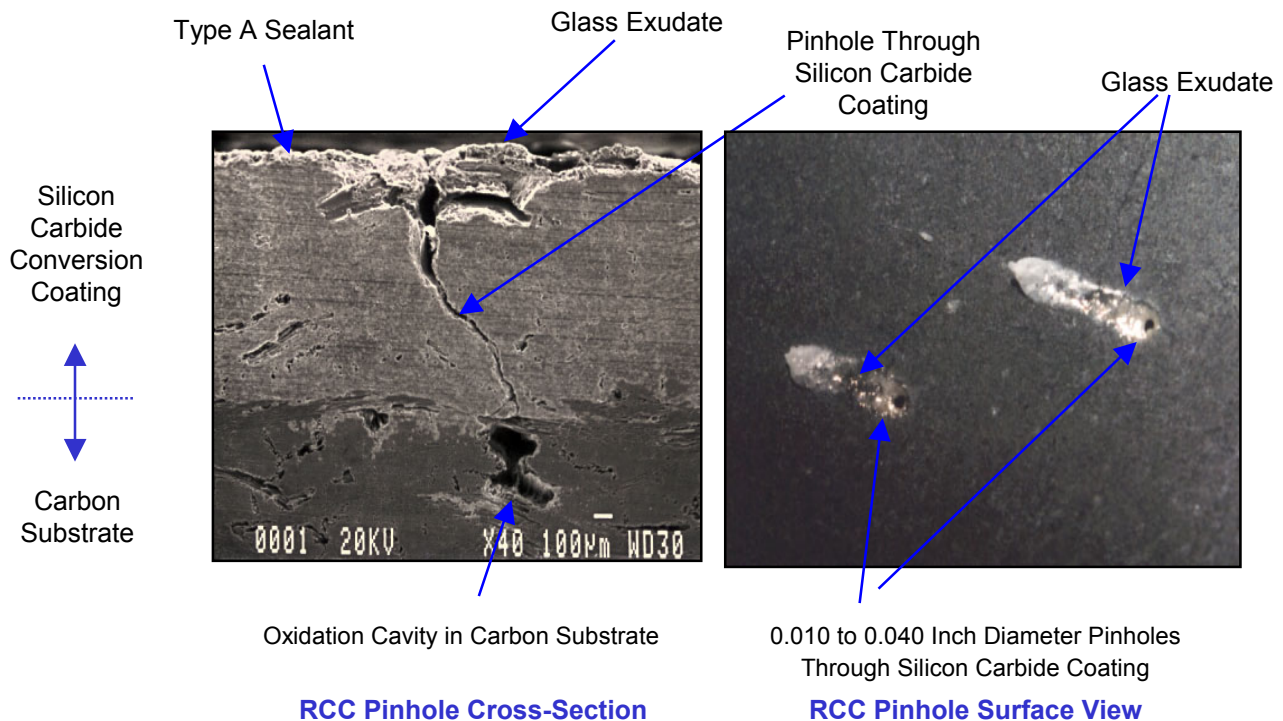
Figure 10-10. RCC pinholes

Another phenomenon, discovered first on Columbia after STS-50 landed, was the existence of pinholes (Figure 10-10) in the RCC panels. The pinholes were found primarily in the wing leading edge RCC and were subsequently identified on all orbiters. Testing has shown that the pinholes are most likely the result of the accelerated oxidation process involving zinc oxide and the silicon carbide coating. The reaction of the zinc oxide and the silicon carbide produces a silica (glass) exudate that flows out of the pinhole area. The presence of zinc oxide is theorized to originate from the paint primer used to recondition the launch pad after each mission and is considered an accelerator to the oxidation process. The zinc-based contamination accumulates on the wing leading edge RCC as rainwater drips off of the launch pad. This contamination rests on the RCC without reacting to the surface material while at ambient conditions at the pad. All of the damaging oxidation occurs once the RCC is exposed to the high temperatures, pressures, and excess oxygen of re-entry. Only a few pinholes have been observed on the nose cap RCC, most likely because the nose

cap remains under a protective cover while at the launch pad. It is also believed that sodium chloride contributes to the oxidation process, but to a much lesser extent than the zinc oxide.

In 1997, pinhole acceptance criteria were established. Pinholes with surface dimensions less than 0.040 inches discovered during routine processing flows are acceptable to fly as is for up to 16 missions unless the carbon substrate is exposed, in which case the panel must be repaired. Pinholes discovered at OMM greater than 0.040 inches are unacceptable. Although the pinholes themselves constitute only a small mass loss, they are not considered to be a safety-of-flight issue by themselves. Analysis has identified that the sustainable thru-hole size in-flight due to orbital debris is 0.25 inches in the lower surfaces of RCC panels 5-13. A hole under 1 inch in diameter anywhere else in the RCC is considered survivable for a single mission.

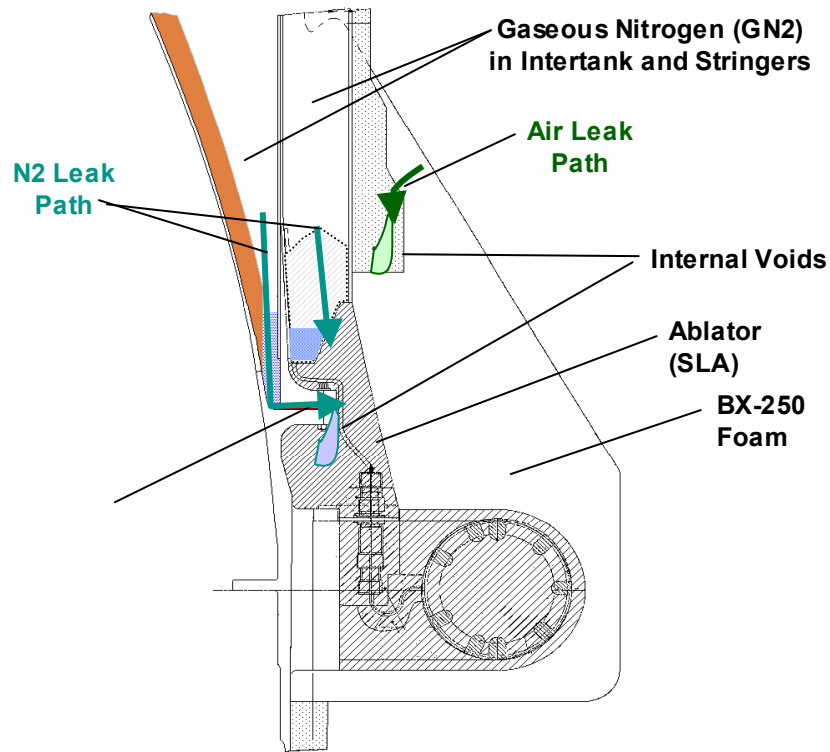
Figure 11-8. Schematic of bipod ramp - potential cryopumping

Cryopumping could contribute to bipod foam loss, shown schematically in Figure 11-8. The mechanism that drives cryopumping is the transformation of a gas to a liquid at cryogenic temperatures. Gases may condense within a void or porous material at low temperatures. Air in cavities or porous material liquefies when in contact with structure below -297°F for oxygen or -320°F for nitrogen. Pressure is reduced locally due to the condensation. If a leak path exists, more air will be “pumped,” providing more gas to condense. When the structure warms, the consequence of cryopumping is that the liquefied air returns to the gaseous state with a local pressure increase. If the leak path is large, gas escapes with no detrimental effect. However, if the leak path is small,

cracks may form in the TPS to relieve pressure, or a rapid increase in pressure may result in a divot. In order for this to occur, the inlet source must be blocked off to avoid venting out the inlet. It should be noted that testing has been unable to demonstrate cryopumping in this application.

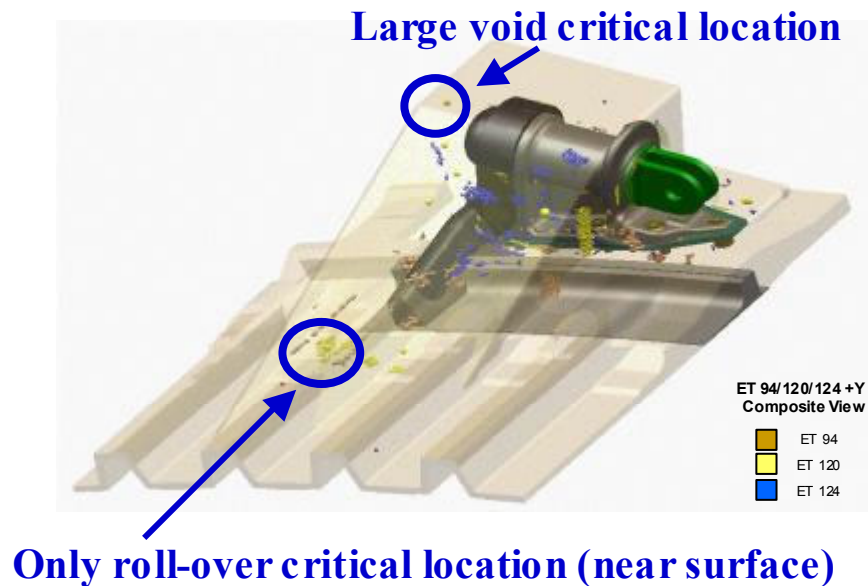
Figure 11-11. Defects found at critical locations

The dissection of six bipod ramps indicated similar patterns for geometry-induced defects in all ramps. Roll-overs were observed at complex substrate elements, and the majority of observations were associated with spraying over complex details at the substrate. Sporadic voids were also observed. One internal delamination and one weak plane at the knit line were observed. Critical locations, or areas at-risk for producing debris, were identified near the edge of the machined foam surface for both voids and roll-overs (see Figure 11-12). Vacuum pressure is the primary driver for divot formation; however, wind shear also contributes to flight loads. A combination of multiple large voids, geometry-induced defects, and critical locations is needed to produce significant foam loss. For example, a large interconnected void at close proximity to the surface plus a “weakened plane” (see Figure 11-13) may produce foam loss.
