OCO-2: A Second Chance to Fly

Case Study

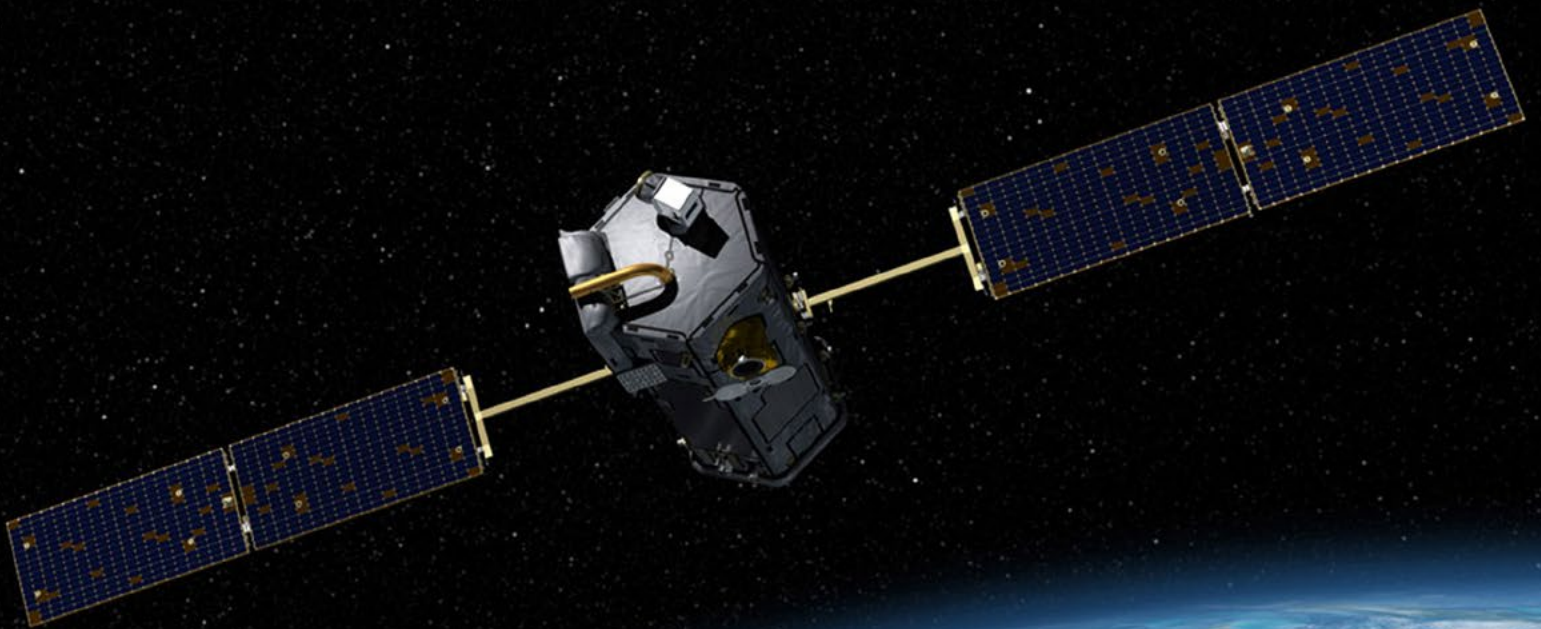
Artist's impression of Orbiting Carbon Observatory-2 (OCO-2), which makes precise global measurements of atmospheric carbon dioxide (CO₂) to help scientists better understand its sources and "sinks."

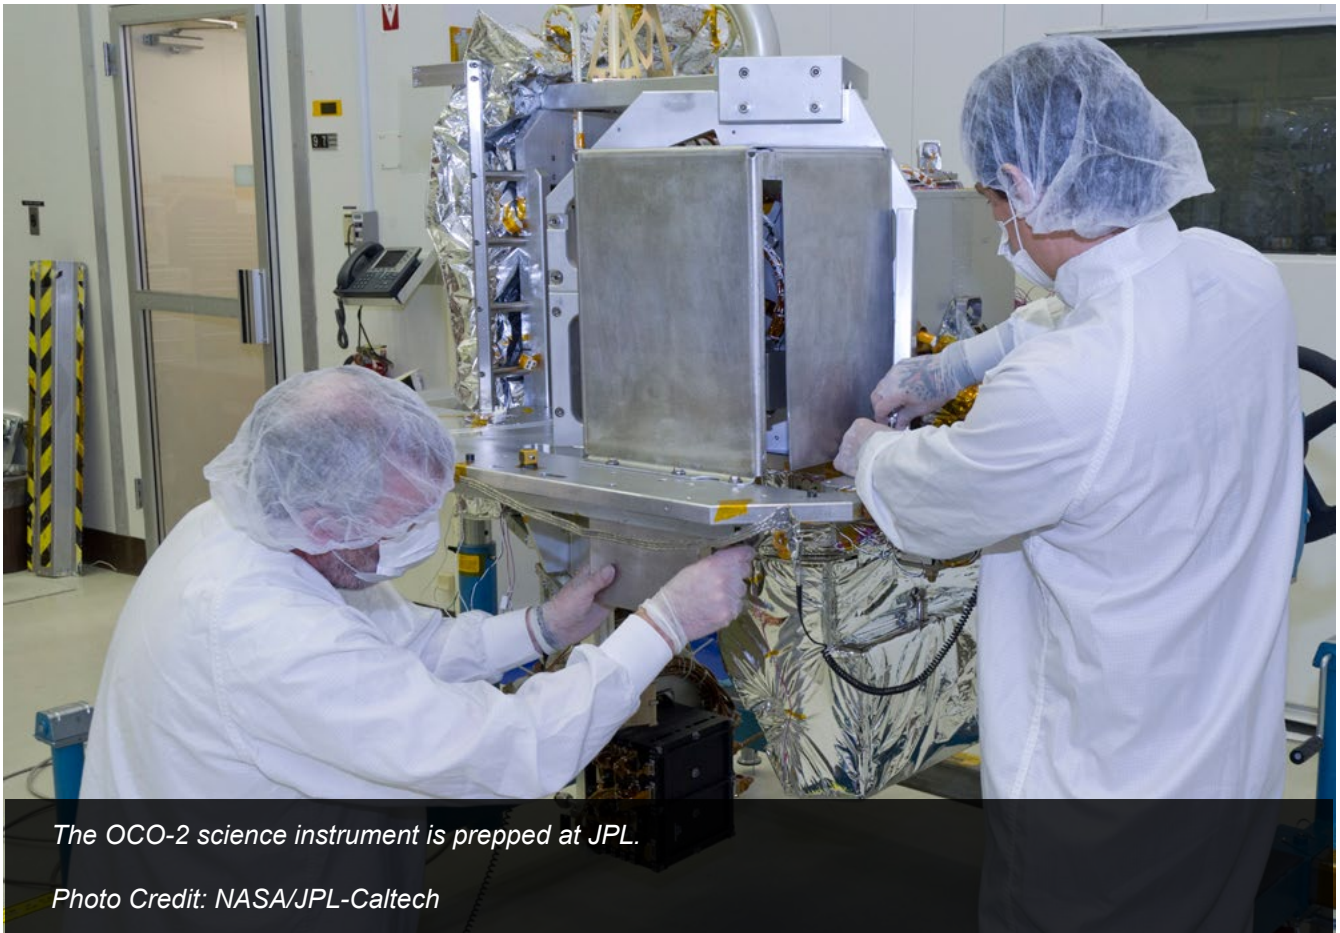
The OCO-2 science instrument is prepped at JPL.

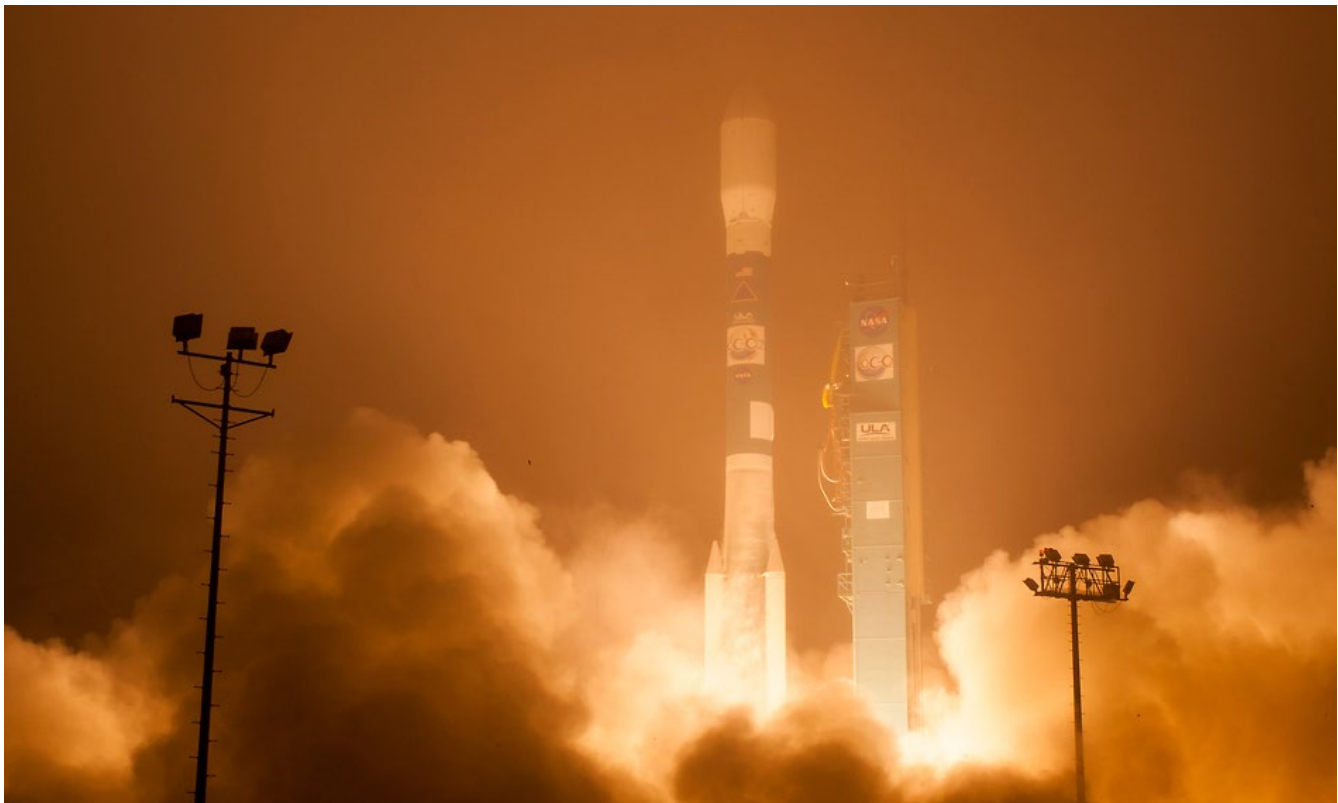
A United Launch Alliance Delta II rocket launches with the Orbiting Carbon Observatory-2 (OCO-2) satellite onboard from Space Launch Complex 2 at Vandenberg Air Force Base, Calif. on Wednesday, July 2. OCO-2 will measure the global distribution of carbon dioxide.

They ended up selecting a proven launch vehicle: the United Launch Alliance Delta II 7320 rocket. In addition to its reliability, the powerful Delta II simplified the spacecraft’s ability to reach orbit. According to Welch, “The launch vehicle that OCO used had a larger dispersion of where the injection orbit could be. So we launched into an orbit that was much lower than the A Train, which meant we needed about 20 days of thruster firings to move up to orbit. With OCO-2, I think we only had six, maybe eight, burns in total. Because the Delta is a much more accurate launch vehicle, we got up a lot closer to start with and had a lot less effort to transition to the mission orbit.”
